Paris Session 2022

Irish experience on Cable Systems accessories, lesson learned

SC B1 Insulated Cables – PS1 – Q6
Cable System accessories reliability and QA

Daniele Giustini, Ireland

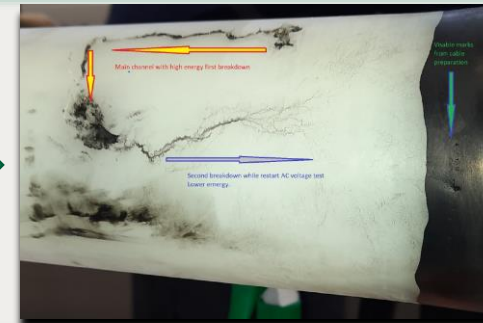
Possible reason from grinding with too high pressure so material melting and rubbed off.

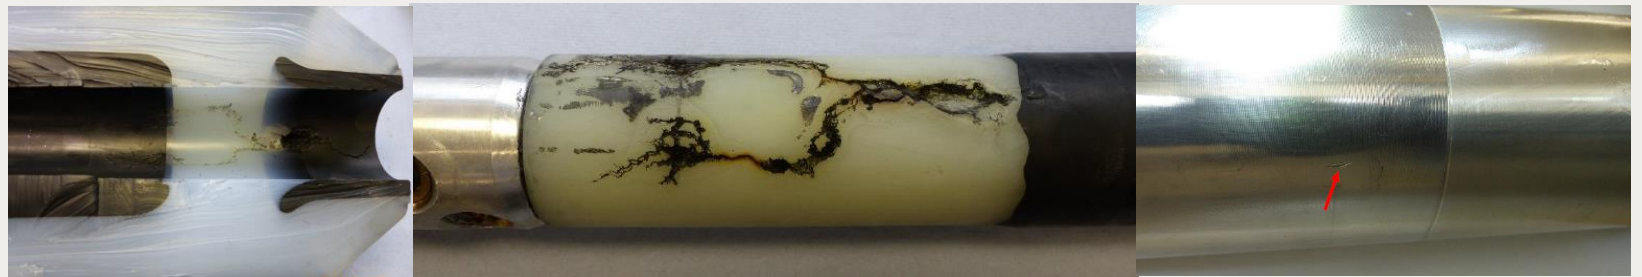
The scratches in the insulation resulted from a sharp protrusion at a gouge in the conductor connector.
