Paris Session 2022

Meteorological Data Monitoring to Improve the Fault Location and Identification

B5 PROTECTION AND AUTOMATION

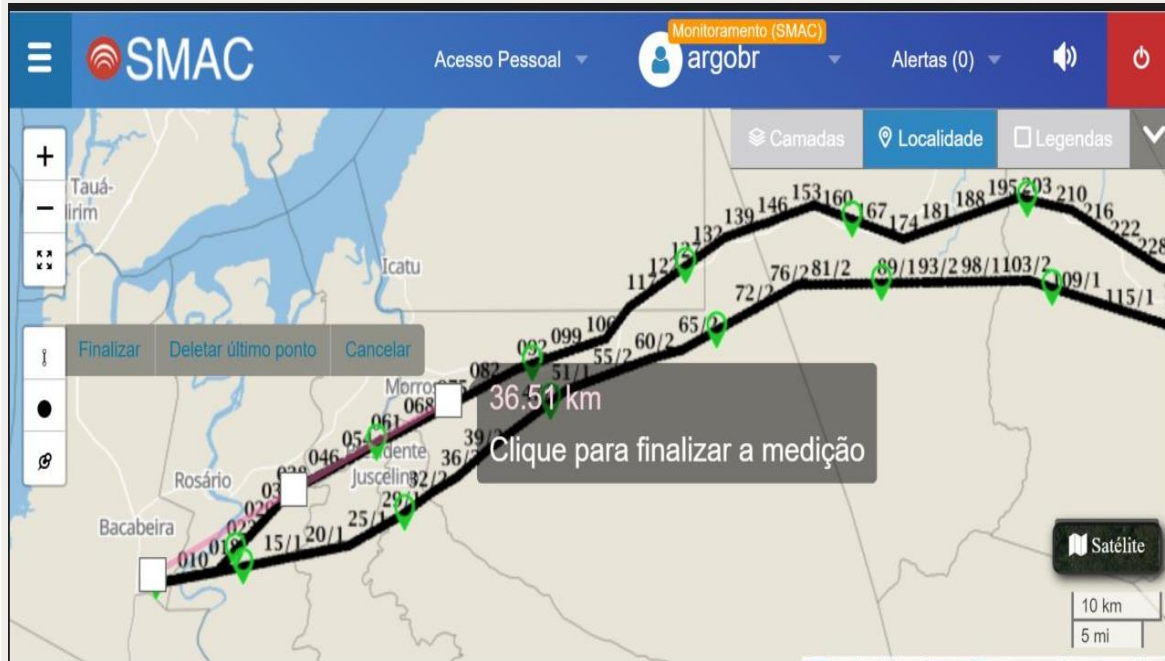
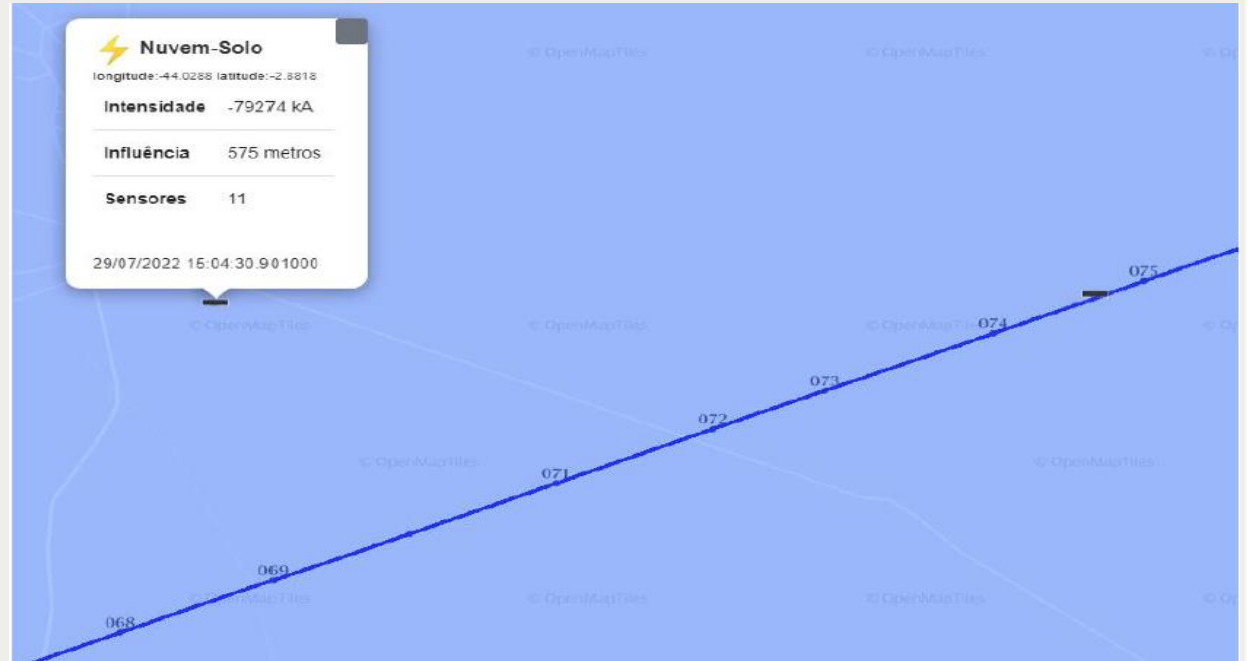
Real Case Disturbance in the BIPS

Fault Distance Calculation and Transmission Towers Identification

Atmospheric Discharge Identification and Transmission Towers Identification

- On July 29, 2022, at 15:04h (GMT-03h) there was an **automatic disconnection** of a 500 kV TL in the BIPS;
- The fault was identified by the TSO protection team department (single-line to ground fault);
- The TL has a length of **286 km** → **protection relay** identified the Fault Location (FL) at **29,9 km** from one reference terminal;
- **SMAC tool** located the fault at **36,5 km** from this reference terminal → **between towers 69 and 71**, and magnitude of AD **around 79 kA** (causing the backflashover phenomenon).

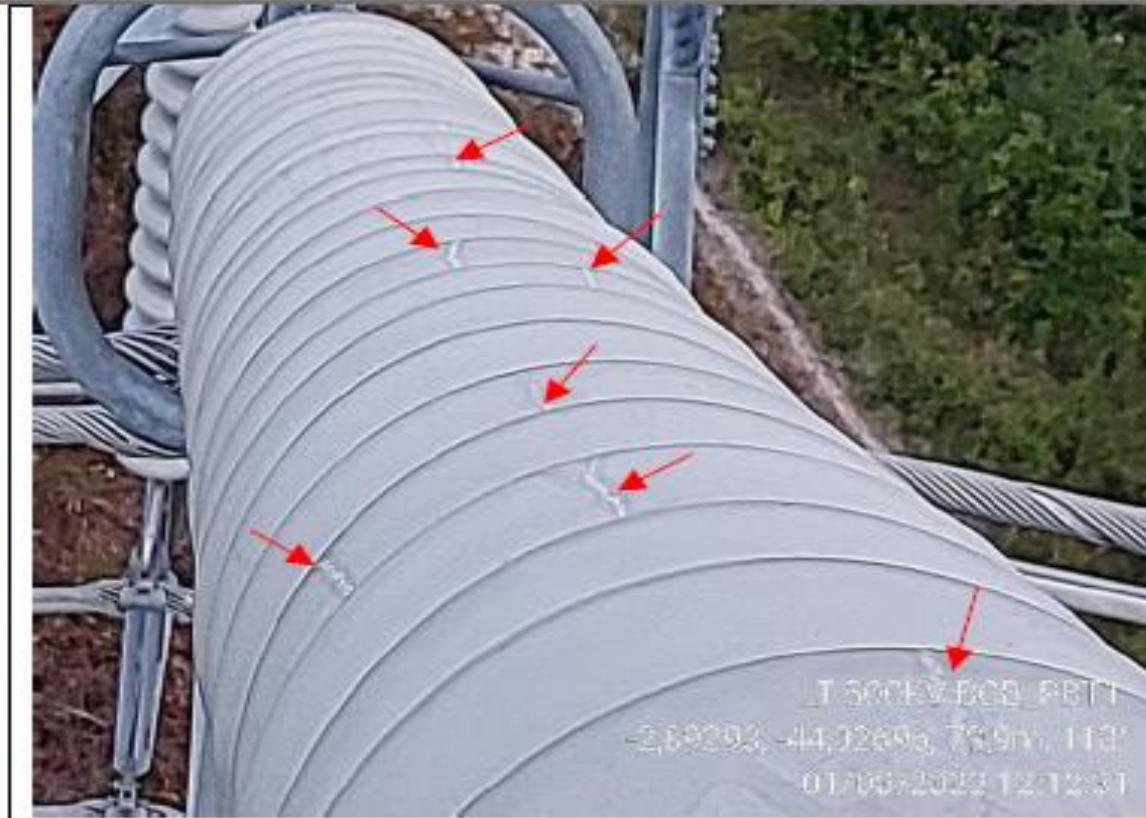
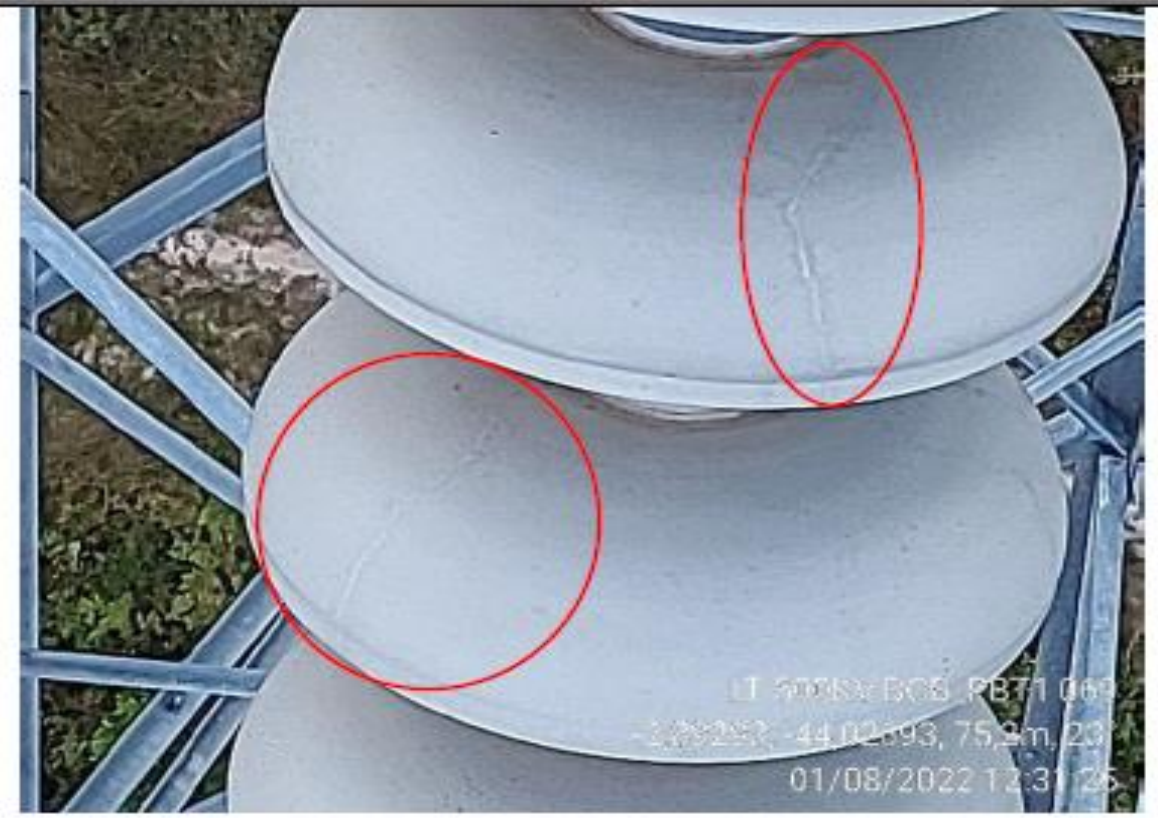
Atmospheric Discharge Identification – Tower n° 69

Field Inspection – Maintenance Team

- **After visual identification**, carried out by TSO maintenance team, **traces of AD** were found on the insulators;
- **Total time duration** after disturbance until identify the root-cause in the field using SMAC software → **2 days** only!
- **The use** of support tools to **locate** and **identify** faults on high voltage transmission lines is extremely important for **root-cause analysis** by the **maintenance** and also by TSOs **disturbance analysis team**.
