Paper ID_10249

Investigations on Vacuum Tap Changer Failures of Converter Transformers and Maintenance Suggestions

Electric Power Research Institute of China Southern Grid, China

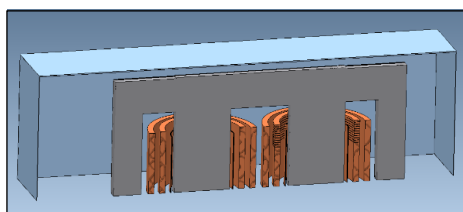
Fig. 2 1/4 3D simulation model of converter transformer of failure 1

- To save computation source, a 1/4 3D symmetry model is constructed by real geometry. The regulating winding is divided into three segments to simulate three-step voltage regulation.

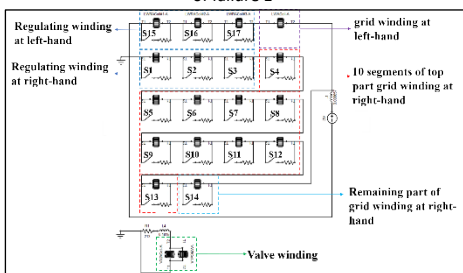
Fig. 3 Simulation circuit settings

- The load impedance at valve side is tuned to $(213+57j)\Omega$ to match the voltage and load current of grid side and valve side.
- To simulate the short-circuit of windings disk by disk, the top part of the right-hand grid winding is expressed as 10 segments of sub-windings, each segment includes 2 disks. Besides, each segment of winding is in parallel with a switch. By controlling the operation time of each switch, the dynamic short-circuit process of windings can be achieved.

- The resistance at the short-circuit point of winding is also considered, set by 0.01Ω . For the remaining part of grid winding at right-hand, the resistance is set by 4.5Ω to simulate the long short-circuit arc.

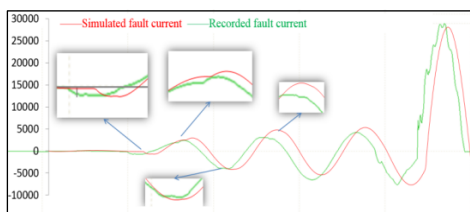
Fig. 4 Simulation fault current and recorded fault current

- The simulation step is set as 0.2ms. Before switching on S1, a period of 20ms is calculated to make the transformer stable.
- The simulation result is shown in Fig. 4, it can be seen that the calculated fault current is in a good agreement with the recorded ones. Especially, the oscillations of fault current are reproduced successfully, which can be explained as extra short-circuit of windings according to our simulation.

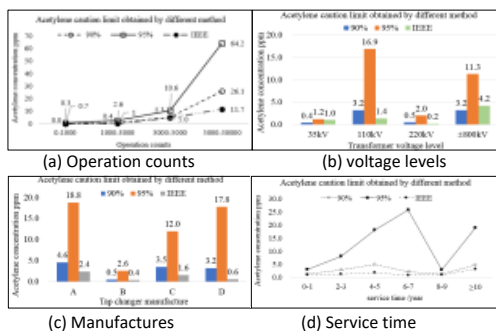
Fig. 5 distribution of caution limit of acetylene

- Caution value of acetylene is positively related to the operation counts of VLTCs, and quite dependent on the design of manufacturers. While little connections are found with voltage levels and service time.

- To apply the caution limits, different weights are assumed for each dimension. Manufacturer, operation counts, Voltage and service year is set as 0.5, 0.3, 0.1 and 0.1, respectively.
