10511_2022

Lightning strike to ground – a case study about observed cable damages, risk estimation and protection method

Valentinas DUBICKAS*, Erik THUNBERG*, Johan HANSSON*, Andreas DERNFALK**, Peter SIDENVALL**

Svenska kraftnät*, I2G**

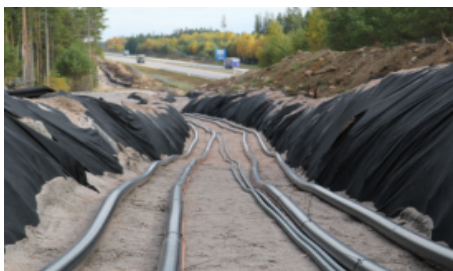
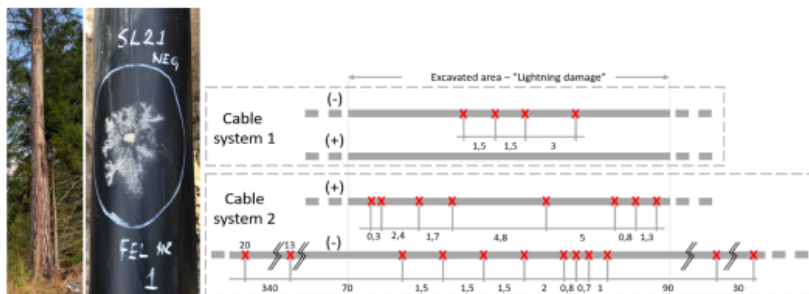
This study is about the cable sheath damages caused by lightning strike to the ground in proximity. The sheath damages were found on two parallel HVDC underground cable systems where each of them is nearly 200 km long. The damages were found at 10 locations along the cable route after approximately 7,5 years. Damages were not severe enough to immediately damage the cable main insulation system, however these allowed for water intrusion under the sheath. Observations at the locations also revealed a few lightning damaged trees in the proximity of the cable systems.

The puncture severity ranged from: only damaged HDPE sheath; puncture in Al laminate; somewhat damaged outer semiconductive layer. The circumferential location of punctures was often aligned with the edge of Al laminate seam.

Oversheath Lightning Impulse (LI) strength was tested for the cable samples of these particular cable links. It was found to be in the range 115-140 kV. The puncture locations often coincided with aluminum laminate irregularities. The effective breakdown strength including field enhancement effects found from the testing was 25-31 kV/mm.

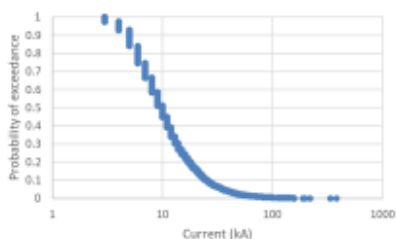
The method was developed for estimating the expected frequency for sheath damages from the lightning strike. It is based on the lightning statistics in the cable corridor, estimation of probabilities for exceeding certain lightning current magnitudes, series of FEM of E-field calculations in the ground caused by lightning current at varying distances, current amplitudes, soil resistivity and knowledge of oversheath LI strength.

- Lightning statistics and current data has been retrieved from Swedish Meteorological and Hydrological Institute (SMHI) for 10 km wide corridor along the cable route during the same period when damages occurred. Estimated average lightning strike density 0,59 strikes/(km² * year).
- FEM modelling showed that field enhancement due to Al laminate irregularities was found to be factor of ca 1,4-2.
- Combining a risk distance from the nearest cable where a strike can be expected to cause damage, together with ground strike density, lightning current distribution and total cable route length, an estimate of the number of sheath damages is found.

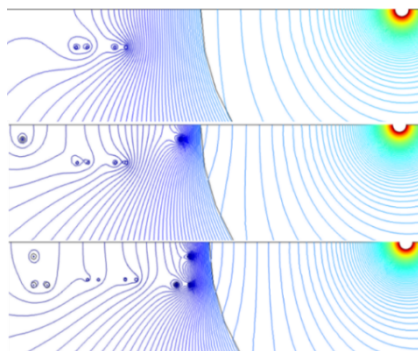
The calculated expected sheath damages per year of 1,53 correspond well with the observed 10 damaged locations during 7,5 years, i.e. $10/7,5 = 1,33$ which is equivalent to MTBF of 0,5-1 years.

Effectiveness of cable protection against lightning strikes using shield wires was investigated. Introduction of shield wires increased MTBF to 2-4 years for simpler configuration and 10-20 years for more complex.

A protection method using buried shield wires introduced parallel to the power cables was investigated. With increasing complexity of the arrangement, the MTBF could be sequentially improved. The most complex configurations resulted in MTBF of ca 10-20 years, however even simpler configurations can provide adequate protection.
