Study Committee B1

10690_2022

Investigation of Cause of Breakdown and Replacement of 275kV SCOF Cable by XLPE Cable in Japan

TEPCO Power Grid

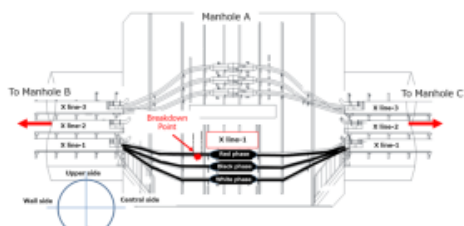
Fig.1 Location of insulation breakdown

- In 2019, a 34-year-old 275 kV SCOF line (copper 2000 mm² with aluminum sheath) broke down
- The insulation breakdown occurred immediately after the restart operation

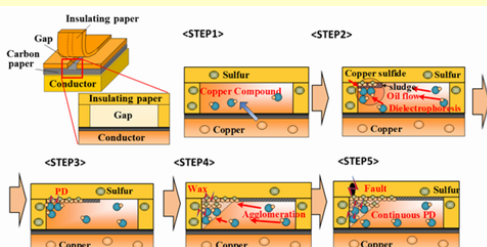
Fig.5 SCOF cable charging degradation mechanism

- Step1. Copper is dissolved from the conductor and other components into oil as copper compounds
- Step2. Oil flows and dielectrophoresis make copper compounds concentrate in the paper gap, leading to oxidation sludge and copper sulfide
- Step3. Minor PD occurs
- Step4. Copper compounds agglomerate and PD makes wax
- Step5. Continuous PD occurs and it result in loss of insulation strength
- Step6. A switching surge causes a dielectric breakdown

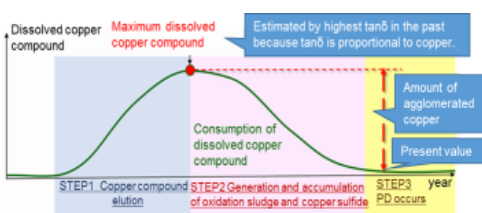
Fig.7 Concept of diagnostic method using ICP measurement

- ICP diagnosis is a diagnostic method for determining the progress of imposed deterioration based on the amount of dissolved copper and the amount of gas generated.
- The diagnosis results were compared with the results of dismantling surveys and reported to be approximately 96% consistent.
