Study Committee B1 Insulated Cables

Effective Strategic Planning in the Restoration of a Submarine Cable Fault

Ibrahim ALNASSER*, Yasir AHMED¹, Paul O'ROURKE²
 Saudi Aramco¹/GreenLink²

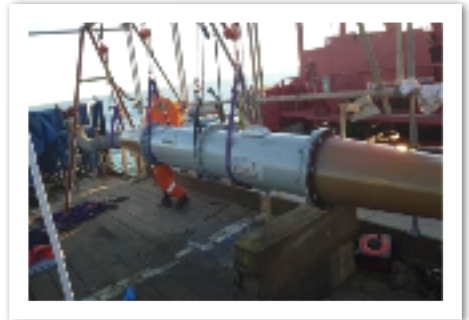
• Figure 2. Completed Joint #1 prior to laydown

- Extensive water travel in cable resulted in a three-joint repair

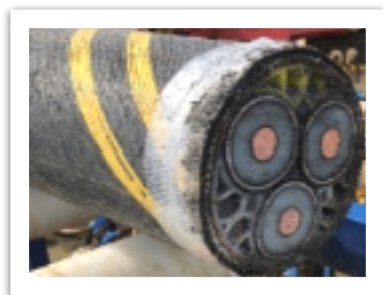
• Figure 6. Cross section of subject cable

- Fault was caused by the anchor penetrating one cable up to the conductor.

- The huge mechanical force on the submarine cable led to abnormal phenomena of extensive water travel, protrusion of the conductors, shrink back of the insulation, and loose adhesion force between the conductor and the XLPE insulation.

- Cable was stretched due to the huge mechanical force exerted by the ship's anchor, which created a channel between the conductor and insulation.
 - The water penetrated the cable core through the hole caused by the anchor and flowed relatively freely in the channel between the conductor and insulation.

- The aforementioned abnormal activities stretched the cable copper conductor beyond the plastic limit and XLPE insulation below the plastic limit
 - Cable manufacturing is in accordance with the design specifications.
