10955_2022

Time to Failure Testing of Model HV XLPE Cables in Salt Water at High Electrical AC Stress and Temperature

¹Sverre Hvidsten, ²Karl Magnus Bengtsson and ²Elise Olsen

SINTEF Energy Research¹, Nexans Norway²

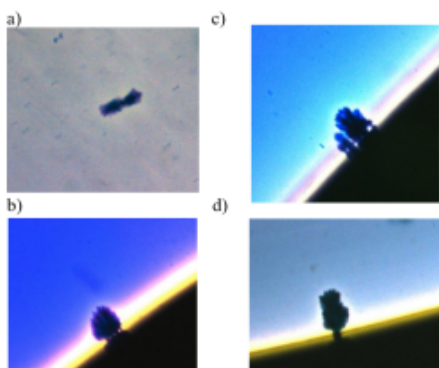
Figure 6: a) 138 μm long vented water tree growing from the conductor screen (Cable No. 2). b) 130 μm long vented water tree with inception site close to the end section for Cable 5. c) Bow-tie tree growing in the insulation of Cable No. 2 with a length of 123 μm . d) 140 μm long vented water tree growing from the insulation screen in Cable No. 4.
