11164\_2022

## Experiences and Insights Rehabilitating a 69kV SCFF Cable System after Pressure Loss

### Project Overview

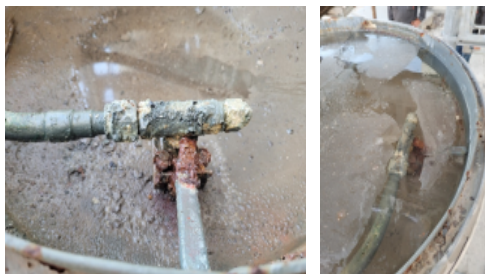
### Corroded Oil Reservoirs

- After the cable system pressure gauge dropped to zero the facility was directed to immediately take the circuit out of service
- An inspection was then performed to determine the cause of the pressure drop and any other issues present on the cable system
- One of the trifurcating joints was leaking in two places which caused the system to lose all hydraulic pressure
- The inner valves and fittings of the oil reservoirs were severely corroded
- Initial DGA and moisture content testing showed elevated results

- The old, damaged reservoirs and piping were replaced with new, pre-pressurized oil reservoirs and piping so oil could be added and the hydraulic system controlled upon repair of the leaks
- New oil reservoirs were filled with DF100 synthetic fluid
- Leaking fitting on the trifurcating joint was replaced with a new fitting
- Old, leaking lead wipe was removed and a new wipe was performed between the cable sheath and the joint body
- Lead wipe was tested for leaks using a whitewash of talc and alcohol
- Reinforcing wire was then added and sealed with self-amalgamating and PVC tapes
