Paper 11165_2022

Developments towards a Risk Based Maintenance program to reduce fires at LV cable terminations and plastic enclosures

André CUPPEN^{*1}, Bernard GREENWOOD², William HEFFERNAN³, David BREDDA²

¹Powerco Ltd., ²Unison Networks Ltd., ³EPECentre

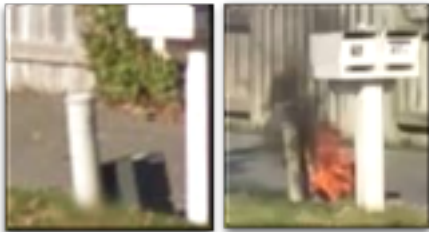
A fire occurred at an LV pillar which resulted in the complete destruction of the pillar, and property of the customer damaged. The figure below show a pillar before, during and after a fire.

The result of this fire was fire damage to customer's mailbox. Figure 2 below shows the remains of two similar style pillars, of different brands, after a fire.

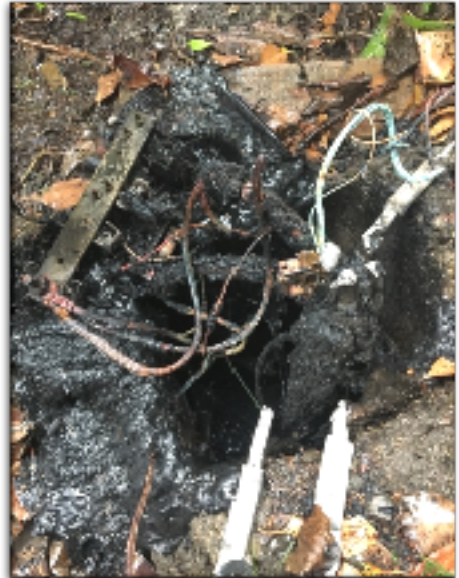
Fault investigation result

The clip showed that a short circuit occurred while the fire was in progress, and the power stayed on for more than 2 seconds. This indicates that the short-circuit was the effect of the fire, not the cause.

Analysis of the video and photos taken of the fault event indicates that a sustained arc event can be triggered by a fire occurring at a pillar. The fire in turn could be the result of a fault of a component inside a pillar.

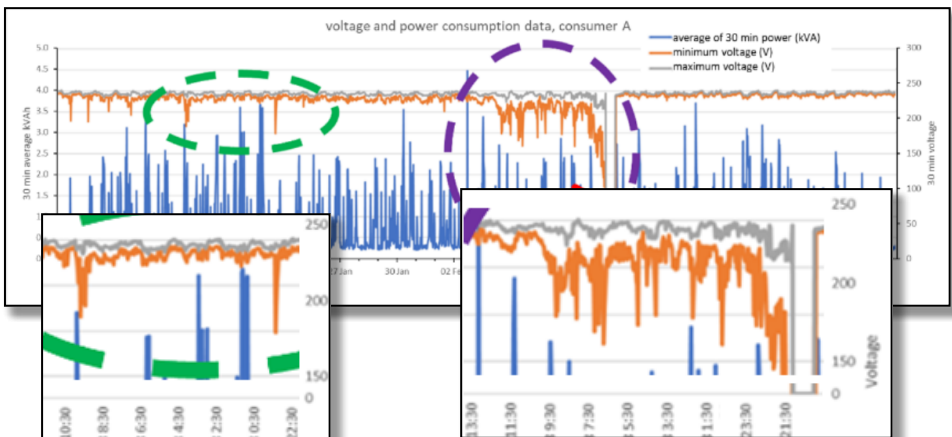
'Fault detecting' smart meters

Smart meter data from the customers showed that poor power quality had preceded the event for weeks. voltage and current disturbance waveforms preceded the fault many weeks and days before the failure. These disturbances can even be detected in the data collected by the 30-minute intervals measured by the 'smart meters' installed in the NZ power network.

Disturbances in voltage may be useful as a diagnostic indicator. Fault monitoring equipment that detects 'temporary short-circuit transients in a real grid' as explored by [5] or Power Quality Meters as employed by [6] could provide diagnostics to detect these defects on LV cable circuits.

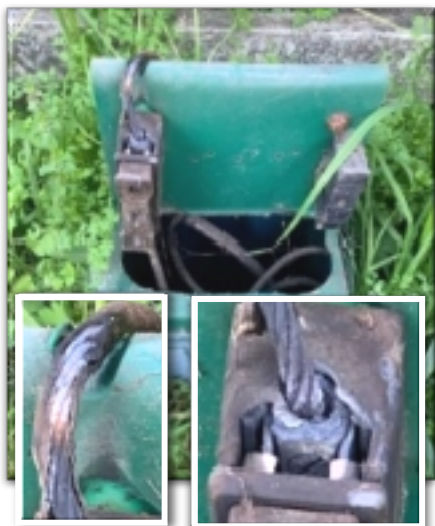
Hot connections on the fuse holder can damage both the fuse holder, the connected cables and the pillar housing.

Signs of overheating due to a 'hot connection' include among others A) melted and deformed plastic, B) signs of pyrolysis (incomplete combustion) such as blackening, soot and brittle of the cable insulation & fuse holder, and C) signs of high temperature corrosion.

The figures above shows an example of a fairly new fuse holder melted and charred electrical cable inside a pillar.

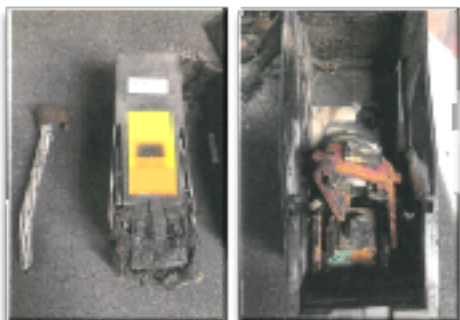
The figures below example of aluminium cable conductor of which the insulation has charred off (left), the heat damaged fuse holder base and insert (right) note the grub screw and part of the connection plate still connected to the conductor

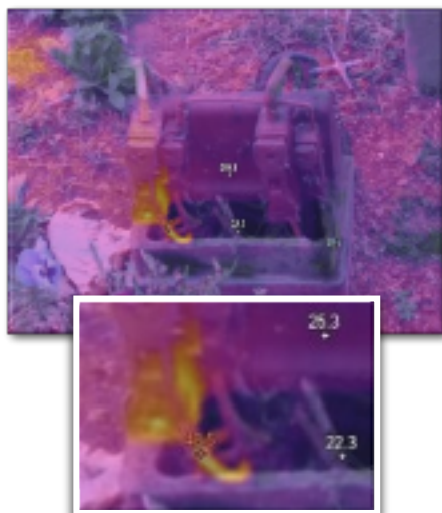
Thermal scan of a hot connection

The newly developed internal inspections includes a thermal scan of the pillar components. The pictures below shows an example where a hotspot is evident on one of the fuse holders: 48.5°C is evident at one end of the fuse holder, while the pillar body is at 25.3 °C.
