Overhead Lines

10766\_2022

### Operational Evaluation of RTV Coating Performance over 17 years on the Coastal Area at Jubail-SA

JAAFAR A. ALTHAWAB, MUSLEH A. ALAMERI  
Saudi Electricity Company – National Grid-SA

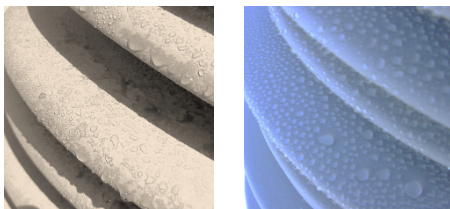
#### Physical Appearance of Coating Paint over the Case Study period:

- Minor cracks and aging on RTV coating were observed only at the portion close to the High Voltage side of some insulators.
- Some surface discoloration changes from grey to light black at the portion close to the H.V side.
- No erosion or coating chalking was detected
