## Study Committee C2

### Power System Operation & Control

#### Paper 10159\_2022

# Brazilian Power System Operation under extreme operating conditions: recent examples and proposals to face future challenges

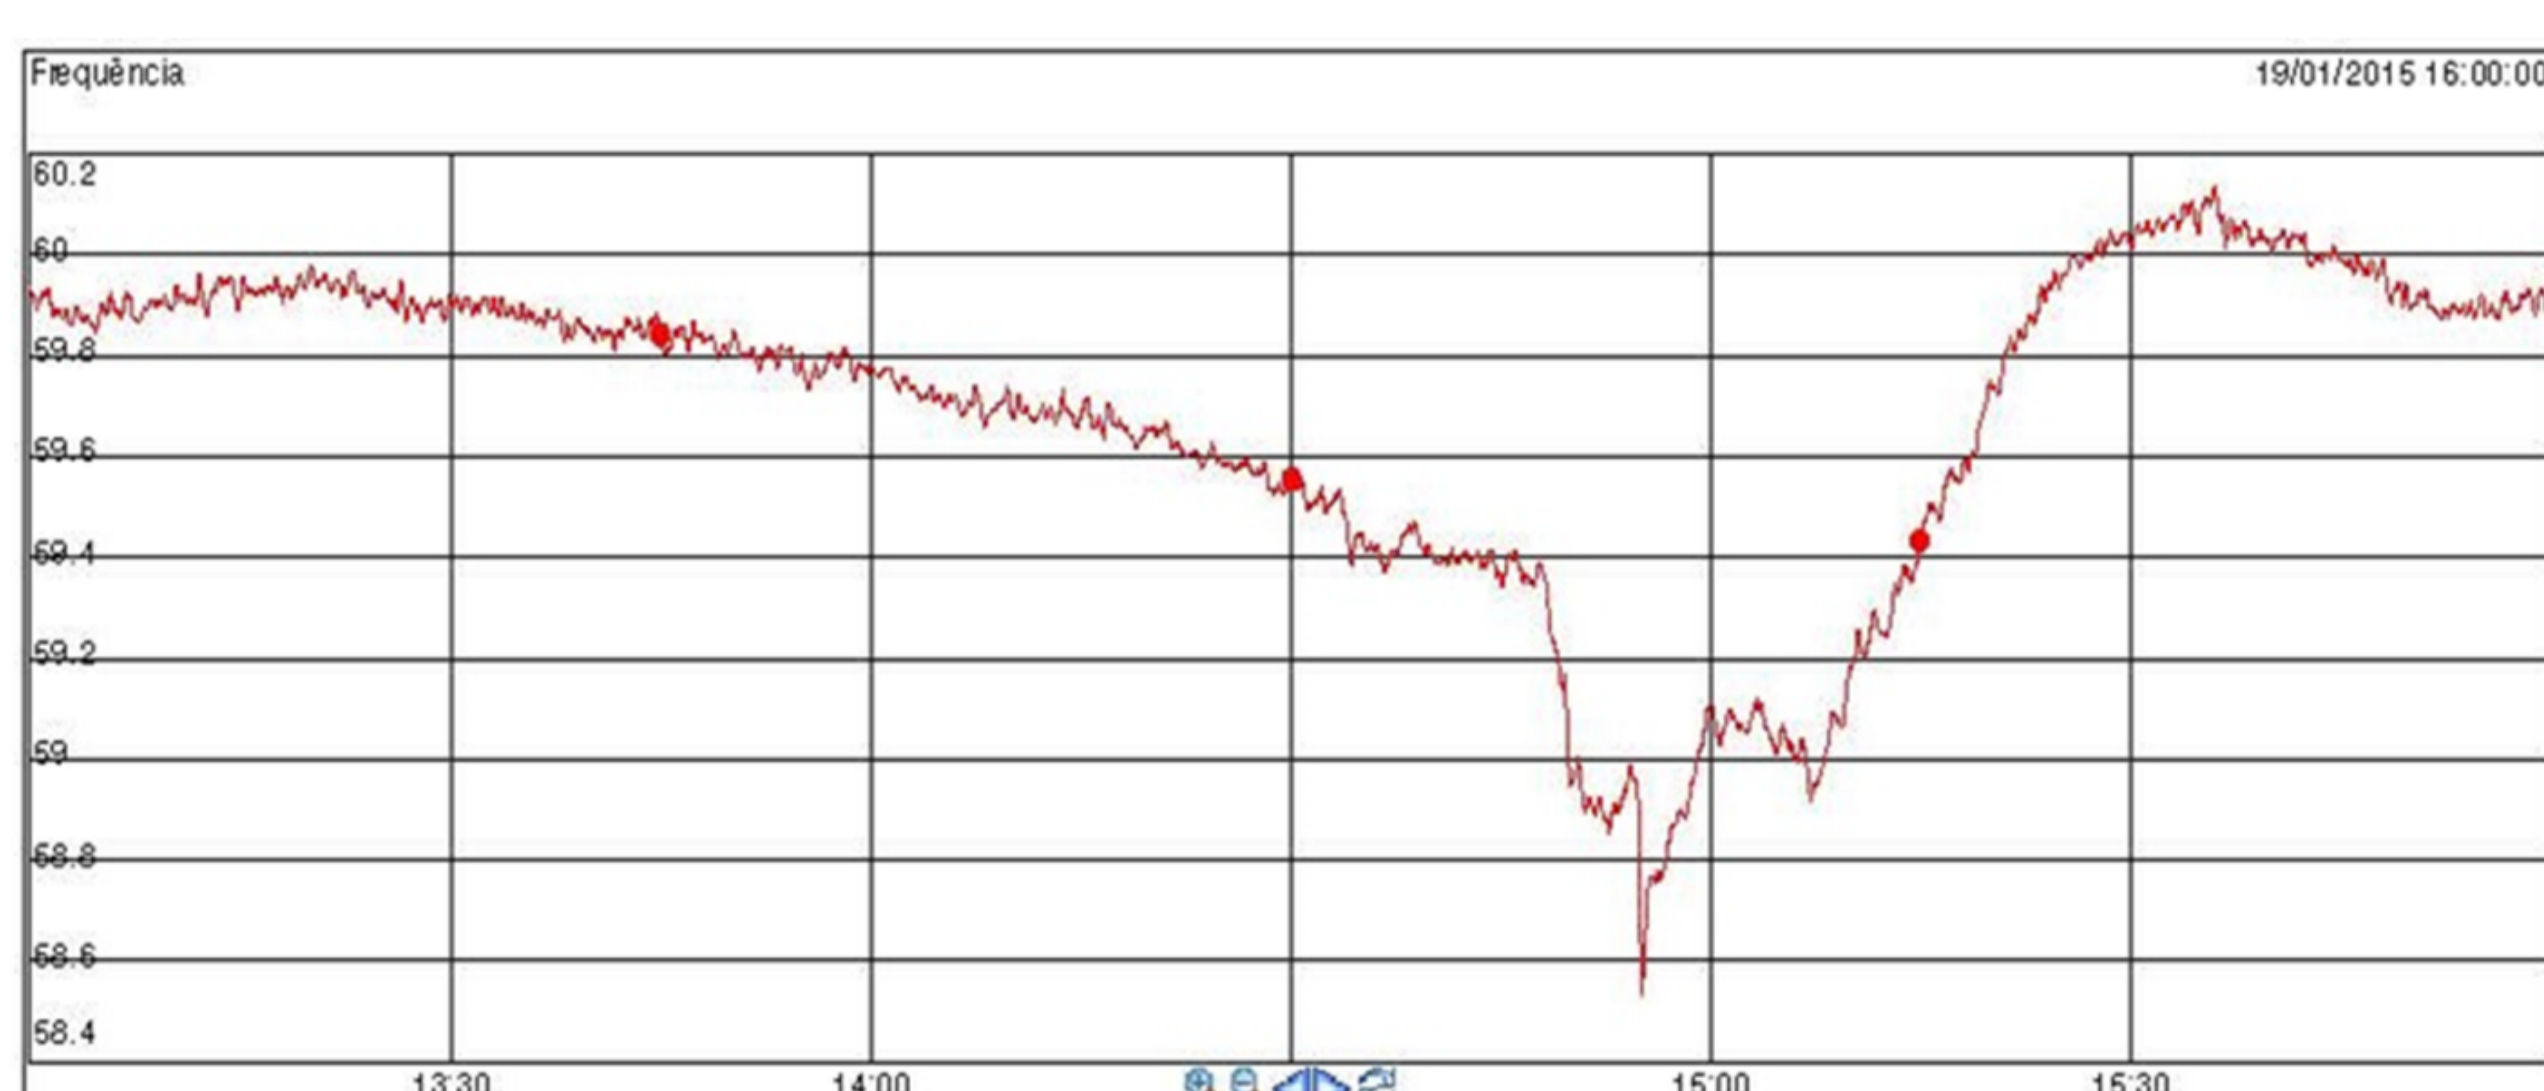
From 2:48 pm, with the frequency stabilized at 59.4 Hz, a double contingency occurred, leading the SE/N inter-regional interconnection to disconnect, causing an abrupt drop in frequency, which reached values below 59 Hz, imposing the need to carry out manual load cuts in the Southern, Southeastern and Midwestern regions.

At 2:55 pm, following the loss of another generation block, the frequency reached the value of 58.53 Hz, requiring additional load cuts in the S/SE/MW regions.

Figure 1 shows the BIPS's frequency graph on the day of the disturbance, with emphasis on the interval 1-4:00pm

To restore the BIPS's frequency, manual load cuts were commanded by ONS and totaled 4,447 MW in the Southern, Southeastern and Midwestern regions.

The execution of the requested cuts, together with the operation of some generation units that had been turned off, were effective in restoring the BIPS's frequency, which returned to 60 Hz at about 3:25 pm. From then onwards, it was possible to gradually start load restoration, which was virtually completed at 3:55 pm.

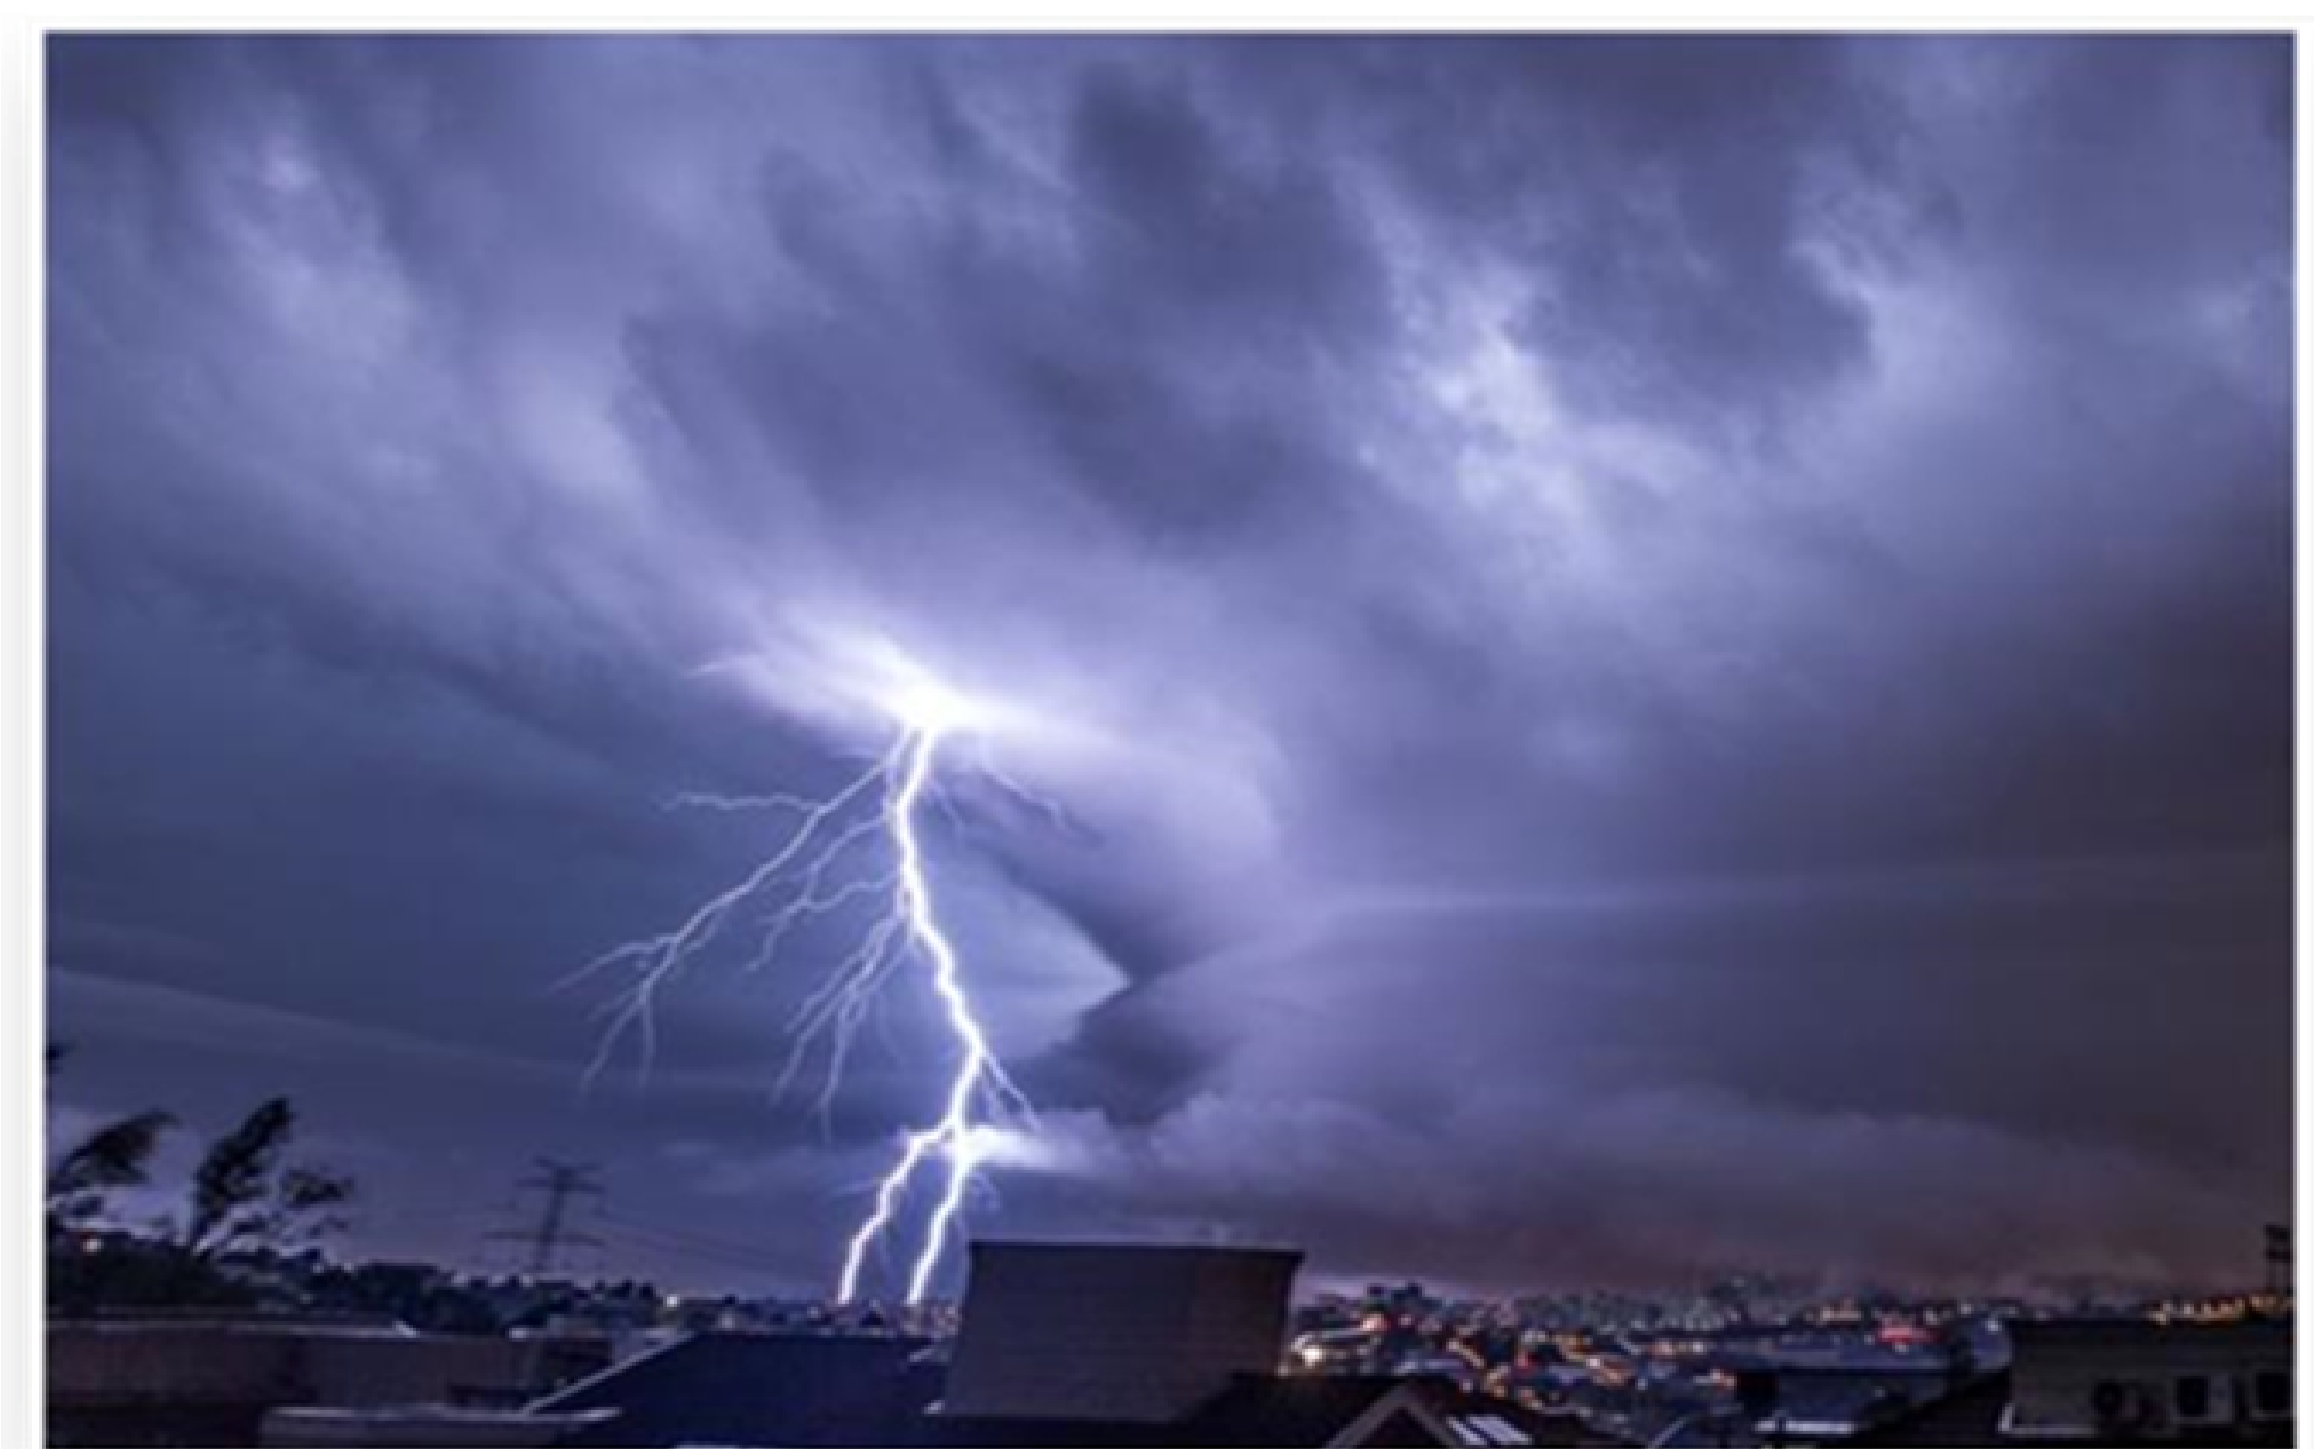
In the period from June 1st to 6th, 2016 there were very adverse weather conditions in the state of Sao Paulo. In the early hours of Sunday (June 5th), there were almost seven hours of rain in the city of Campinas (SP), with 1,450 atmospheric discharges. Figure 2 shows a photo of the exact moment of one of the micro explosions that hit this city. According to UNICAMP's Meteorological and Climate Research Applied to Agriculture (Cepagri), the repetitive behavior of micro explosions in previous days, alerted to the possibility of the phenomenon becoming more frequent with the climate changes underway on the planet.

Figure 2 - micro explosions verified in the city of Campinas

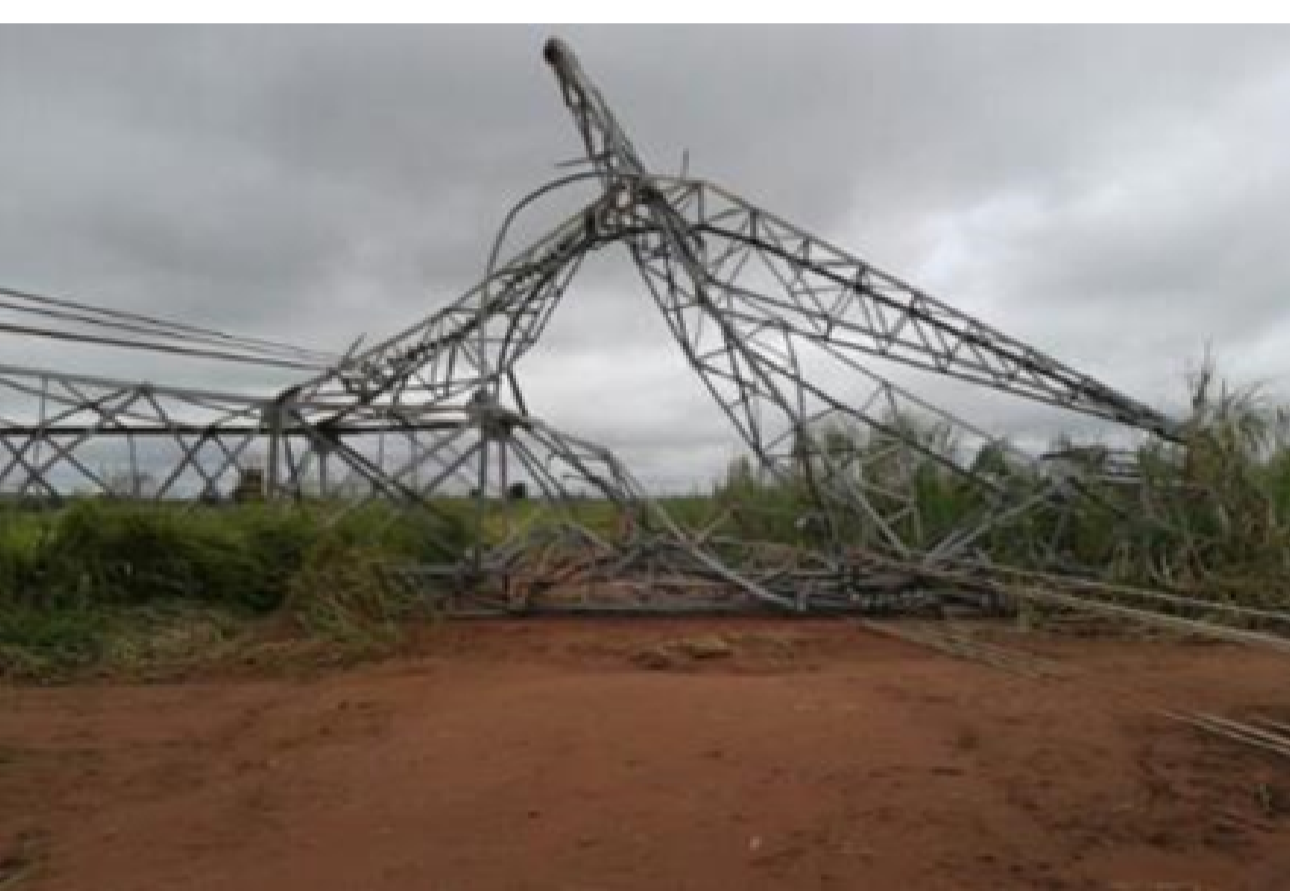
The following figures depict the damage caused by storms on some 440 kV transmission lines (figures 3 and 4).

Figure 3 - Bauru-Cabreuva TL

More than 50 towers were destroyed, leading to the outage of 16 (sixteen) 440 kV circuits. The average transmission lines repair took 11 days.

Immediately after the disconnection of the Lines, CTEEP transmission company concentrated efforts on identifying/restoring the affected lines.

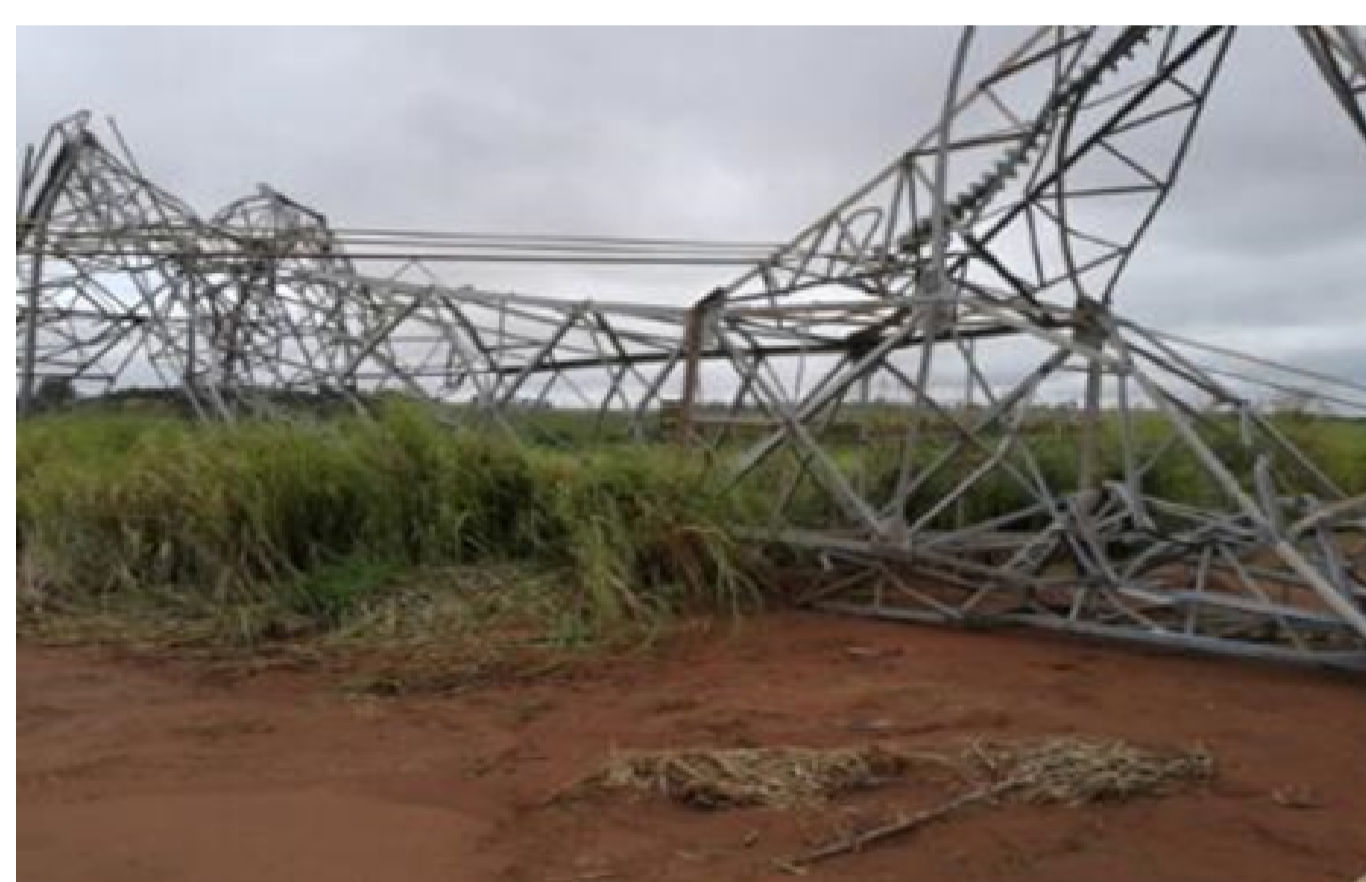
Figure 4 - Bauru-S. Angelo TL
