Study Committee C4

Paper ID: 850

SYSTEM FOR AUTOMATIC EVALUATION OF LIGHTNING EFFECTS ON TRANSMISSION LINE AND SUBSTATION EQUIPMENT

Case study 1: PREDICTION OF SURGE ARRESTER FAILURE

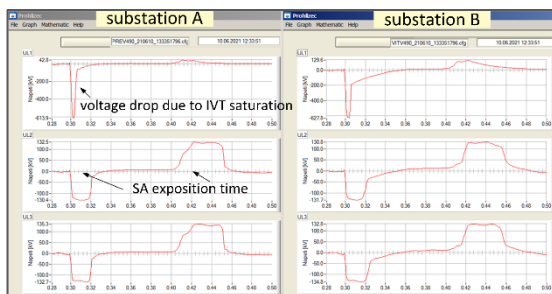
Simulated voltages on the secondary side of IVTs

Simulated voltages on the primary side of IVTs (surge arrester exposure)

$$V_p = 630 \text{ kV}, I_{ch} = 189 \text{ A}, t_p = 100 \text{ ms}$$

- If the ET-LEADS system was in operation, the high risk of surge arrester failure would be indicated
- The overvoltage was caused by the lightning event – see the database table of coupled lightning detection and transmission line position data

- The surge arrester in the L1 phase, which was damaged by the lightning event, was short-circuited and completely destroyed due to the high-energy absorption after the power line energization

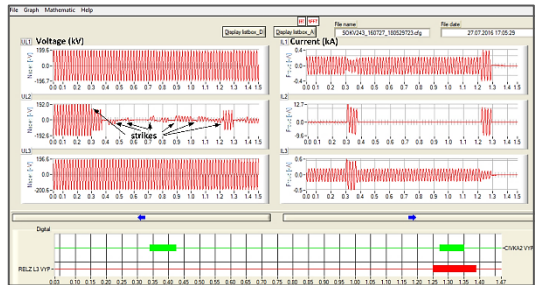
Failure record of the short-circuit event and following unsuccessful reclosing

- Investigation of the 220-kV outage is presented
- The unsuccessful reclosing operation occurred after short-circuit on the power line
- The results of transient analyzes were not available for TSO operation staff

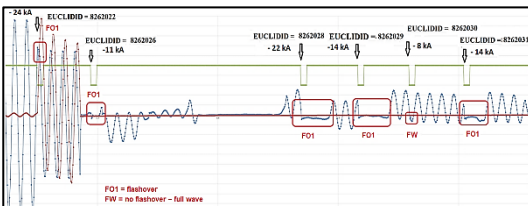
Failure record of the short-circuit event and following unsuccessful reclosing association with direct stroke to power line

- The ET-LEADS algorithms for equipment failure do not find any relevant risk
- If the ET-LEADS system was in operation, the line outage time would be significantly reduced
