**Study Committee SC-A1 | PS 3 – DEVELOPMENTS OF ROTATING  
ELECTRICAL MACHINES AND OPERATIONAL EXPERIENCE**

**FAILURE OF LARGE TURBO-GENERATOR DURING FIRST RUN-  
CASE STUDY OF INDIAN POWER UTILITY**

**R C Jha**  
**NTPC Ltd.**  
[rcjha@ntpc.co.in](mailto:rcjha@ntpc.co.in)

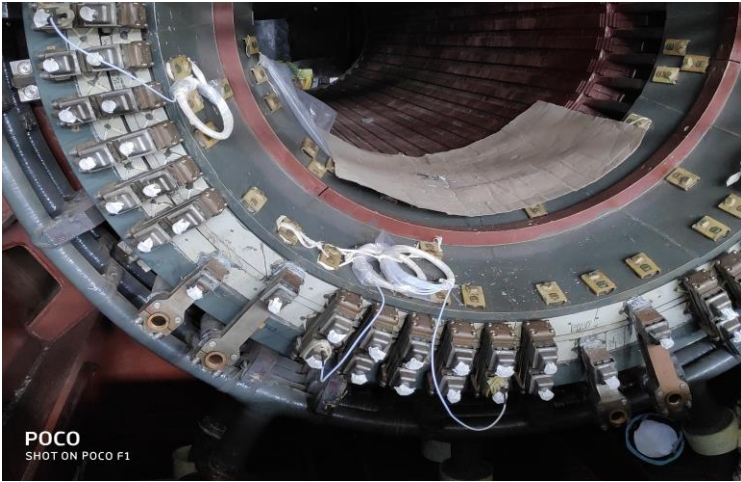
The Generator tripped on earth fault and after several iterations the fault was traced to CBBs. In the CBBs, overheating had occurred, and insulation failed at several locations (Fig.4). The root cause analysis revealed obstruction in the Hydrogen cooling path.

Fig.4 CBBs of the case study. Hydrogen entry path openings in CBBs can be seen

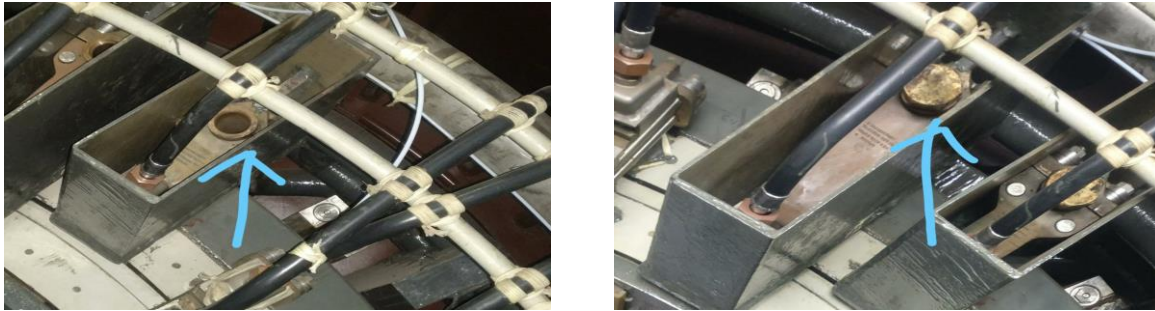
During inspection, it was observed that the packing envisaged by factory included plugs (caps) at the entry points of cooling gas to CBBs to avoid foreign material ingress during transportation and erection at Site (Fig.5). These caps were supposed to be removed before boxing up the Generator. This activity was missed out. Blocked cooling caused severe thermal stress to CBB insulation during the initial operation.

Fig.5 Hydrogen cooling entry point (LHS) and temporary plug (RHS)

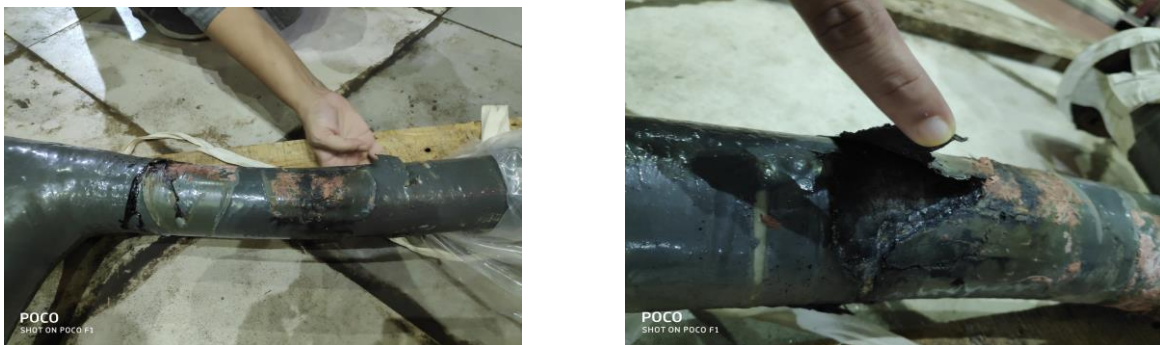
As there is no instrumentation envisaged for monitoring, alarm or tripping, the above problem went undetected. The CBB insulation got charred at several places (Fig.6).

Fig.6 Detailed view of charred CBBs.

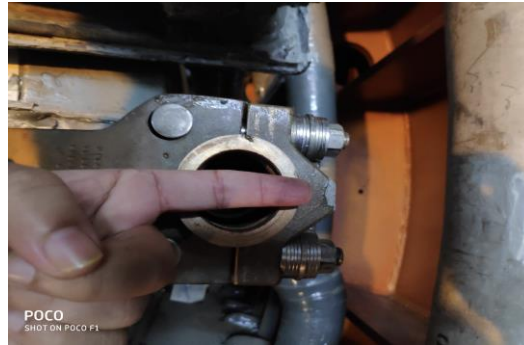
Fig.7 A simple check to ensure free passage of cooling path.

It is worth to mention that the CBB experiences a very high thermal as well as mechanical stress and is not being generally monitored in large generators. A simple air-flow check by blowing clean air into one end of the CBB and feeling at the other end by hand to ensure clear passage to gas (suspecting a foreign material incursion) might have alerted the staff (Fig.7). Now, OEM has provided temperature monitoring by fixing duplex RTDs on each phase and neutral side CBB and the same shall be followed in future to monitor this critical part of generator winding. Field checks have also been introduced.
