**DAMAGED GENERATOR ROTORS:
THE ECONOMIC AND LOGISTICAL BENEFITS OF REPAIR OVER SCRAPPAGE**

Wojciech BETLEJ
Quartzelec Ltd
United Kingdom
wojciech.betlej@quartzelec.com

The following scenario occurred on a 140 MVA generator in a Ghanaian power station, causing severe damage to several rotor components. The customer report confirmed that issues with one of the circuit breakers occurred, tripping the generator during run-up. Subsequent attempts to start the machine were unsuccessful and static electrical checks indicated a problem and the decision was made to unthread the rotor and conduct the appropriate investigation.

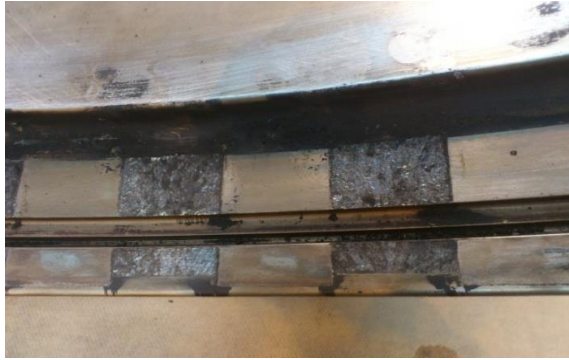
Figure 2 & Figure 3 clearly show severe damage caused by high currents flowing in the damper circuit during the motoring incident. When the rotor is stationary, there are no centrifugal forces to load the slot content against the rotor to cause full contact between the ends of the rotor slot wedges and the end winding retaining rings. Contact between the slot wedge flanks and wedge slot flanks also becomes intermittent.

Most of the induced currents flow through the aluminium wedges and rotor body surface, causing substantial heat to be produced when a high resistance joint occurs between two damper circuit components. This explains the severe arcing damage on wedge tips, flanks and retaining rings. Similar damage was found in every slot dovetail.

Figure 2. Molten retaining ring fit area

- Both retaining rings showed evidence of severe arcing damage and were not safe for return to service.
- Existing retaining rings were reverse engineered. New retaining rings were manufactured from 18/18 material to ASTM A289.

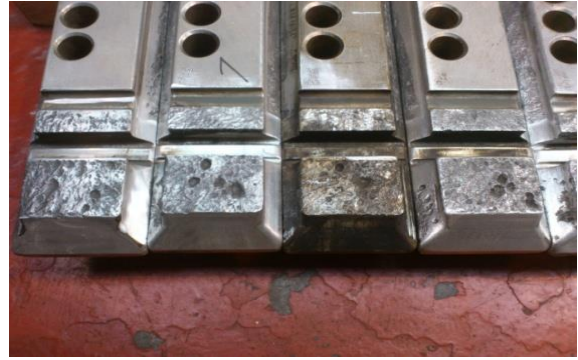
Figure 3. Molten wedges

- All aluminium wedges showed evidence of severe arcing damage along their entire length and were deemed unfit for use.
- Because the rotor slot dovetail was opened to remove arcing damage, new wedges were required.
- Existing aluminium wedges were reverse engineered.
- New wedges were manufactured to incorporate new modified shape and original vent hole configuration.

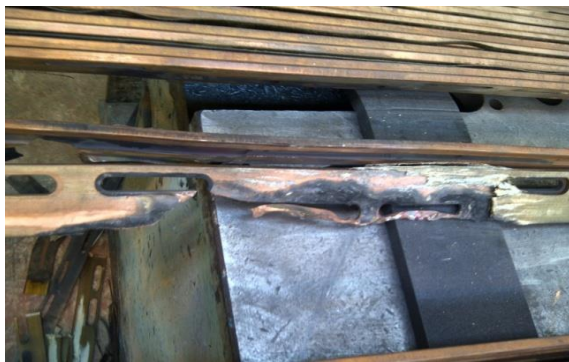
In addition, more almost 20% of the copper winding on the rotor had either been melted away or suffered severe distortion. See Figure 4 & Figure 5 below.

Figure 4. Molten copper from slot 24

- The rotor copper was thoroughly inspected to identify damaged turns.
- Hardness tests were conducted to review the condition of coils affected by high temperatures.
- Collapsed copper corners were found on every top turn, prompting the decision to replace every coil.
- Approximately 20% of the winding was deemed unsuitable for re-use.
- New copper turns were manufactured using silver bearing copper, drawn to incorporate the contraflow cooling system.

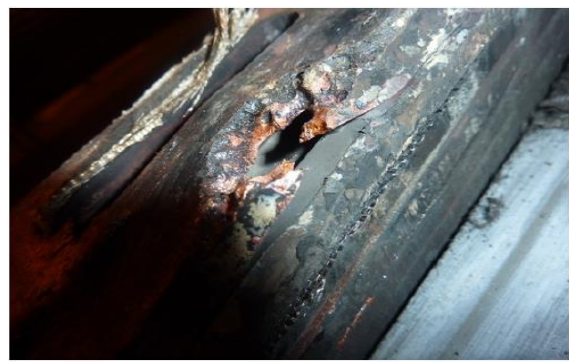
Figure 5. Molten copper from slot 11

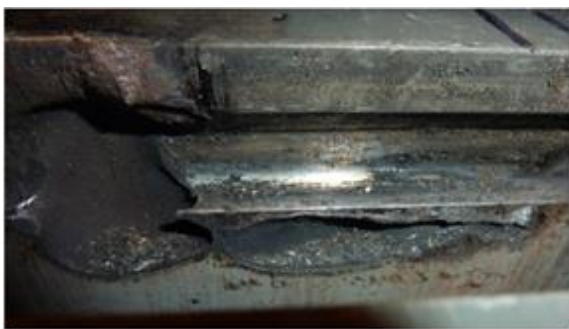
Later investigation confirmed the presence of a double earth fault, resulting in severe arcing damage. Two deep excavations (250mm and 300mm axially, up to 20mm deep) were found within two of the forging slots where material had vapourised at the site of the earth faults. It is believed that an earth fault had occurred during attempts to run the generator after the motoring incident. See Figure 6 & Figure 7 below.

Figure 6. Molten tooth in slot 11

- The locations of the earth fault on the rotor body were dressed out.
- Metallographic replicas recorded to make sure that the heat affected zone was completely removed.
- Additional hardness tests were conducted in multiple locations around the damaged area.
- A weld repair to the rotor body was subsequently carried out (see below).

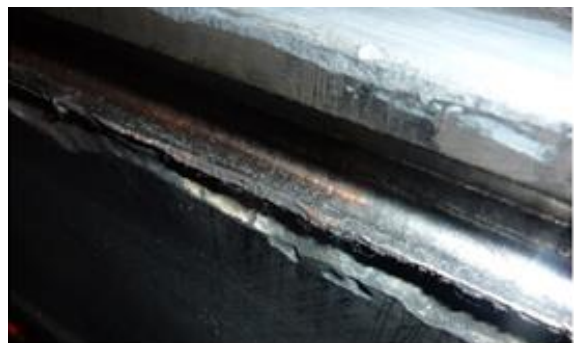
Figure 7. Molten tooth in slot 24

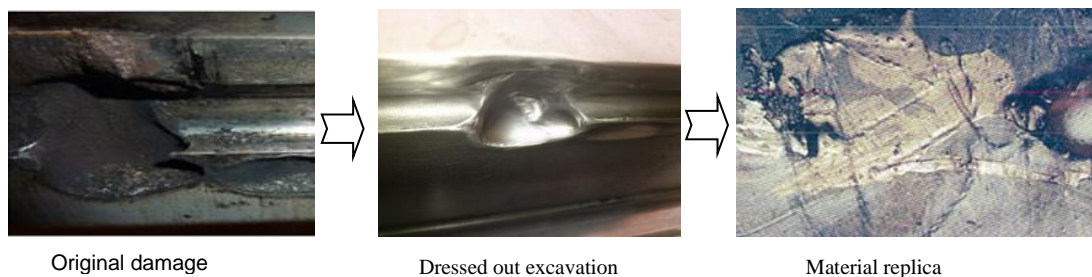
Figure 8. Earth fault location recovery process

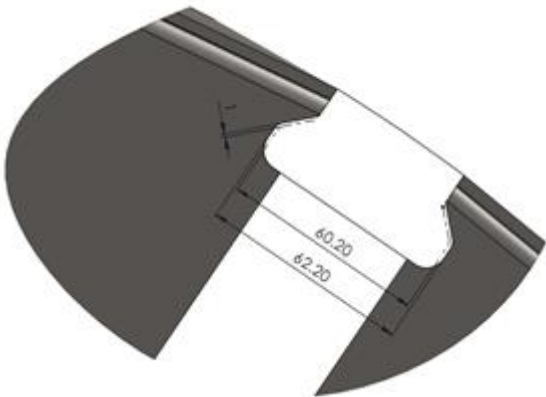
To determine if machining the profile to remove the damage material was acceptable an FEA study was undertaken of the original profile and of the new profile, see Figure 10.

Figure 10. New profile dimensions and the old in chain dotted

- Severe arcing damage was confirmed in all rotor dovetails.
- The depth of the most severe damage was measured.
- It was identified that it was necessary to open every slot by 1mm in order to remove all damage.
- stress analysis of the rotor teeth was conducted to prove the mechanical integrity of the new dovetail and wedge design (see below).

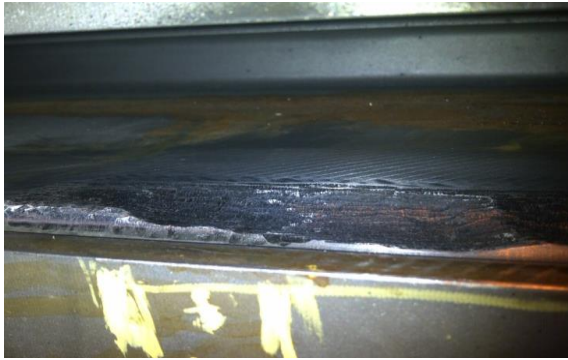
Figure 19. Slot 24 ready for weld repair

Once the excavations had been prepared by the removal of heat-affected areas – confirmed by performing a set of material replicas and additional hardness tests – preparation for TIG welding commenced.

The rotor forging was preheated, this helped to increase the strength of the weld by providing finer weld structure by full martensite transformation using highly accurate temperatures. The welding was then carried out in accordance with internal processes at previously agreed parameters by highly experienced welders specialising in this procedure.

The welding locations were then carefully dressed to allow NDT inspection. Both magnetic particle and ultrasonic tests were carried out by a specialist NDT technician with over 35 years experience to confirm effective fusion between materials. Finally, both weld locations were hand-polished and the forging stress relieved in accordance with company standards.

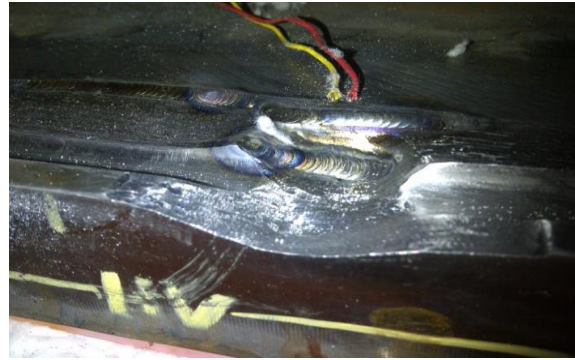
Figure 20. Slot 11 ready for weld repair
