A2 - Power Transformers & Reactors  
PS 1 / Experience and New Requirements for Transformers  
for Renewable Generation

**Condition Assessment of HVDC converter transformers at limited time of  
outage applied to the Fenno–Skan 1 transmission system**

Fenno–Skan 1 is the HVDC transmission system between Dannebo in Sweden and Rauma in Finland. The transmission system has been in service since November 1989, and after more than 30 years of successful operation it has become necessary to evaluate operational risks of the converter transformers and make a strategic decision on the possibility of extending their expected service lifetime.

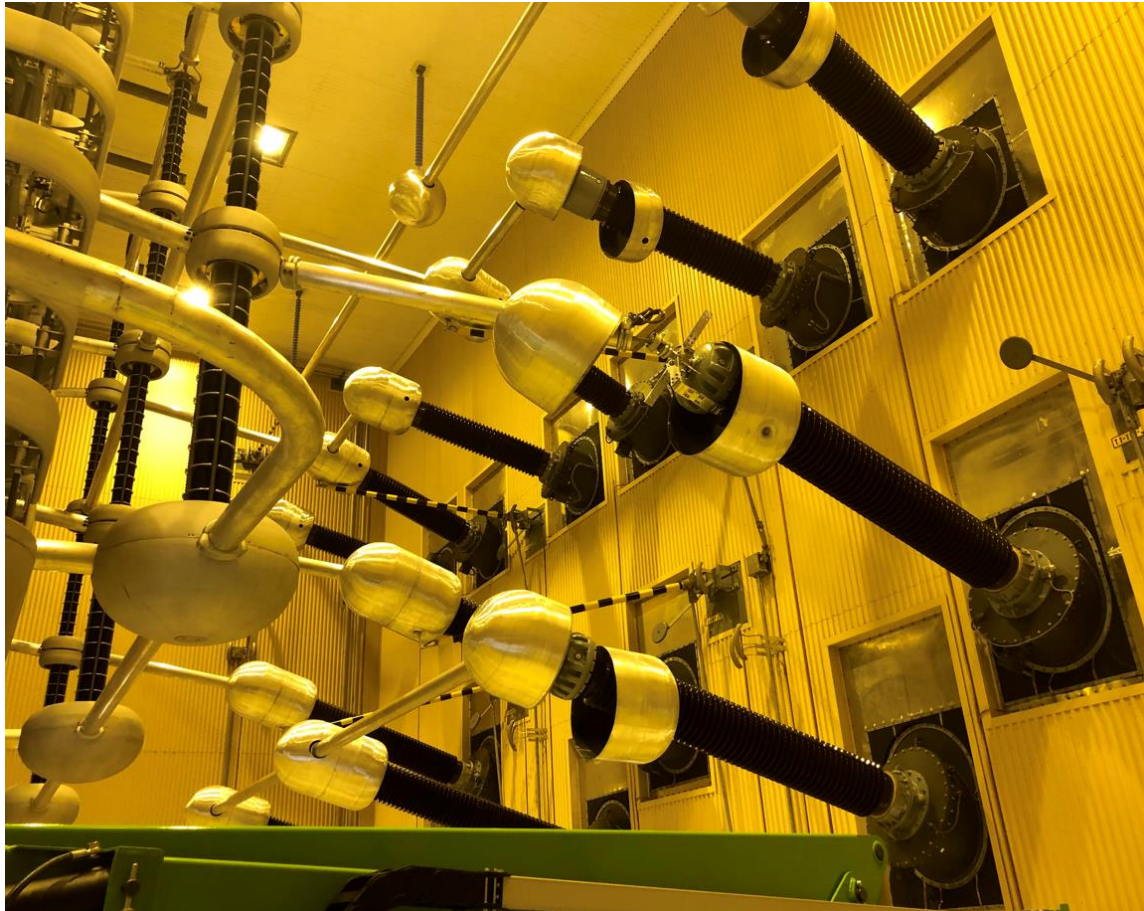
Figure 2. Valve winding bushings of three single-phase transformers

Specific for the project was that the service outage period of the Fenno–Skan 1 transmission system was so limited that the time for electric measurements was restricted to maximum one day per transformer. It was not even possible to completely disassemble external connections from the bushings of the Valve windings, see the Figures 2 and 3 - only the bushings of the Line winding were freed from the external connections.

Inability to completely disassemble external connections from the bushings of the Valve windings put following limitation on the scope of condition assessment: oil sampling from the Valve winding bushings was not feasible; applied voltage to the Valve windings was limited to 0,2 kV; measured dielectric parameters of insulation of Valve windings and bushings for some transformers were not valid; SFRA traces of the Valve windings may have been influenced.

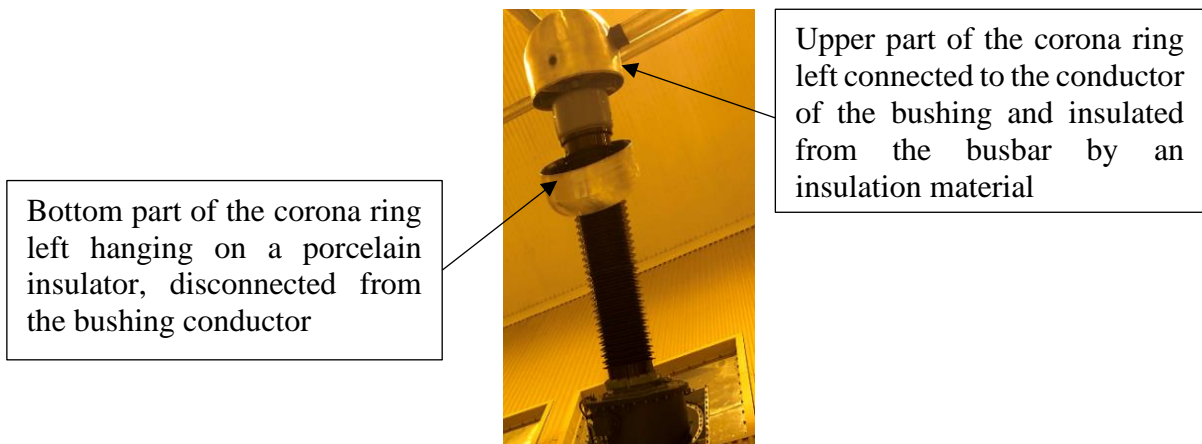
Figure 3. Setup of external connections of Valve winding bushings during the measurement

Measurement leads connections were arranged in accordance with IEC 60076-18, except when measuring Valve windings. Due to the setup of external connections of their bushings (Figures 2 and 3), measurement leads were connected to ribs of the corona rings.

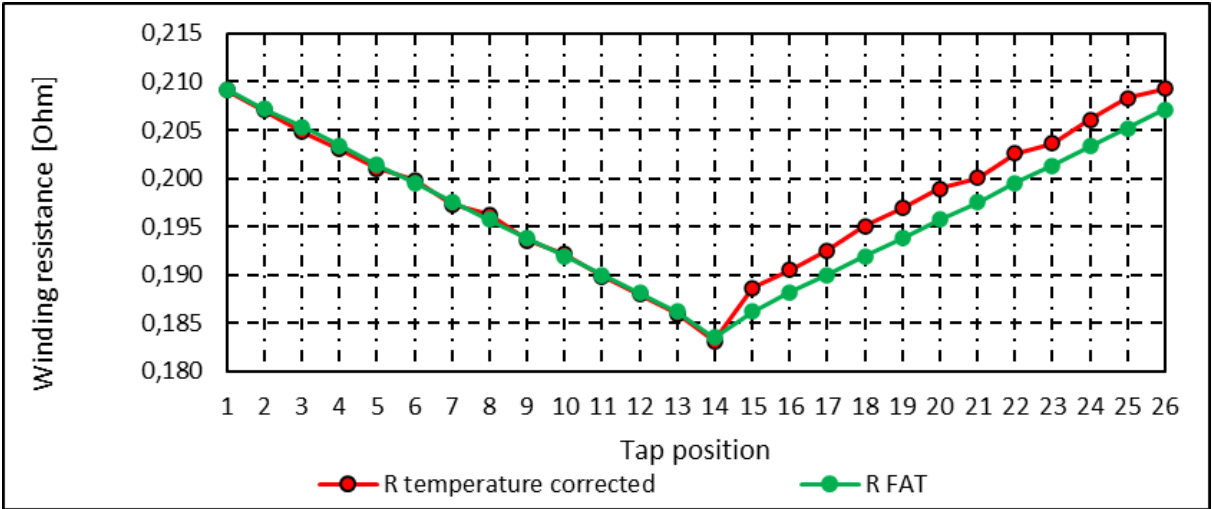
Figure 4. Winding resistance measurement results of the Line winding

Temperature corrected values of winding resistance were within  $\pm 2\%$  of the FAT values which is acceptable. However, for the Line winding the values obtained on the tap changer positions 15 – 26 had slightly increased deviation from FAT (examples of measurement results of one of the units presented in Figure 4). Tap changer positions from 15 to 26 correspond to the change-over selector position which was not used in service for a long period. Therefore, slightly increased winding resistance at the tap changer positions 15 – 26 were interpreted as an early evidence of formation of an oxidation film on the surfaces of the change-over selector contacts.

Method indicated an abnormality	Detected abnormality	Recommendations for remedial actions to maintain short-term reliability
Winding resistance	Measured values are acceptable. Suspected early evidence of the formation of an oxidation film on the contact surfaces	The formed films are generally removed by switching the on-load tap changer (OLTC) through its full cycle thanks to the wiping action of the moving contacts
Oil analysis for the oil from the transformer main tank	The results do not indicate any abnormal condition. Meanwhile metal passivator content has dropped below the level that is normally considered acceptable	As a short-term solution, addition of more passivator is suitable. For continued long-term operation oil reclaiming or oil change may be more suitable alternatives
DGA and oil analysis for the oil from the OLTC	DGA results indicate an incipient hot run in the OLTC. Oil analysis shows that the breakdown voltage is low and does not meet the requirement of IEC 60422	The oil in the diverter switch tank should be changed. In connection with this, a service on the OLTC should also be performed (as well as checking the contacts). An alternative solution is to upgrade the diverter switches to a vacuum type

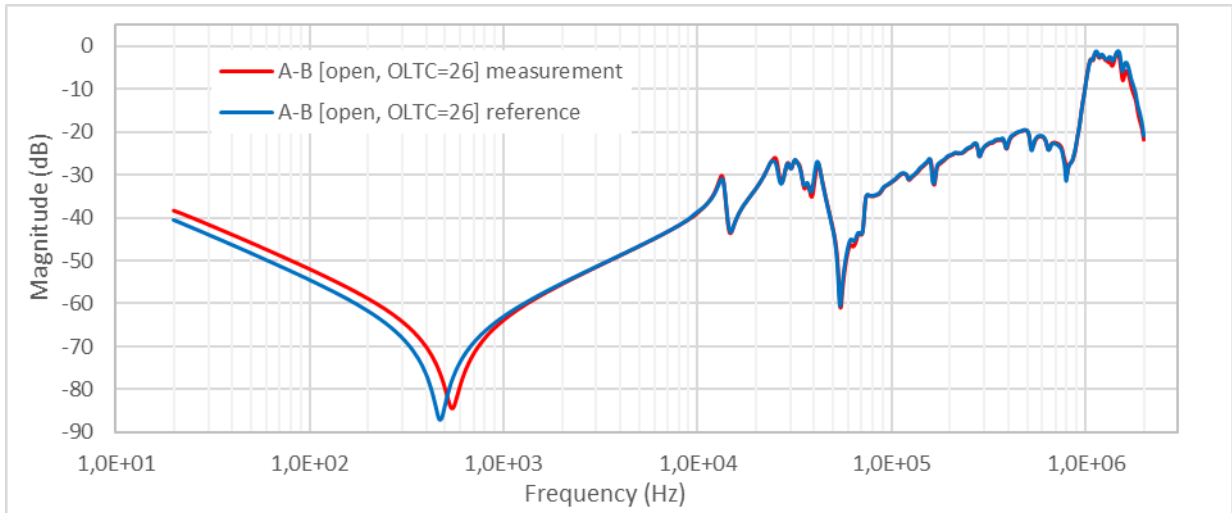
Figures 5. SFRA measurement result from Line winding, “open-circuit” test

The comparison with the traces obtained from the units of identical design (sister unit) does not show any obvious sign of an active part damage. Disturbance in open-circuit configurations (Figures 5, 7 and 8) at frequencies below approx. 1 kHz are normal and caused by different remnant magnetization of the core.

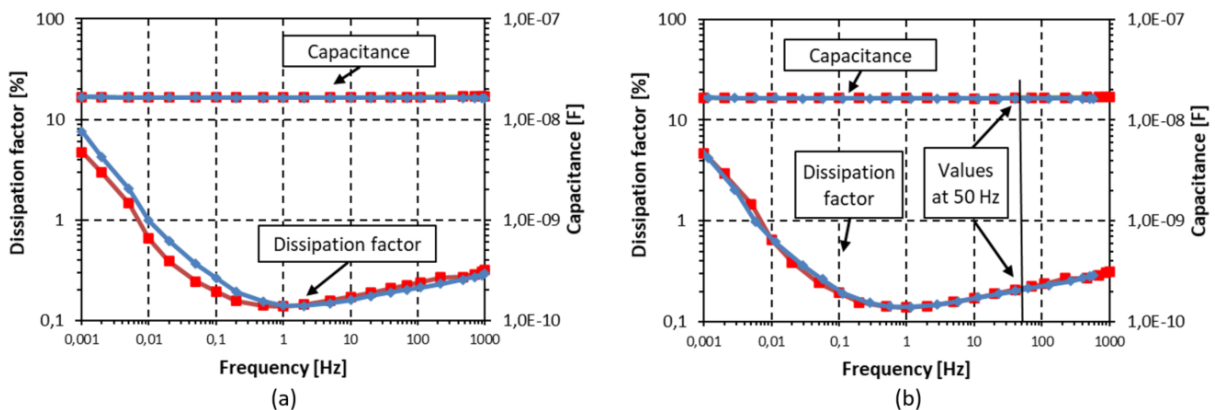
Figure 9. DFR response of Line winding insulation (red) compared with the reference response from a sister unit (blue): (a) before temperature compensation; (b) after temperature compensation – normalized to 20 °C

Due to the setup of external connections of Valve winding bushings (Figures 2 and 3), DFR measurement results of insulation of Valve windings and their bushings for some transformers were not valid. However, valid DFR results indicated acceptable insulation condition for all transformers. Moisture in cellulose estimation results were below 0,5 % for all units.

Example of frequency dependencies of both capacitance and dissipation factor obtained on Line winding insulation of one of the units is given in Figure 9. Comparison of the measured response with the reference obtained on a sister unit shows expected results, i.e., good fit between responses after temperature compensation (see Figure 9 (b)).

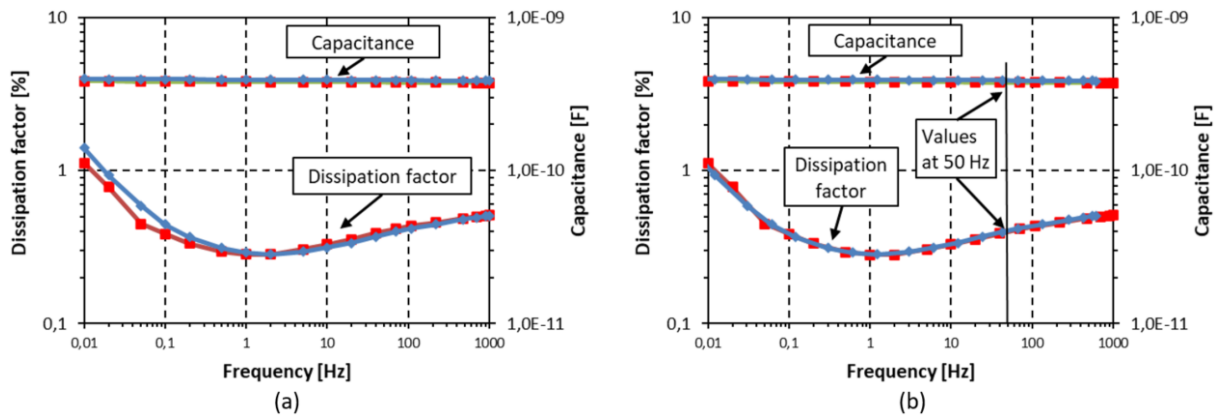
Figure 10. DFR response of a bushing of  $\Delta$ - connected Valve winding (red) compared with the reference response from a sister unit (blue): (a) before temperature compensation; (b) after temperature compensation – normalized to 20 °C

Responses of the bushings did not show abnormality. Example of a DFR response of a bushing of  $\Delta$ - connected Valve winding is shown in Figure 10, with no deviation from the reference after temperature compensation.

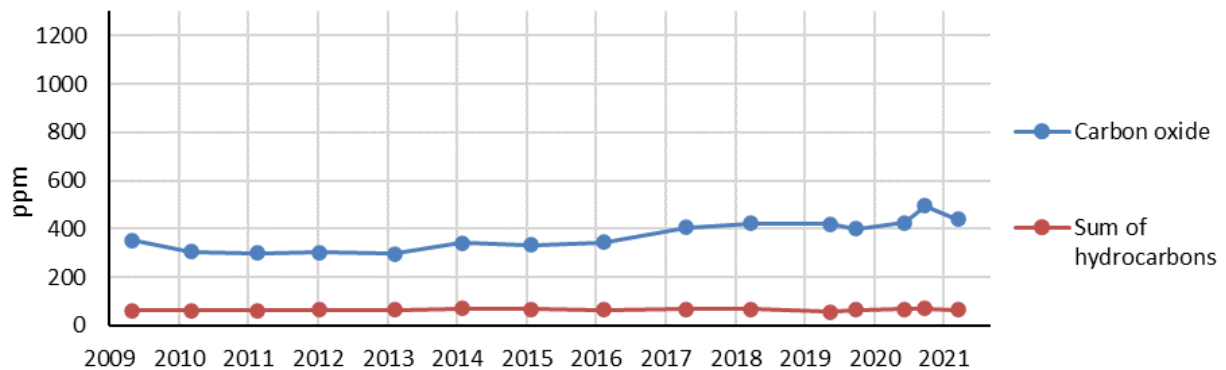
Figure 11. Sum of hydrocarbons and Carbon oxide 2009 - 2021

DGA analysis results do not indicate any abnormal condition of the main tank insulation of any transformer, see for example sum of hydrocarbons and carbon oxide results for one of the units in Figure 11.
