A2 – Power Transformers & Reactors

Impulse Testing of Power Transformers - Impact of Internal Varistors built into On-load Tap Changers

Dharam VIR*, Pradeep RAMASWAMY, Yuriy FRADKIN, Tim ROCQUE
SPX Transformer Solutions, Inc.
USA

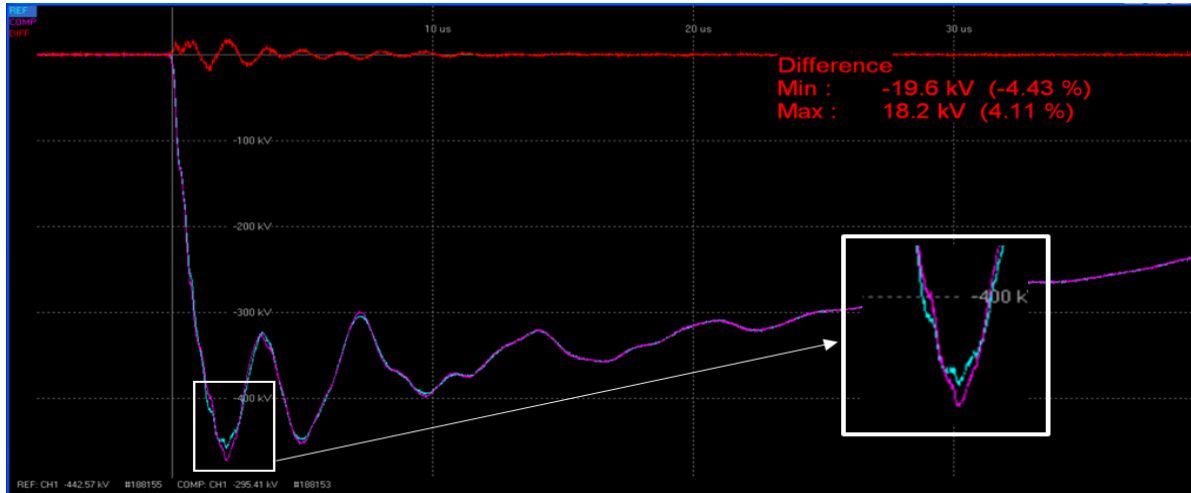
Figure 3 Voltage waveform for X3 (reduced to full)

During the Full wave test, the voltage waveform at reduced voltage did not match the waveform at full voltage on X3 during impulse testing on 16L tap, but the voltage waveforms matched on N and 16R taps (see Figure 3). The X3 reduced-to-reduced and full-to-full voltage waveforms matched on all taps. X1 and X2 impulse voltage waveforms matched on any tap.

Variations observed in the voltage and current waveforms were due to varistors conducting in the tap changer during the impulse test. In the specified LTC, the manufacturer has installed varistors in the diverters of the LTC to optimize the size of tap changer. The difference in performance between phases could be attributed to LTC lead cable lengths slightly changing the RLC network for each phase, as well as tolerance in the conduction voltage of the varistors. This is probably the cause that the problem was noticed on one phase X3 and not all phases.

The unit was drained and an internal inspection was performed. No issues were found during the inspection. After performing many diagnostic tests, it was found that varistors were used in the tap changers, which can cause waveform mismatches. Hence it was decided to bypass the varistors from the circuit on all three phases and re-test. The unit was processed and returned to test for diagnostic impulse tests.

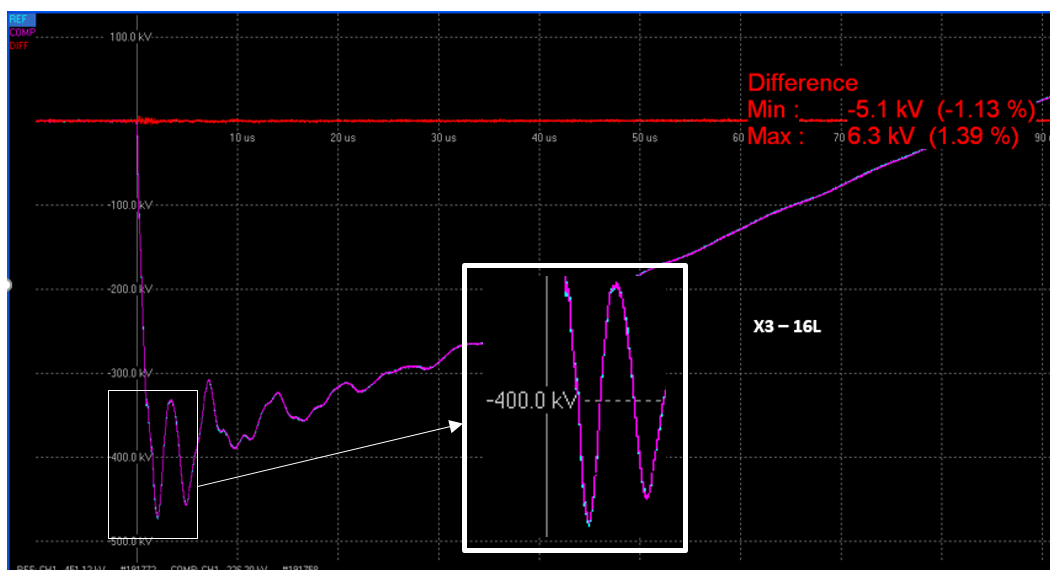
Figure 4 X3-16L voltage waveform with varistors bypassed

Impulse testing was performed on X1, X2 and X3 (16R and 16L taps). The waveform mismatches previously seen when testing reduced-to-full on X3 (voltage) were no longer present, confirming the interaction of the varistors as shown in Figure 4.

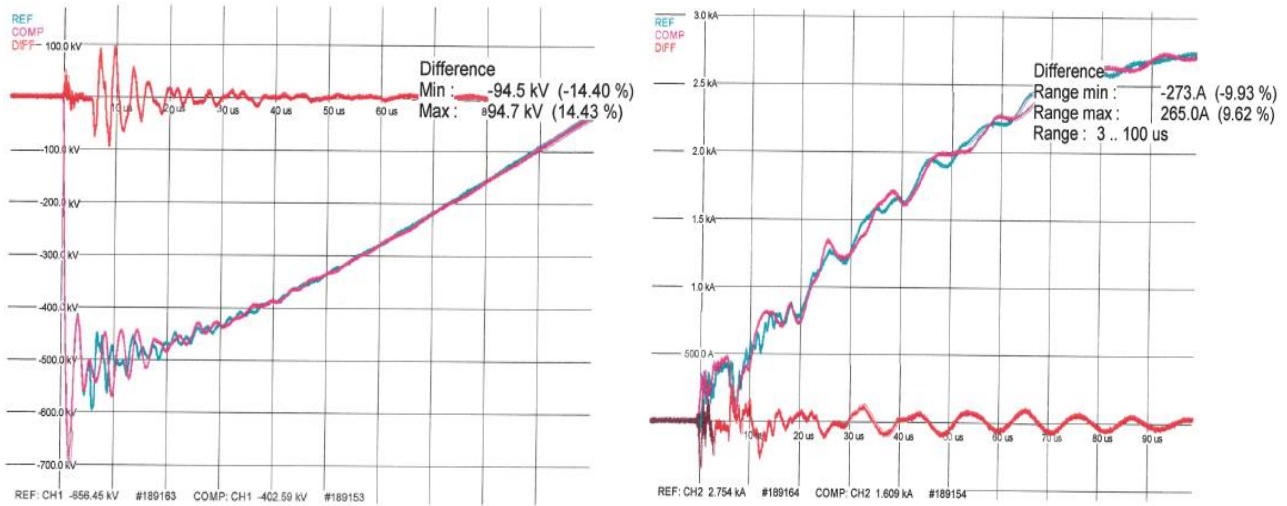
Figure 5 X3 Impulse voltage and current waveforms

During impulse testing, the transformer showed voltage and current mismatches on X3 as shown in Figure 5. An audible noise was heard but the failure did not go to ground. X1 and X2 had minor mismatches at the time when X3 had its issue. All HV impulse testing had been completed and was acceptable.

The unit was drained and prepared for internal inspection. X3, RV and TV leads were traced and inspected and no failure points were found. The unit was processed, oil filled and returned to test. X3 impulse was good at 50%, but mismatches returned at 70 and 100%, with mismatch getting larger after chop wave testing. During this round of testing X2 also failed on full wave (after chop wave), with sound internal to the unit and mismatches on both voltage and current. X1 was tested, but did not exhibit significant mismatches.

Mismatch seen at 5-7 microseconds was due to conduction of varistors (operating Maximum Continuous Operating Voltage (MCOV) 45KV). After discussions with the vendor, the cause of varistor's operation (below the specified MCOV of 45kV at about 30KV design value) was believed to be the effect of gradual increase of conductivity before reaching MCOV, leading to misinterpretation of failure while comparing reduced to full waves.

This transformer was a typical example where both the tap changer varistor operation and a RV lead-to-lead failure were present. This resulted in both waveform mismatch and audible noise during the test. Since the built in varistor was not taken into account, the appropriate impulse failure protocols were not used. This delayed the process of troubleshooting and arriving at the root cause.

All three RV coils and all RV lead cables were replaced during repair of the unit. The RV coils were redesigned changing lead numbering to achieve interleaving of cables. This helped to reduce the voltage between tap changer selector and pre-selector such that the varistor internal to the tap changer may not activate and cause mismatch between reduced full wave and full wave impulse shots.

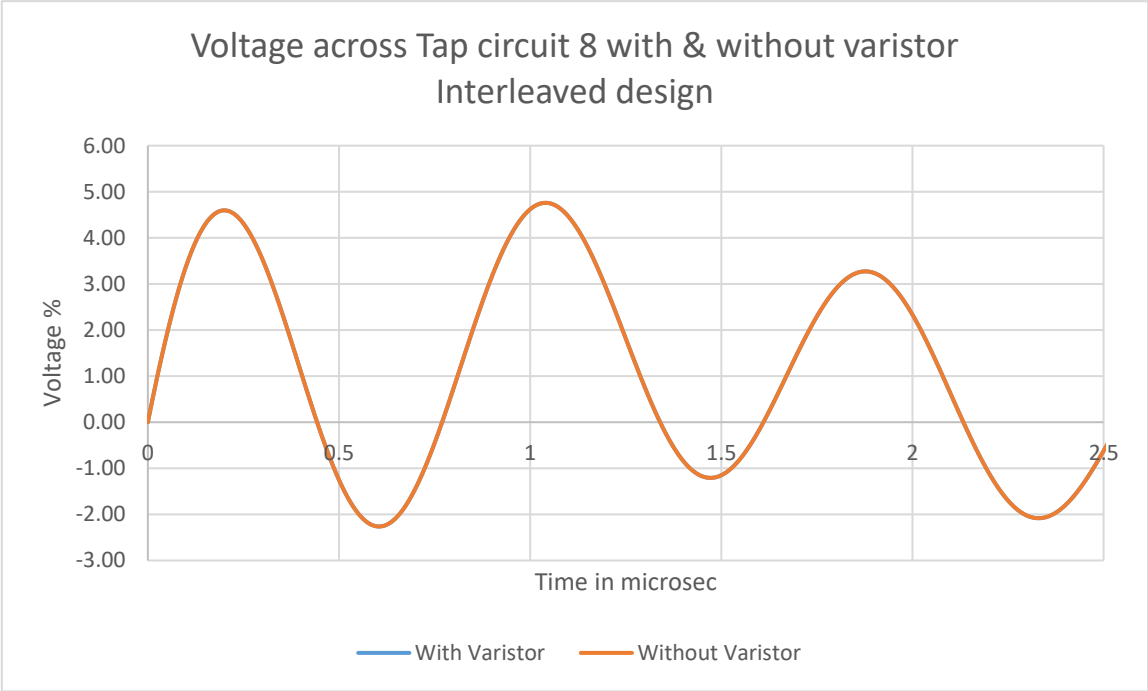
Figure 6 Varistor operation for interleaved design

As seen from Figure 7, there is a small voltage mismatch with and without varistor indicating that the varistors are triggered for non-interleaved designs. However from Figure 6, there is no voltage mismatch with and without varistors indicating that the varistors are not triggered for interleaved designs.
