Analysis of Failed Cable Termination: Role of Workmanship and Electrical Stresses**Nitin R SHINGNE*, Gaurav S DHIMAN, Uday N PUNTAMBEKAR, Satish H CHETWANI****Electrical Research and Development Association (ERDA), Vadodara
India****nitin.shingne@erda.org; gaurav.dhiman@erda.org; uday.puntambekar@erda.org;
satish.chetwani@erda.org****SUMMARY**

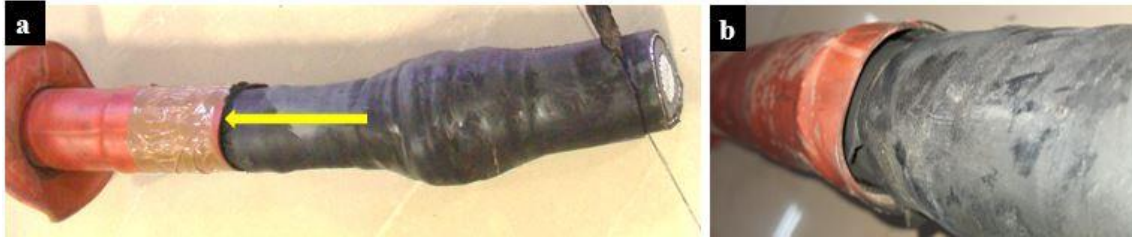
One of the failed sample showed gap at the cable junction, and indicated that the inner components were exposed to outer environment, as shown in Figure 2. This also indicated that the outer heat shrink tube was not properly heat treated or not treated at all. The termination had failed with visible damage between the first and second shades, as shown in Figure 3a. Back side of the damaged surface showed a fold in the heat shrink tube as shown in Figure 3b. After cutting the heat shrink tube from the folded region, electrical stress control (ESC) tube is visible which was also folded near the damaged area, refer Figure 3c. It appears that both the heat shrink tube and ESC tube moved upward because of improper installation. Since both the ESC tube and heat shrink were not heat treated and only loosely placed on the termination, it may have folded during installation on an electric pole. The cable termination was installed on an electric tower and connected to an overhead conductor.

Figure 2: Images near the cable junction: a) the heat shrink tube slipped away from junction highlighted by yellow arrow and b) gap visible between heat shrink tube and internal layer of termination

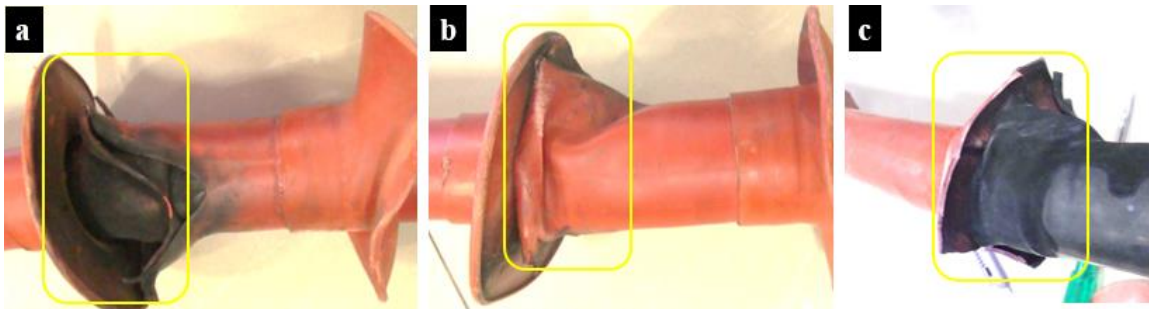
Figure 3: Damaged cable termination: a) blackened part near a shade and b) fold in head shrink tube and c) after removal of heat shrink tube, folded stress control tube is visible. Damaged part highlighted in box

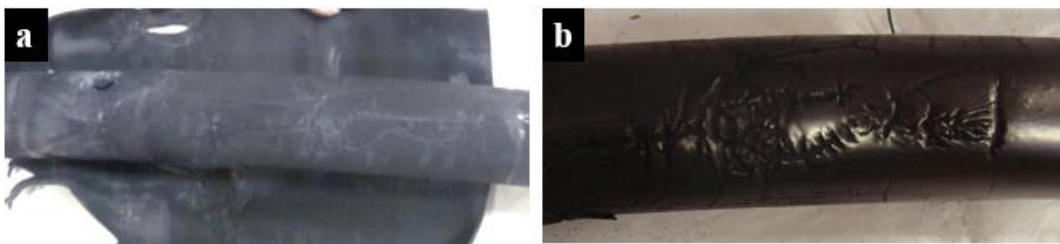
Removal of the outer heat shrink tube and ESC tube revealed puncture in the XLPE insulation, as shown in figure 4a. After cleaning the surface of the XLPE insulation under the ESC tube, showed surface morphology indicating localised heat over a long period of time, refer Figure 4b. The localised heating may have taken place because of electrical discharges due to improper placement of ESC tube and lack of heat treatment resulting in air cavities in the cable termination.

Most of the XLPE insulation in the cable termination had blackened because of degradation of insulation due to the electrical discharges. Only one area where heat shrink tube was properly attached to XLPE insulation remained unaffected. This was the results of poor adhesion of heat shrink tube with XLPE insulation resulting from improper heat treatment.

Figure 4: a) Stress control tube under heat shrink tube removed from XLPE insulation and b) damaged XLPE insulation indicating localised heating

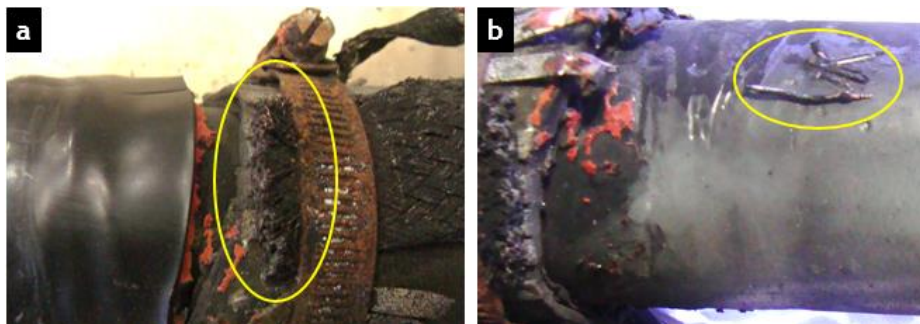
Two more cable terminations were found damaged in the same region below the ESC tube. The damaged area with ESC tube was visible, the XLPE insulation found punctured beneath the ESC tube. In this cable termination the components of cable junction were corroded indicating water ingress, visible in Figure 5a. Improper sealing of the cable junction may have resulted in the water ingress. The ground connection, near the cable junction, was connected through steel wires wrapped around the copper shield. Due to the tight fitting, the wires partially penetrated the insulation thereby changing the localised electric field, refer Figure 5b. The XLPE insulation also showed indications of tracking which might have resulted from high electrical stresses.

Figure 5: a) Ground connection at the hose clamp and b) Wires used for grounding on copper screen penetrated the insulation

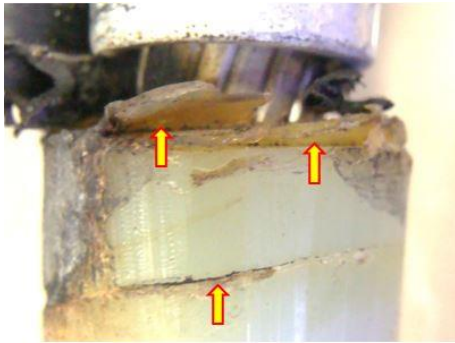
Among the four failed samples, only one of the cable termination failed near the termination end. This sample showed number of cuts in XLPE insulation near lug as shown in Figure 6. These cut showed clear tracking marks indicating high electrical stresses. The sharp edges in the insulation resulted in localised concentration of electric stresses leading to tracking and failure of the cable termination.

Figure 6: Cut marks on XLPE insulation shown by arrows

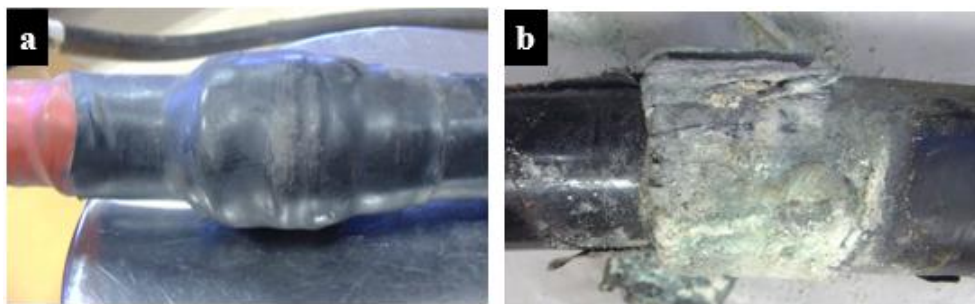
One of the apparently healthy sample removed for analysis had a cut mark on outer heat shrink tube. The cut mark was located approximately mid distance from cable junction and inner XLPE insulation was visible. This indicated poor handling and installation of the cable termination. The cable termination was cut open for visual analysis. Opening of the cable junction led to powder falling out from the cable junction. When insulation tape from the cable junction was removed, accumulated white-green colour powder was visible on the cable junction. The copper screen and aluminium armour was found completely corroded, as shown in Figure 7.

Figure 7: a) Cable junction before opening, b) after removal of outer layer – white green powder observed and copper screen and aluminium armour found corroded

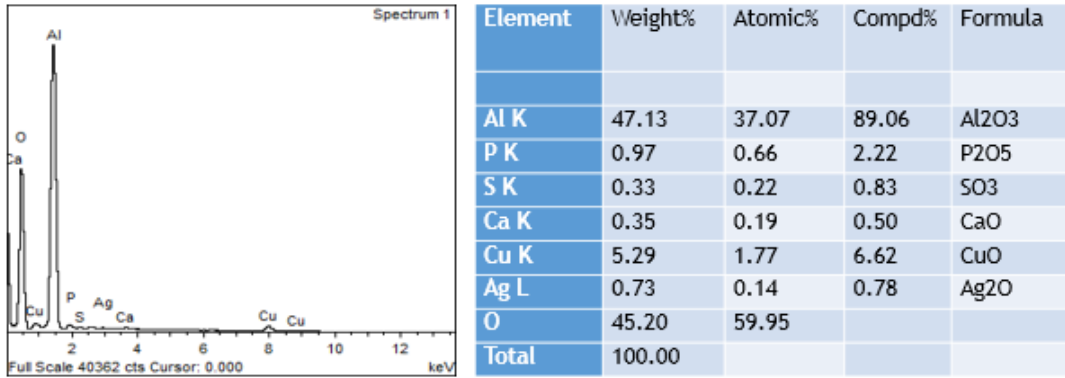
The white-green residue at the cable junction was analysed using Energy Dispersive X-ray Spectroscopy (EDS). EDS gives the elemental composition of material under investigation. EDS spectra of the powder collected from the cable junction is shown in Figure 8 along with the result table. The EDS result of powdered residue, from cable junction, showed prominent presence of aluminium oxide and copper oxide, both are by-products of corrosion reaction. Rest of the elements found in EDS investigation were in low quantity and may come from fillers used in polymeric insulation.

Figure 8: EDS spectrum (left) and elemental analysis results in table (right)

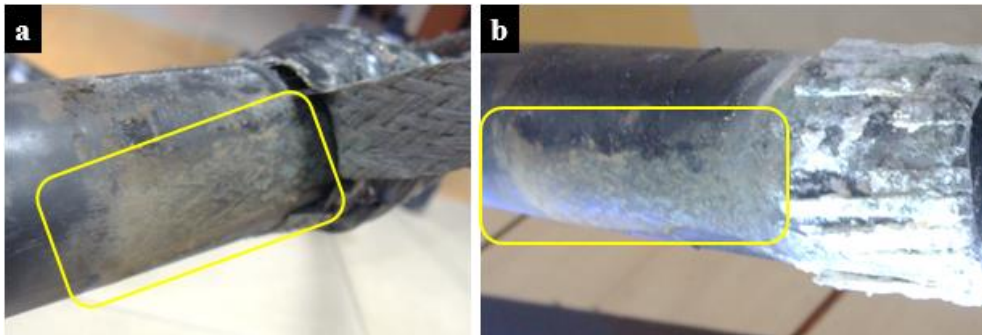
It appears that water along with dust particles may have entered the cable junction which was indicated by dust collected along the grounding wire path as shown in Figure 9. At the cable junction, two dissimilar materials, copper and aluminium, are bound together this can result in galvanic corrosion. The water acts as an electrolyte in presence of two dissimilar metals resulting in accelerated corrosion of copper and aluminium. This results in formation in corrosion by-products copper oxide and aluminium oxide in the form of white-green powder. This may cause failure of cable termination because ground connection was almost lost.

Figure 9. Indication of dust collected along the grounding wire path (yellow box): a) before opening the junction, b) after opening the cable junction showing corroded aluminium armour and copper sheath.

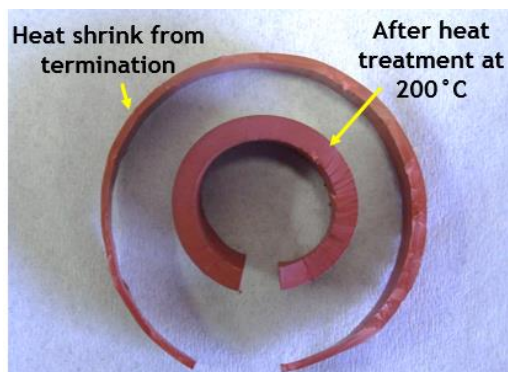
To check the quality of cable termination, as prepared not in use cable termination was opened up for analysis. It was observed that most of the heat shrink tubes on cable terminations were not properly heat treated, resulting in loose contact between heat shrink and XLPE insulation which can cause internal discharges. To check the quality of heat treatment of heat shrink tube, one circular piece was taken from heat shrink tube. Thickness of tube was measured at three locations and then the sample was put in oven at 200°C for 30 minutes. The change in dimension of heat shrink tube, before and after heat treatment, is visible in Figure 10. The wall thickness values of as-received sample and after heat treatment, is given in Table II. Wall thickness of heat shrink tube from as received cable termination shows large variations in wall thickness indicating non-uniform heat treatment during preparation. After heat treatment, the wall thickness has increased and became uniform. This indicates that the quality of heat shrink tube was good but the heat treatment was deficient at the time of termination preparation. This issue was observed for most of the cable terminations.

Figure 10: Outer tube is a piece of heat shrink tube removed from termination sample-10 where the thickness is uneven and inner tube is after heat treatment at 200°C

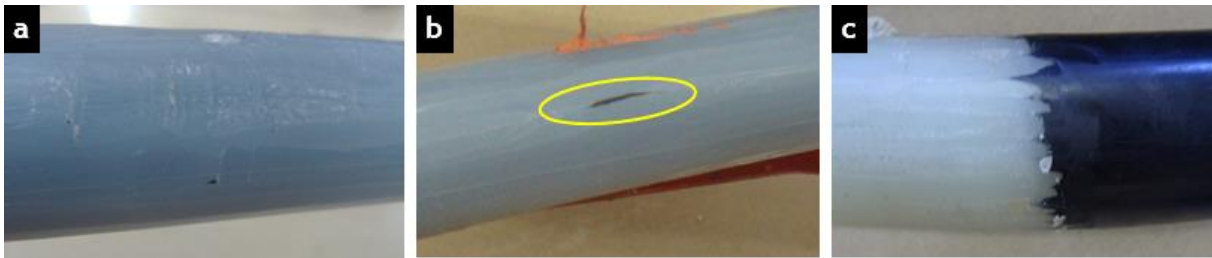
Many of the healthy cable terminations showed rough surface of XLPE, which indicated that insulation was not polished or cleaned, as shown in Figure 11a. At several places the semi-conducting layer was not properly removed from the insulation, Figure 11b. The partially remaining semiconducting layer can increase the localised electric stress which can lead to failure. Edge of the semiconducting layer near the cable junction was not properly smoothed, leaving behind edges of semiconducting layer as shown in Figure 11c. Sharp edges result in localised concentration of electric field.

Figure 11: a) Cut marks and rough surface of XLPE insulation, b) Partial semiconducting layer remained on XLPE insulation and c) Un-evenly cut edge of semi-conducting layer

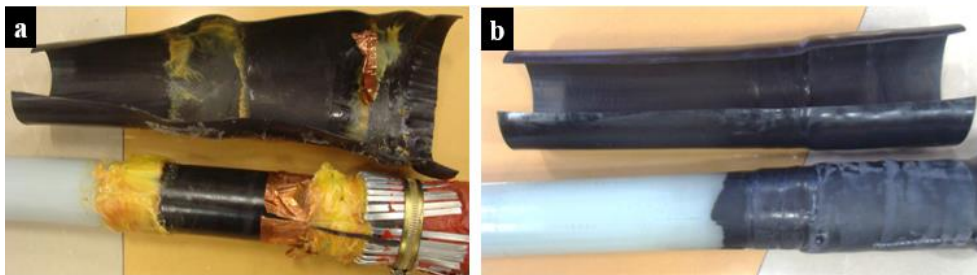
In all the failed and working cable termination it was found that the placement of ESC tube was not consistent. The length of ESC tube was different; the copper screen and semiconducting layers had different lengths, as shown in Figure 12 for two samples. Gap between semiconducting layer and ESC tube was also observed in some cases. This non-uniformity in sample preparation may have resulted in different electric field profile and stress concentration near the cable junction. To understand the electric field distribution near the cable junction FEM analysis was performed.

Figure 12: Near cable junction, semi conducting layer and detached electrical stress control tube from two different cable terminations

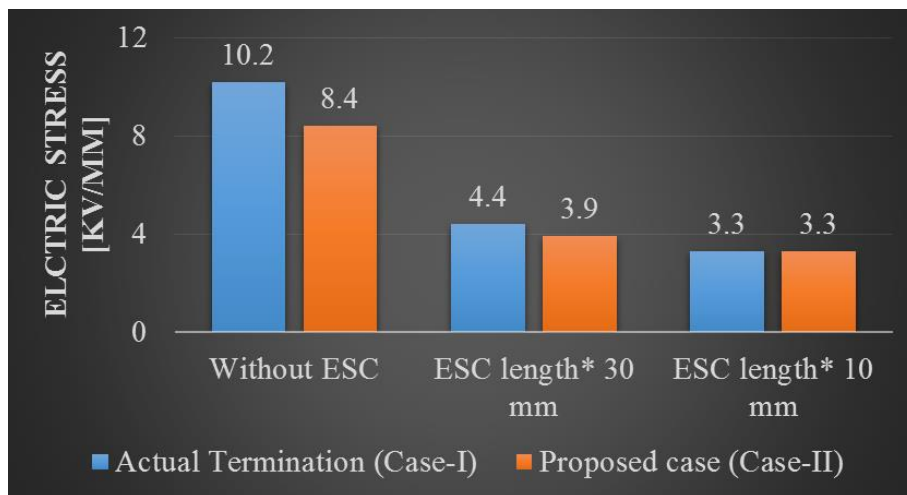
Figure 14 shows FEM simulation results. The ESC length is set to several groups to better indicate its influence on electrical stress. A case where ESC tube is not installed also considered to show the large value (10.2 kV/mm) of electrical stress as triple point (this case was not observed in actual cable termination). When ESC covers the triple point the electrical stress reduces to around 4.4 kV/mm. FEM simulations were carried out to find the optimum value of length of ESC that covers the triple point towards the end of termination. Simulations were performed by increasing the length of ESC in step of 5 mm from the triple point. The optimum length was found to be 10 mm from triple point, a length more or less than 10 mm increases the electrical stress at triple point. Optimization of ESC tube length can reduce the electrical stress by 1 kV. This optimised length ESC tube corresponds to a particular case with material properties in Table III. Therefore, optimum design and length of each component near cable junction will vary for different manufacturer due to variations in material properties of the termination kit. Optimization of different parameter based on material properties is important for cable termination to reduce the electrical stress. Optimization of localised electrical stresses at the cable junction can result in better performance of cable terminations with reduced failures.

Figure 14: Electrical stress in the actual and proposed geometry of cable termination with or without electrical stress control (ESC) tube. (*ESC length – overlap of ESC tube measured from triple point towards end of cable termination)

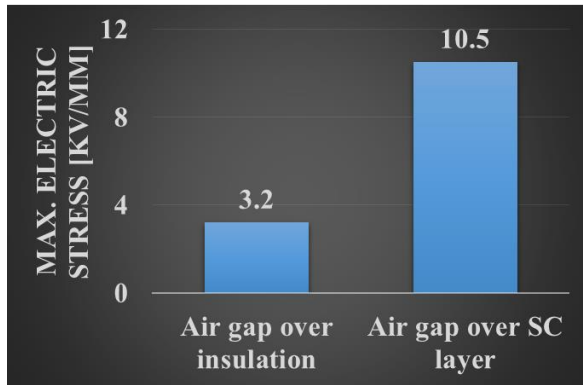
Some of the cable terminations were not properly heat treated, increasing the possibility of air gap over the XLPE insulation and the semiconducting layer. FEM simulation results of a case where air gap is present between insulation or semiconducting layer and ESC tube is shown in Figure 15. In both cases ionization of air can lead to electrical discharges and failure of cable termination. Therefore, uniform and proper heat treatment of the ESC tube and heat shrink tube is essential.

Figure 15: FEM simulation results in case of air pockets under ESC tube for air gap over insulation and air gap over semiconducting layer (SC layer)
