**Lightning strike to ground – a case study about observed cable damages, risk estimation and protection method**

**Valentinas DUBICKAS\*, Erik THUNBERG, Johan HANSSON**  
**Svenska kraftnät**  
**Sweden**

**SUMMARY**

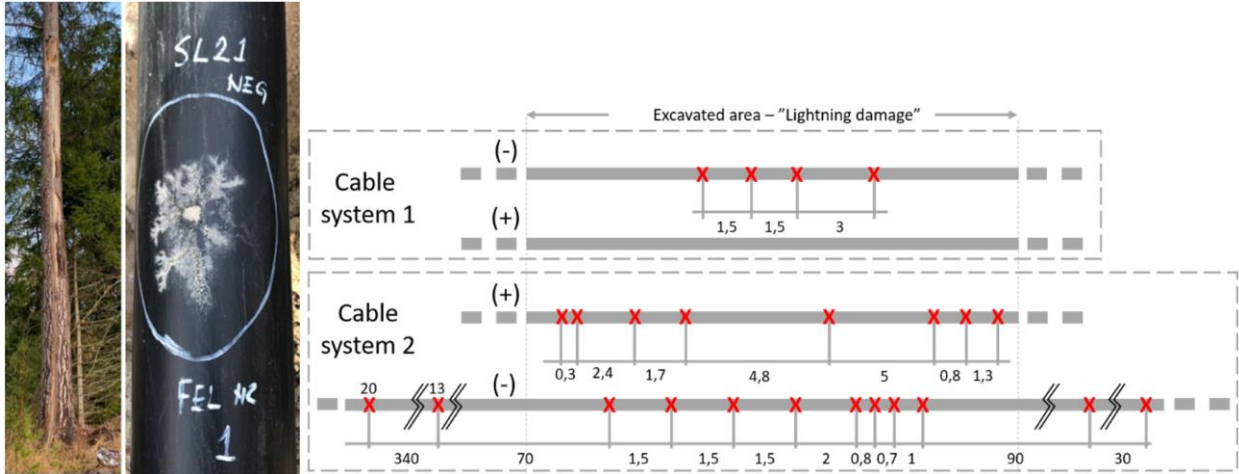
Sheath damages were found at 10 locations along the cable route after approximately 7,5 years during the period January 2013 to June 2020. Each location was most commonly found to have numerous

sheath punctures up to 24, most of which were usually limited to a 20-30 m long area, see Figure 2. However, some could also be found up to about 400 m further away. Few locations were less damaged with few 1-3 punctures. At the locations with numerous punctures it was common that the sheaths of both cable systems were damaged. The damages were not severe enough to immediately damage the cable main insulation system, however these allowed for water intrusion under the sheath. At four locations, lightning-damaged trees were observed at a distance of 10-30 m from the sheath damage location. At these locations the sheath damages were the most severe. In total 7 out of 10 damages occurred in proximity to a forest edge at a distance of about 10 m.

Figure 2 Lightning damaged tree in proximity of damage location (left). One sheath puncture (middle). Schematic illustration of numerous sheath punctures of both cable systems at one damage location, distances between punctures in meters (right).

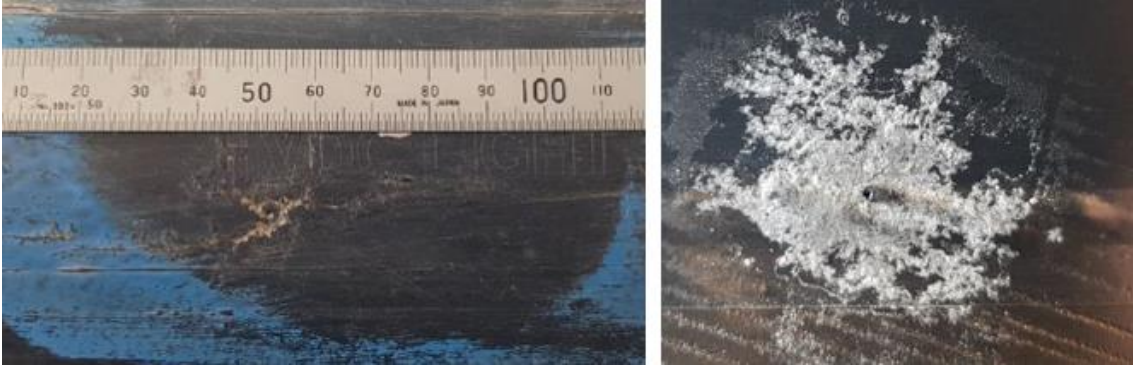
Approximately 10 m long cable piece containing multiple sheath damages was cut out and afterwards dissected in a material laboratory. The observed sheath punctures varied in severity. The puncture severity ranged from only damaged HDPE sheath; larger had damaged sheath and small puncture in Al laminate, see Figure 3; while the most severe case had damages in sheath, Al laminate and even somewhat damaged outer semiconductive layer. The punctures were in radial direction through the sheath. It was also observed that the circumferential location of punctures was aligned with the edge of Al laminate seam. The sheath thickness was measured and was found in agreement with the project requirements. Water intrusion under the sheath was present where Al laminate was punctured however the water penetration along the cable was limited to few decimetres along the cable.

Figure 3 Puncture in the sheath seen from outside (left) and from inside (right).

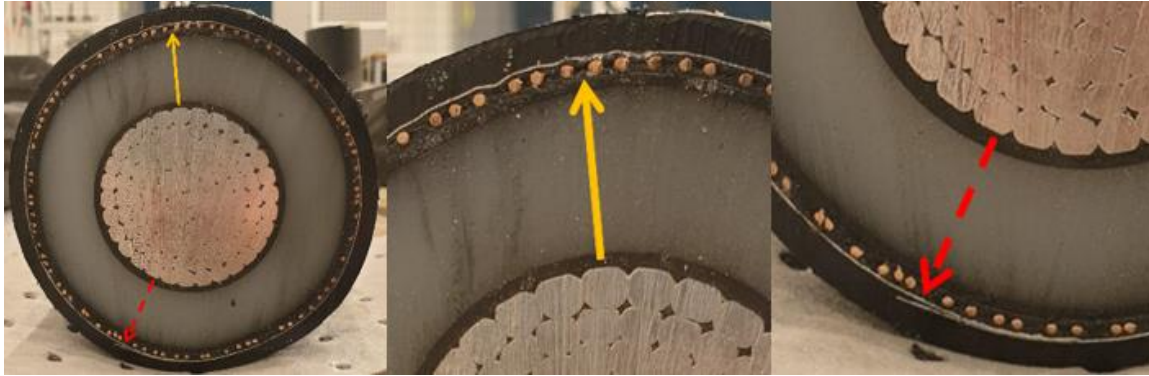
For all test samples the area of penetration occurred some centimetres outside the edge of the energized surface on the outside of the sheath. This was where the conducting layer had been scraped off. This indicates that the unmanipulated sheath can handle slightly higher voltage amplitudes than what was shown in the test results as. The dissection of the test samples showed that the radial location of the puncture did not coincide with the seam of aluminium laminate, but in two of the three cases the puncture occurred at similar location where the laminate had a wavy structure, Figure 5.

The irregularities due to sheath scrapping and small deformations of aluminium laminate causes local increase of electric field, however such conditions are considered to reflect the actual conditions in field. Considering the breakdown voltage stated above and sheath thickness of 4,5 mm the effective lightning breakdown field strength of the sheath was found to be ca 25-31 kV/mm.

Figure 5 Cross section of cable. Red dashed line indicates the aluminium laminate seam. The yellow arrow indicates the location of puncture which also coincide with the wavy structure of the laminate.

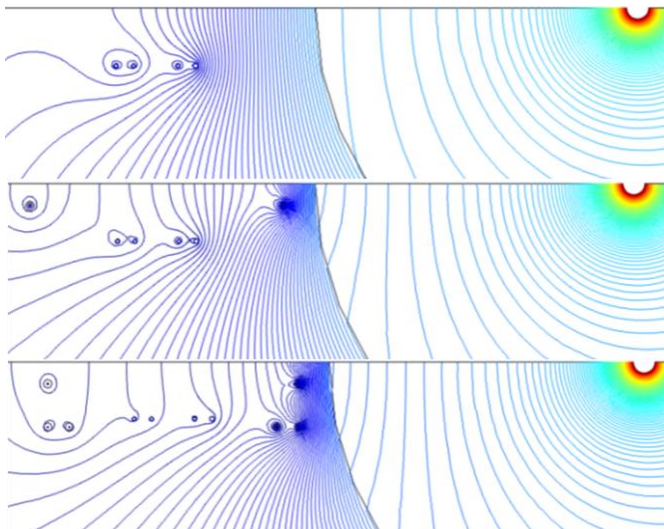
Figure 7 show examples of equipotential line plots for the three different study cases. The results were obtained for a lightning current amplitude of 100 kA, injected at a distance of 10 m from the nearest cable, and a soil resistivity of 1000  $\Omega\text{m}$ .

Figure 7 Geometries and equipotential lines of Case 0 (top), Case 1 (middle) and Case 2 (bottom).

The effects of countermeasures (Case 1 and 2) were estimated by identifying current amplitudes where calculated field strengths matched stresses of Case 0. This is illustrated in Table IV, where similar field strengths are obtained for Case 0/30 kA, Case 2/80 kA and Case 2/100 kA. Applying the different probabilities of exceedance, the relative improvement of protection according to Case 1 and 2 could be estimated at 76 % and 95 %, respectively. Considering the cable route length (ca 200 km), the mean time between failure (MTBF) of the sheath is estimated as shown in Table V.
