Investigation of Cause of Breakdown and Replacement of 275 kV SCOF Cable by XLPE Cable in Japan

Yusuke IKEDA*
Tomoteru KYOGOKU
Tepco Power Grid, Inc.
Japan

Kozo SUZUKI, Tai YOKOYAMA,
Takayuki MINAMI
Sumitomo Electric Industries Ltd
Japan

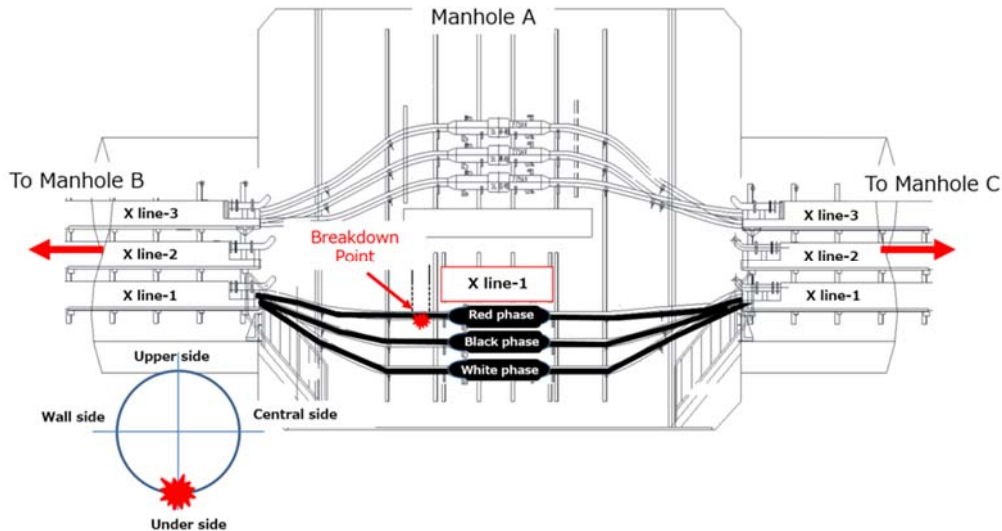
Fig. 4 Location of insulation breakdown

In 2019, a 34-year-old 275 kV SCOF line (copper 2000 mm² with aluminum sheath) broke down. The breakdown point was the cable section near the joint as shown in Fig.4. The insulation breakdown occurred immediately after the restart operation.

- (1) No abnormalities were found in the cable manufacturing record and cable installation record surveys.
- (2) From the DGA data of the joint, the abnormal rank of the SVM was relatively high, but not at a level that showed any signs of imminent dielectric breakdown.
- (3) The three-phase lumped section near the breakdown point became hot because of the temperature analysis at the operational current. However, it was below the allowable temperature. No abnormal heat generation was observed.
- (4) No partial discharge alarm was set off before the breakdown, even with the partial discharge measurement that had been conducted since March 2018.
- (5) We checked the cumulative number of switching surge inputs on the lines. As a result, we confirmed that among the three lines, breakdown line was the only one to occur over 1,000 times (Fig. 4).

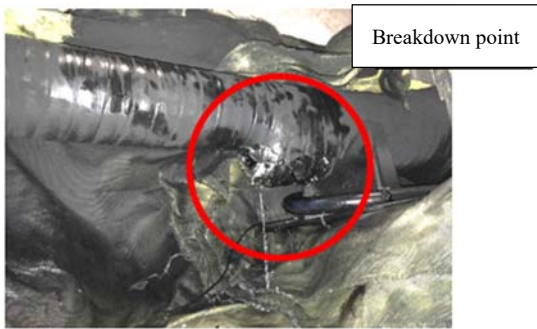
Fig. 5 Status of insulation breakdown (general)

We removed the breakdown area and conducted a dismantling survey as shown in Fig. 5 and Fig. 6. Yellow deposits were found on the surface layer of the cable insulation paper, black deposits on the middle layer up to the area near the conductor, and minute red deposits near the conductor. Elemental analysis confirmed the presence of copper, carbon, and sulfur.

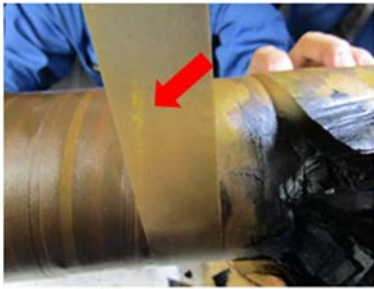
Fig. 7 Yellow deposits

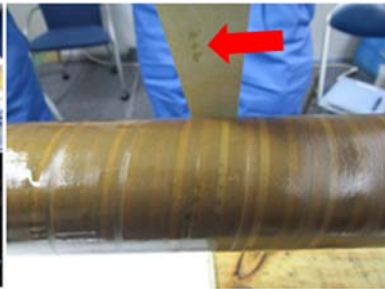
Fig. 8 Black deposits

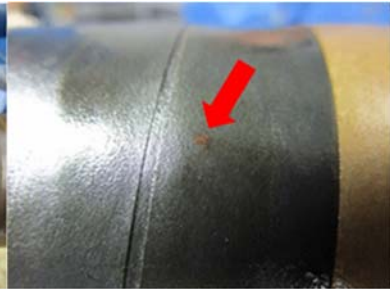
Fig. 9 Red deposits

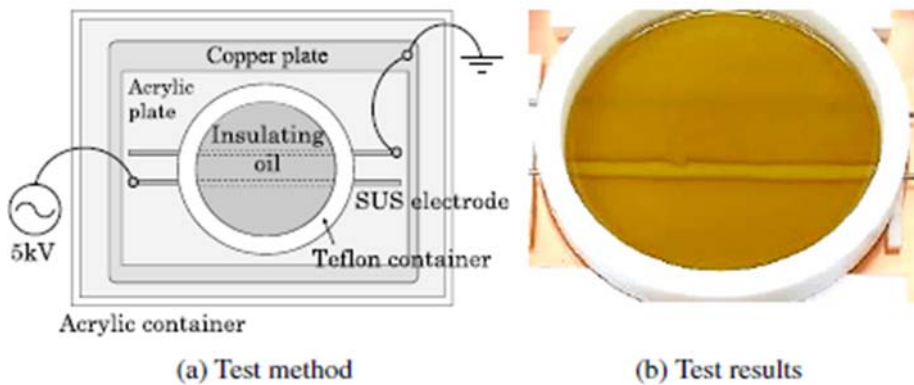
Fig. 10 Dielectrophoresis test results

In the electrophoresis model test with dissolved copper and sulfur, the electrophoresis phenomenon occurred. In addition, higher sulfur content led to higher deposition of the compounds. (Fig. 10)

In other words, it was confirmed for the first time that deposition of copper compounds is promoted by the components of vulcanization accelerators used in rubber products for joints.

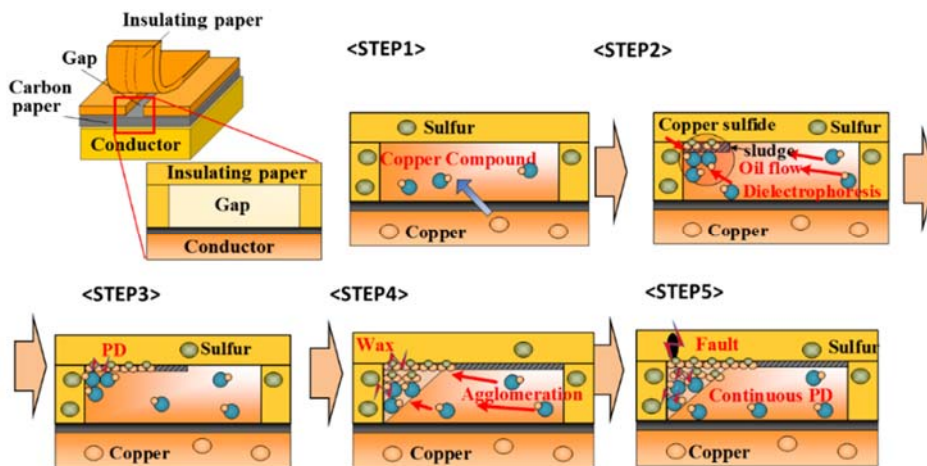
Fig. 11 SCOF cable charging degradation mechanism [3]

- Step 1: The vulcanization accelerator of the rubber material inside the joint promotes the elution of deterioration-causing substances (copper and sulfur components).
- Step 2: Copper compounds are agglomerated and deposited at specific locations owing to electrophoresis, etc.
- Step 3: Partial discharge occurs sporadically by a switching surge at the point of agglomeration and accumulation.
- Step 4: Waxing occurs because of partial discharge
- Step 5: Repeated agglomeration and partial discharge results in loss of insulation strength.
- Step 6: A surge caused by the system switching operation causes a dielectric breakdown in the area where the insulation strength is reduced.

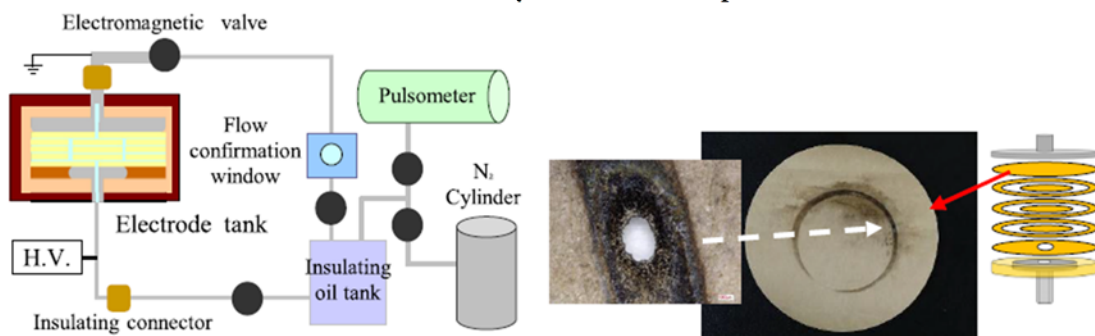
Fig. 12: Simulated cable electric field gradient model and insulation breakdown

To confirm this process, we created the model shown in Fig. 12, which simulates the electric field gradient of a real cable and conducted an electrical charge test. As a result, it was confirmed that partial discharges were repeatedly generated, followed by dielectric breakdown. In addition, we observed copper–sulfur compound deposits in the breakdown holes.

From these results, we have confirmed the validity of the assumed process.

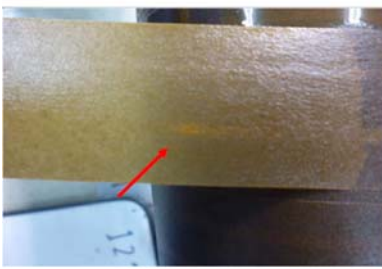
Thereafter, we carried out a removal and dismantling survey of this joint, and found similar deposits, discoloration, and layering in the cable section near the joint. These results demonstrated the validity of the ICP diagnosis results. Based on the results of the insulation breakdown and dismantling survey, we decided to apply this method on a full scale.

Fig. 14: Yellow deposits

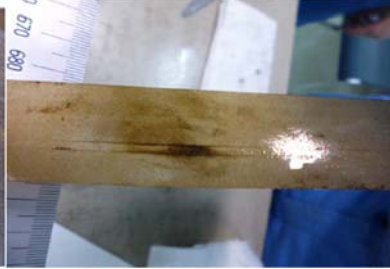
Fig. 15: Black deposits

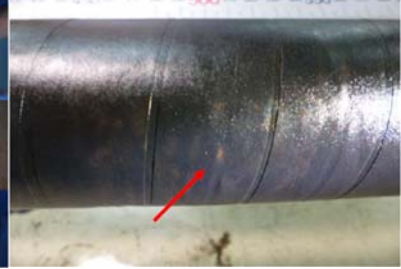
Fig. 16: Red deposits

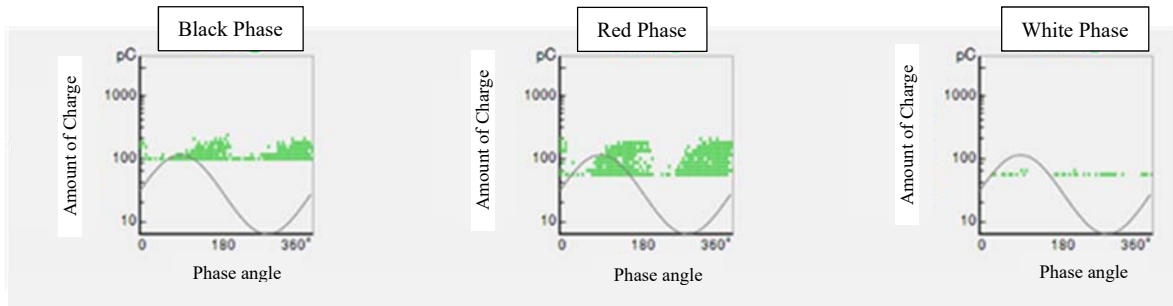
The device automatically sends out an alarm when the three parameters of discharge quantity Q (pC), discharge pulse frequency N (pps), and duration (s) exceed the predetermined threshold values. In this insulation breakdown investigation, we investigated the PD measurement data and found that a signal with phase characteristics specific to partial discharges was observed six days before the occurrence of insulation breakdown, as shown in Fig. 17 and Fig. 18. However, because the discharges were sporadic, the duration did not reach the set threshold value, and the partial discharge alarm did not go off. In the future, we will consider the improvement of the system to detect sporadic discharges to set off the alarm. There are some SCOF cables in ducts and joints in manholes. In partial discharge measurements for such locations, it is sometimes difficult to apply communication methods, such as optical cables or wireless, to transmit signal data or to secure a power supply for the equipment. Therefore, we developed an online partial discharge monitoring system that uses PLC (Power Line Communication) as the communication channel and obtains the induced power from other cable lines. [5] Fig. 19 shows the configuration of PLC.

Fig. 17 Phase characteristics (PQN) measurement data of adjacent joints (13:36:40, 6 d before dielectric breakdown)

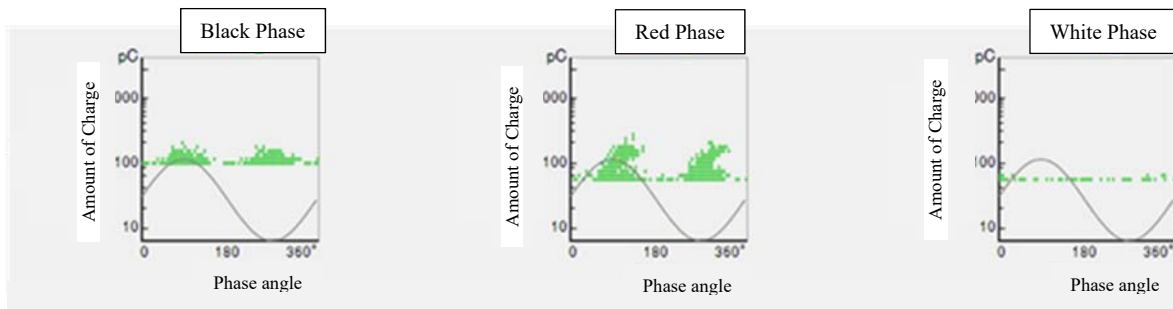
Fig. 18 Phase characteristics (PQN) measurement data of adjacent joints (14:12:10, 6 d before dielectric breakdown)
