B1 – Insulated Cables
PS1 – Learning from Experiences**Experiences and Insights Rehabilitating a
69kV SCFF Cable System after Pressure Loss**

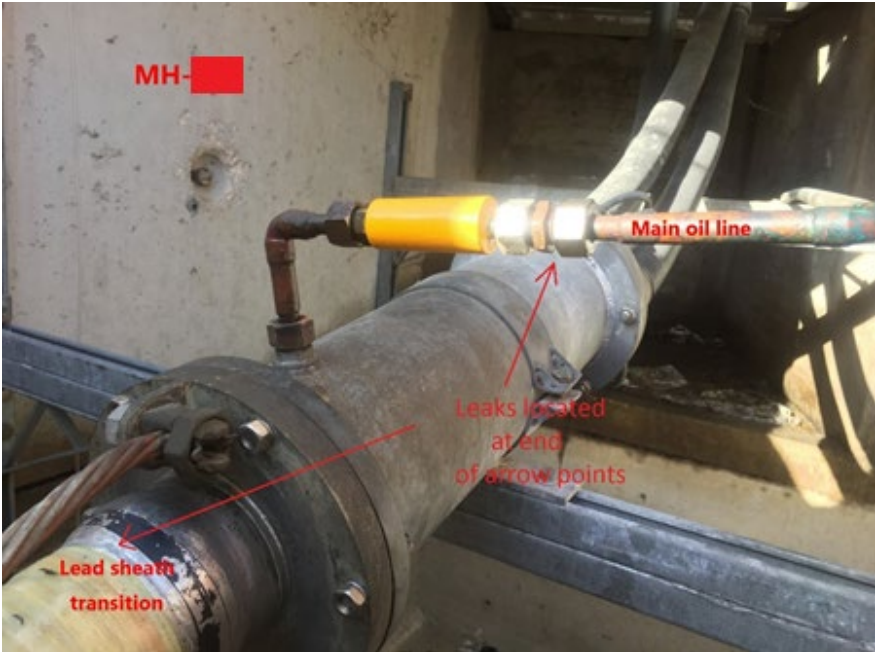
Fig. 3: Leaking Trifurcating Joint

One trifurcating joint was leaking in two places (see Fig. 3). The primary leak was at solder wipe between the cable sheath and the joint body. It was also leaking at the connection to the main oil line. The leaks caused the pressure in the circuit to decrease. During initial discussions the facility operator was advised to add more degassed synthetic fluid to maintain a slight positive pressure on the system while not increasing the pressure as that could worsen the leak. When adding degassed synthetic fluid or mineral oil to a system, it is important to use a degasser that is designed for cable fluid. Other degassers may not sufficiently degas the oil and could introduce other contaminants such as PCBs. Fluid filling was not done correctly and the cable system completely lost pressure. At this point, they were advised to immediately take the circuit out of service and then temporarily seal the leaks using plastic cling wrap and multiple layers of SAP and PVC tape (see Fig. 4). Since the pressure had gone to zero, temperature fluctuations could have resulted in a negative pressure which would pull air into the cable. If this were to occur the cable could not be rehabilitated so it was imperative the leaks were sealed.

Next, the leaking trifurcating joint located at the substation end was repaired. The oil feed was first isolated at the remote end of the circuit so that the feed could then be disconnected from the trifurcator. At this point the fitting that was leaking at the connection to the main oil line was swapped out for a new fitting.

To repair the leak at the solder wipe between the cable sheath and the joint body the trifurcator had to be drained so the lead wipe could be removed. Once the damaged lead wipe was removed the area was prepared for a new wipe to be applied (see Fig. 9). A stick wipe was performed on the leaking area in order to reseal the joint. This involves heating the wipe area with a torch just enough to soften the wiping metal and keep the applied metal malleable. Once the seal was re-established more metal was added to the wipe to reinforce the transitions (see Fig. 10). A stearine-free wiping cloth was used to shape the layers of the wipe and ensure a smooth finish. It is essential to ensure cleanliness throughout this process to achieve a high-quality lead wipe.

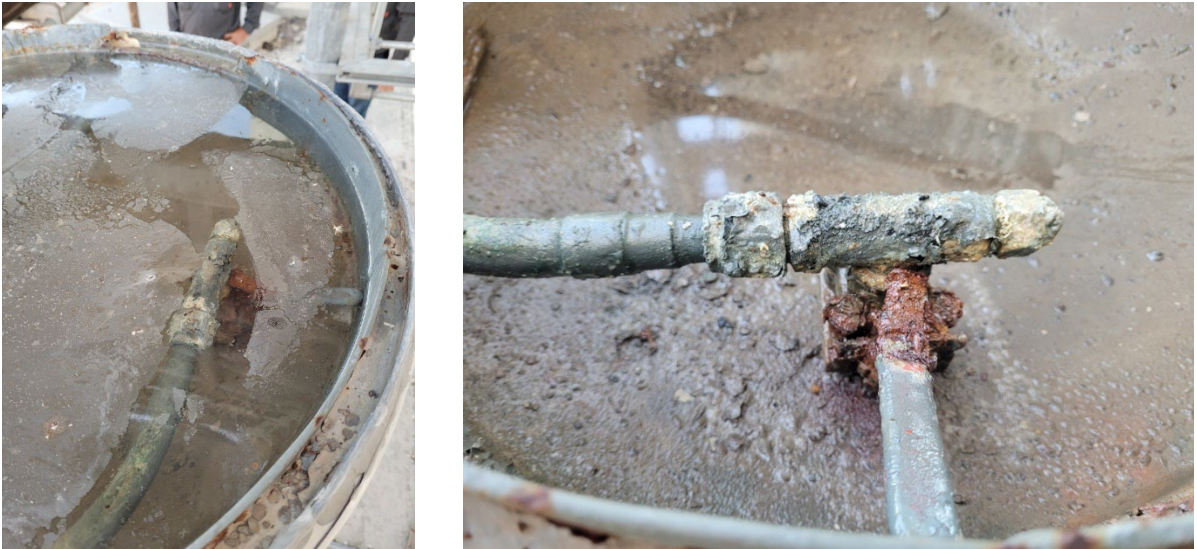
Fig. 5 and Fig. 6: Corroded Oil Reservoir Valves and Fittings

Upon inspection of the circuit, it became clear that the oil reservoirs at both ends of the circuit would need to be replaced. The lids of the reservoirs were not properly sealed which led to the top filling with water and the inner valves and fittings becoming severely corroded (see Fig. 5 and Fig. 6). This level of corrosion did not allow for the necessary connections to be made to re-pressurize the circuit. Also, with the circuit losing pressure and being unable to connect to the corroded fittings, there was no way to verify that the pressurized nitrogen cells inside the reservoirs were still at the correct pressurization level.

The first step in the repair was to replace the old, damaged oil reservoirs and piping. This ensured that a positive pressure could be maintained on the system after repair of the leak. The reservoirs at both ends were replaced with two new pre-pressurized reservoirs filled with degassed DF100 synthetic fluid (see Fig. 7 and Fig. 8). Fluid from both reservoirs was tested for power factor and moisture content prior to installation. Corroded piping was also replaced.
