B1 INSULATED CABLES
PS 1 - Learning from experiences

**Developments towards a Risk Based Maintenance program to reduce fires at
LV cable terminations and plastic enclosures**

¹Powerco Ltd., ²Unison Networks Ltd., ³EPECentre
New Zealand

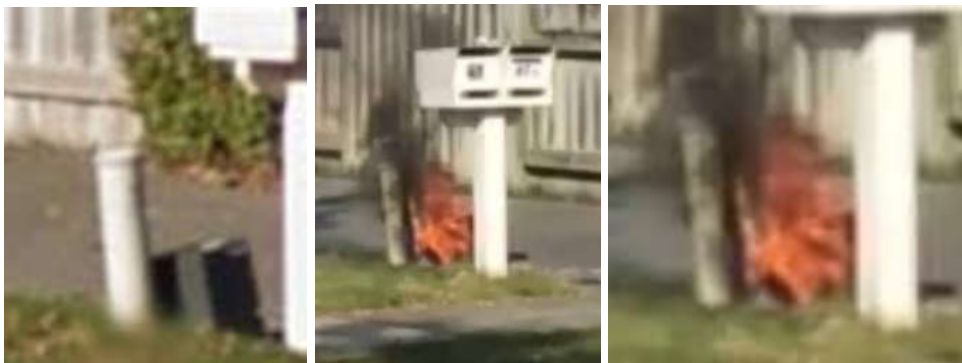
Figure 1 – A plastic pillar on fire, the subject of the case study below: before the fire (left), while on fire (middle) and zoomed in (right)

A fire occurred at an LV pillar which resulted in the complete destruction of the pillar, and property of the customer damaged [4]. Figure 1 above shows a pillar before, during and after a fire. Figure 2 below shows the remains of two similar style pillars, of different brands, after a fire. Additional photos and videos had become available through members of the public that provided a wealth of information to conduct the failure investigation.

Pictures and a video clip were taken of a typical plastic pillar before, during and after a fire. Figure 1 shows the pillar before the event, and while it is on fire. Stills of the video are shown in Figure 7. The clip showed that a short circuit occurred while the fire was in progress, and the power stayed on for more than 2 seconds. This indicates that the short-circuit was the effect of the fire, not the cause. The consequence was further damage to third party property.

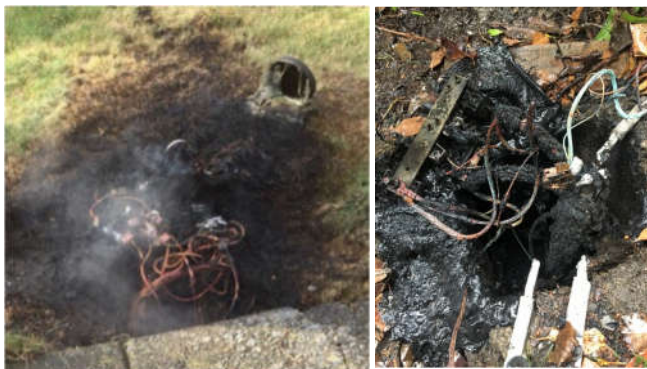
Figure 2 – the remains of two other plastic pillars after a fire

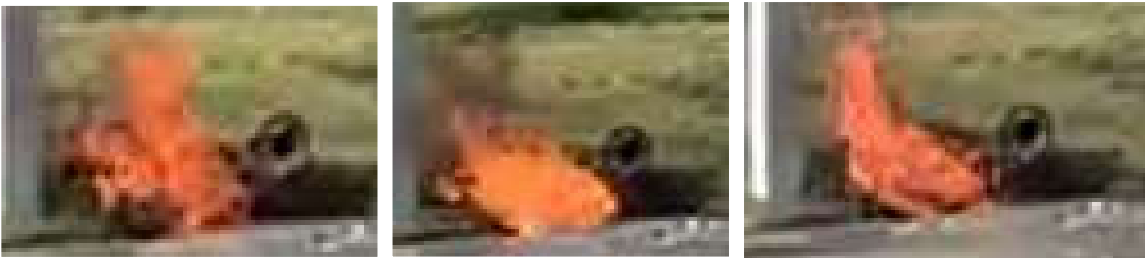
Figure 7 – stills from a video posted on Facebook by a 3rd party

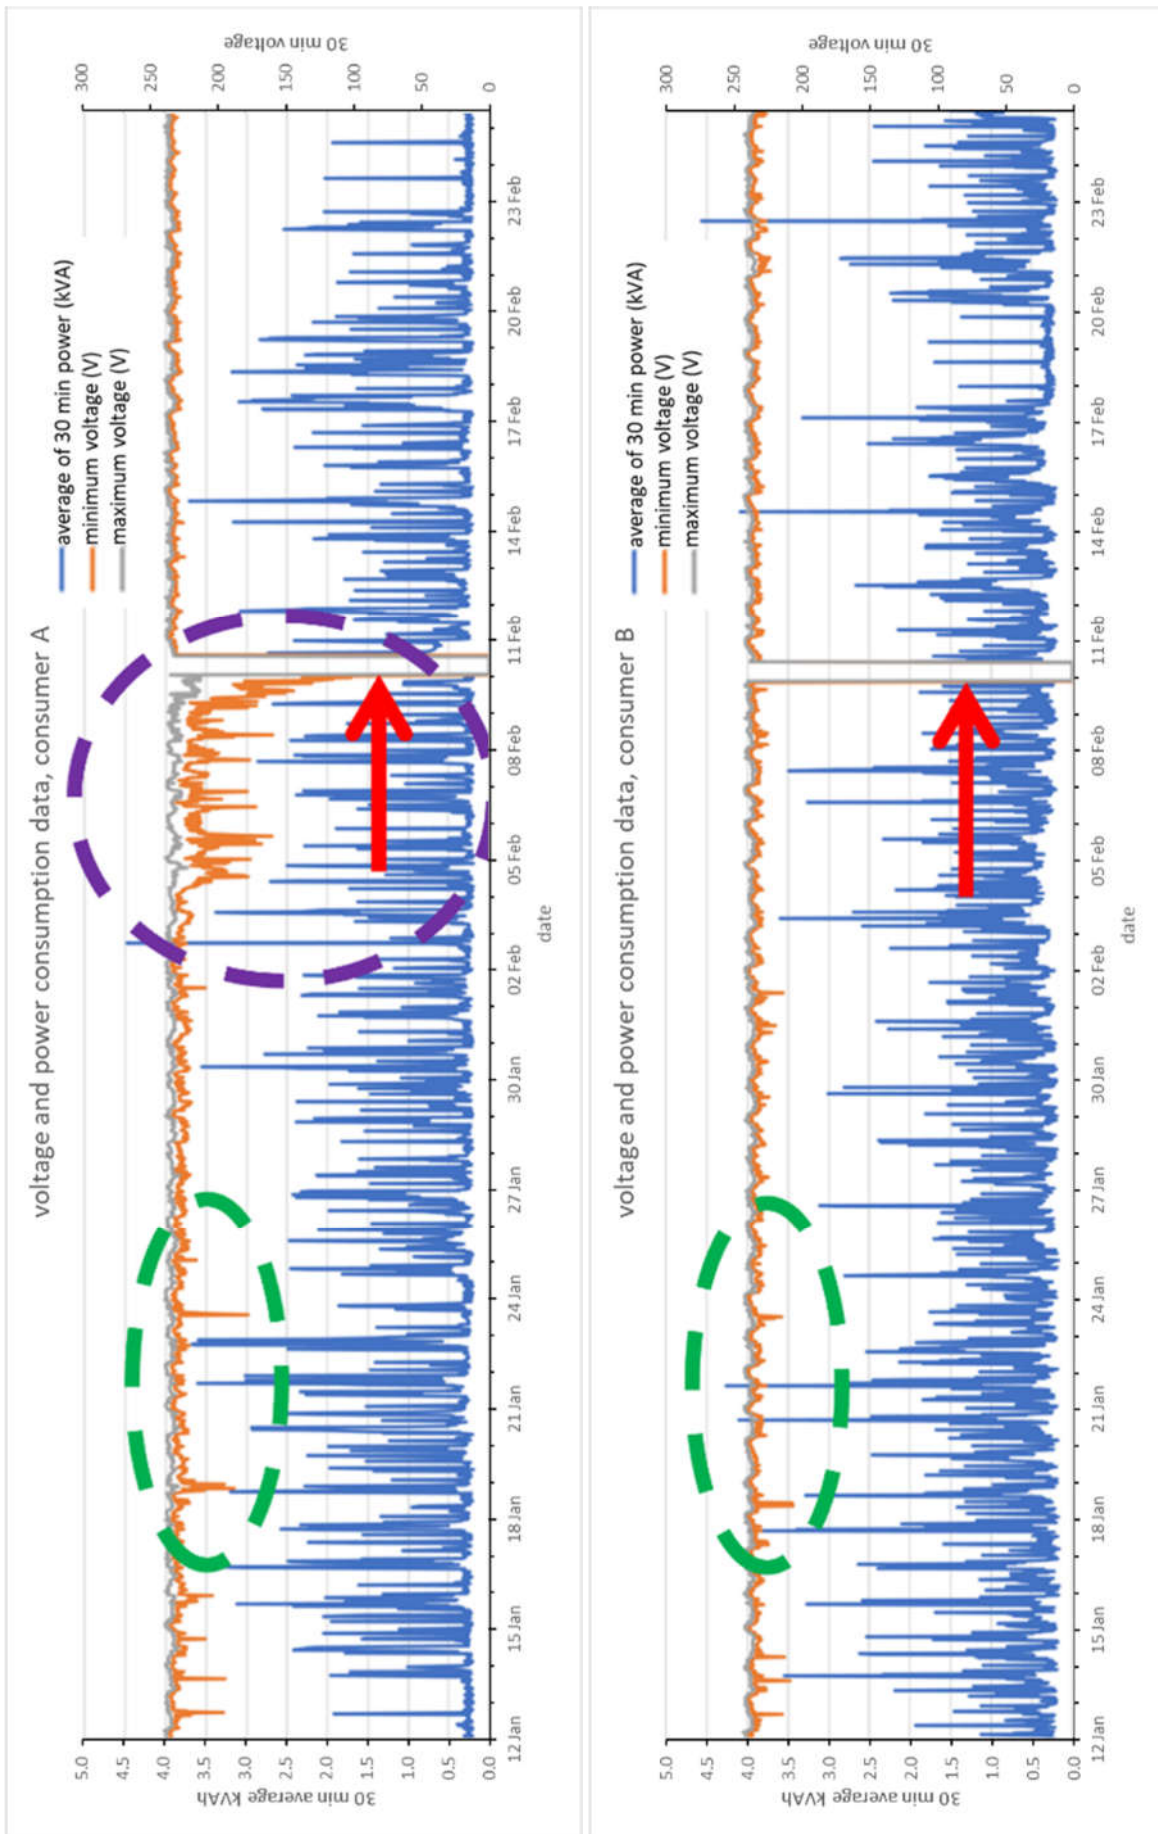
Voltage, current and power 30-minute data was obtained from the two “smart meters” of both customers, each connected to a separate service fuse each in the single pillar (as per Figure 4) — Figure 8 below shows the data from 12 Jan 2018 to 25 Feb 2018. The smart meter data showed fluctuations in the minimum voltage over time, as well as large differences between 30 minute maximum and minimum voltage. The zero voltage period on 10 Feb 2018 represents the time it took to replace the asset and reconnect power.

The voltage dips are visible weeks before the outage at both consumers (ICPs). Days before the outage, severe voltage reduction is visible on one of the ICPs, called ICP A. The outage is clearly visible in the data (red arrow). The voltage dips on ICP A are much more severe than on ICP B in the days before the outage.

Two time segments of particular interest are highlighted in Figure 8 by a green oval (5 days from 18 Jan 10:30 to 23 Jan 22:30) and a purple oval (data spanning 8 days before the failure from 2 Feb 11:30 to 9 Feb 21:30). Almost 10 drops in minimum voltage are observed a few weeks before the event (green oval), while there was no significant drop in the maximum voltage. That suggests that the minimum voltage might depend on the instantaneous current, or on moisture in the pedestal. A severe breakdown of the minimum voltage, and the maximum voltage, was visible days before the outage (purple oval and red arrow), although the drop in the maximum voltage was less pronounced. Note the minimum voltage dips below 200V and difference between max and min voltage of more than 50V.

This failure investigation shows that voltage and current disturbance waveforms preceded the fault many weeks and days before the failure. These disturbances can even be detected in the data collected by the 30-minute intervals measured by the “smart meters” installed in the NZ power network.

Figure 8 – voltage and consumption data for customer A and B. Note the loss of voltage during outage occurring on 10 Feb

Disturbances in voltage may be useful as a diagnostic indicator, if access is granted and the data is available in a timely manner. Fault monitoring equipment that detects “temporary short-circuit transients in a real grid as a method to identify damaged cables” as explored by [5] or Power Quality Meters as employed by [6] could provide diagnostics to detect these defects on LV underground circuits.

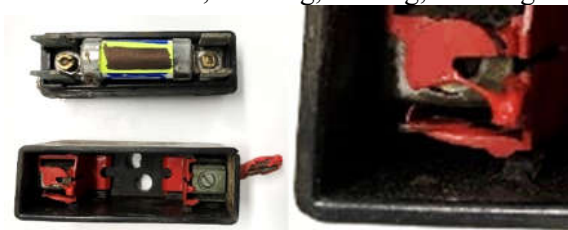
The heat from the hot connection can damage the materials of the nearby components. Figure 10 and Figure 9 shows heat damage of the components in a pillar (fuses, fuse holders, cable insulation), note the discolouration, charring, melting, cracking and splitting.

Figure 9 - Example of melted cable insulation and melted red plastic inserts

Heat damage to cable insulation in LV pillars is likely to have been caused by a hot connection. Electrical arcing or an open flame may also be a cause in instances where a failure has occurred. Figure 9, Figure 13 and Figure 11, among others, show some examples of melted and charred electrical cable inside a pillar.

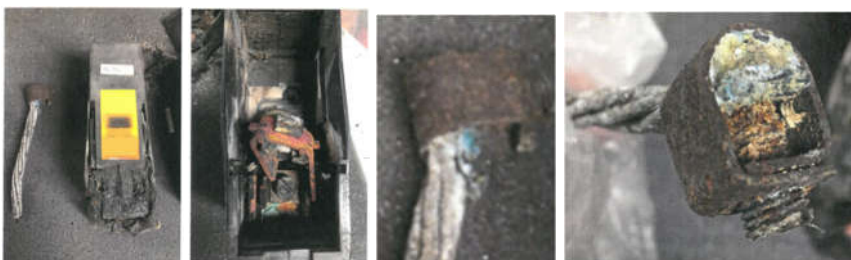
Figure 11 – example of aluminium cable conductor of which the insulation has charred off (left), the heat damaged fuse holder base and insert (right) note the grub screw and part of the connection plate still connected to the conductor.

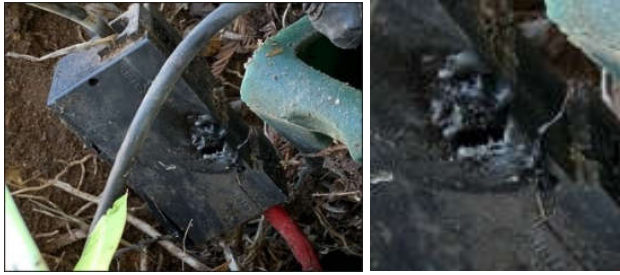
Figure 12 – example of heat damage to a black fuse carriage and the indentation on the green pillar mounting plate

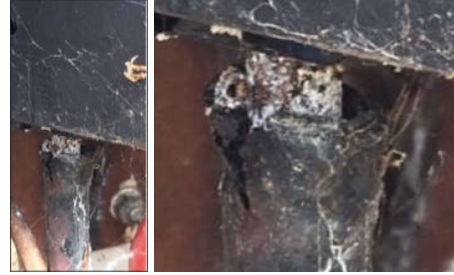
Figure 13 shows an example of charred cable insulation and high temperature corrosion of the conductor, visible as scaling (the formation of thick layers of corrosion products on the metal surface). High temperature corrosion (HTC) is a particular deterioration process associated with high temperatures, recognisable by the corrosion products that differ from those associated with normal corrosion. See [7] for more information on corrosion and HTC.

Figure 13 – example of charred cable insulation and high temperature corrosion

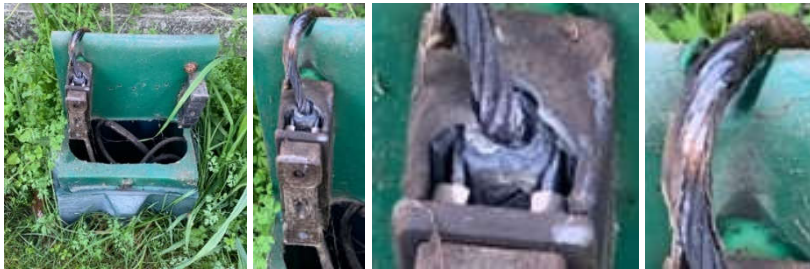
Figure 14 – example of heat damage on the fuse holder and cable as charring, and the disappearance of cable insulation above the fuse holder. damage to the plastic body as whitening of the plastic above the fuse holder, charring of the plastic above the fuse holder, and an indentation of the cable in the top of plastic back plate

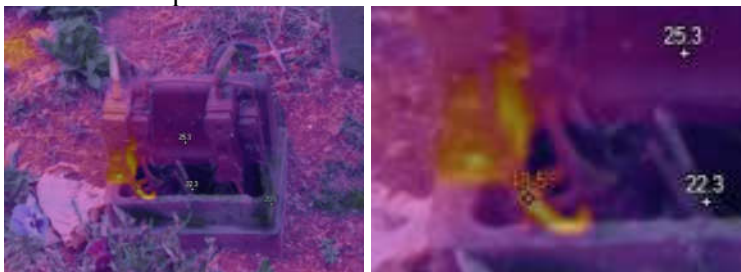
Internal inspections were developed to capture defects in a pro-active, systematic manner. These inspections included a thermal scan of the pillar components. Figure 15 shows an example where a hotspot of 48.5°C is evident at one end of the fuse holder. This has resulted in a temperature rise of 23.2°C, when compared to the mounting plate which has a temperature of 25.3°C. Internal inspections performed of 50 pillars in total at 5 different “pillar fire” locations yielded only 2 pillars with slight indications of possible defects.

Figure 15 – Hotspot at the Bottom of a Fuse Holder: bottom end of the fuse holder at 48.5°C, mounting plate at 25.3°C, incoming cables at 22.3°C

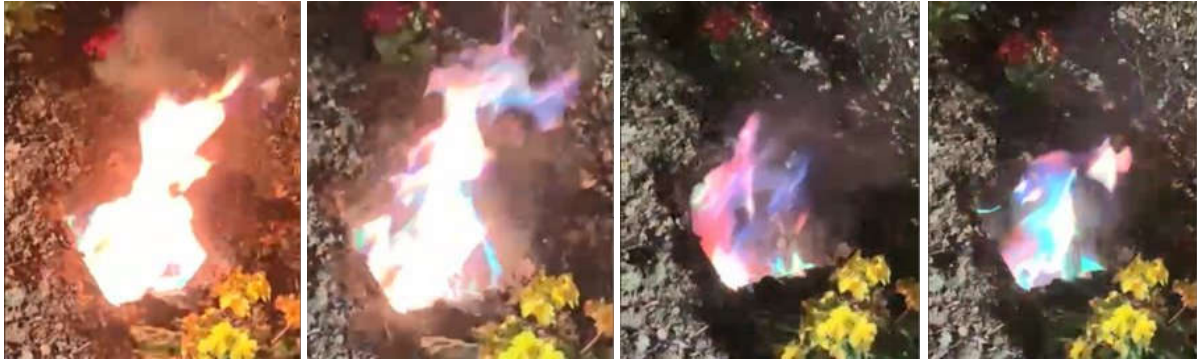
The two sets of photos in Figure 16 and Figure 17 videos of two different plastic pillars on fire. The power to both pillars had been turned off by the time these videos were recorded. This indicates that the fire of the plastic was self-sustaining, as described literature and laboratory tests. The flames are yellow with a blue centre, matching the behaviour of laboratory tests on combustion of PE materials.

Figure 16 – four stills from a video of a burning plastic pillar

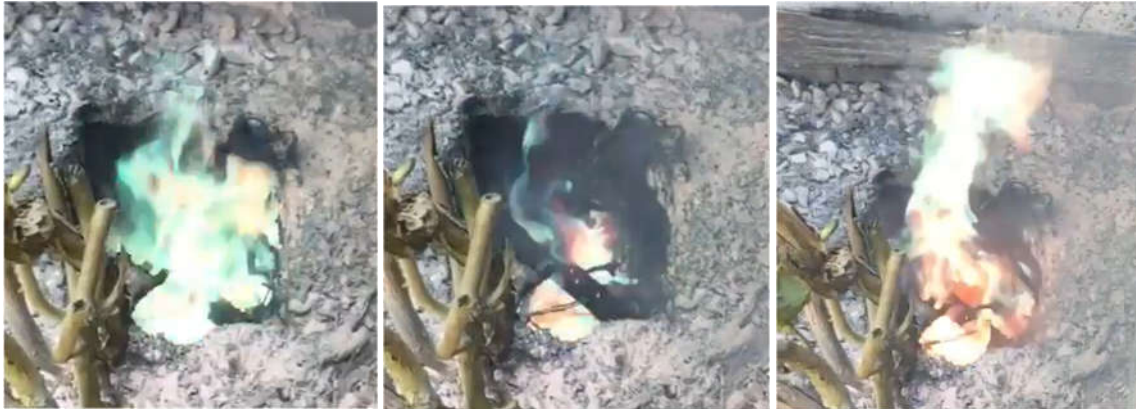
Figure 17 – three stills from a video of a second burning plastic pillar, 28 April 2017, courtesy of Kim Hall, volunteer fire fighter
