**OPTIMIZATION OF VEGETATION MANAGEMENT WITH LIDAR  
INSPECTION REAL APPLICATION CASE**

**David Ernesto GÓMEZ   Mallory SUÁREZ   Samuel ESTÉVEZ**  
**ISA INTERCOLOMBIA**  
**COLOMBIA**

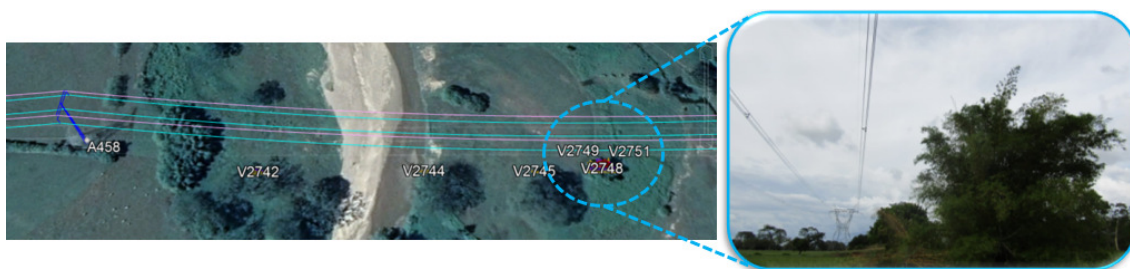
We found 59 points with high risk (distance from phase to top of the tree between 0 to 7 m), 159 points with medium risk (distance from phase to top of the tree between 7 to 9 m) and 348 low risk points (distance from phase to top of the tree between 9 to 12 m). An example of one of this high-risk point is shown in Figure 3. [4]

**Figure 3 Example of a high-risk vegetation point identified**

These points were intervened according to their level of risk, as shown in Figure 4.

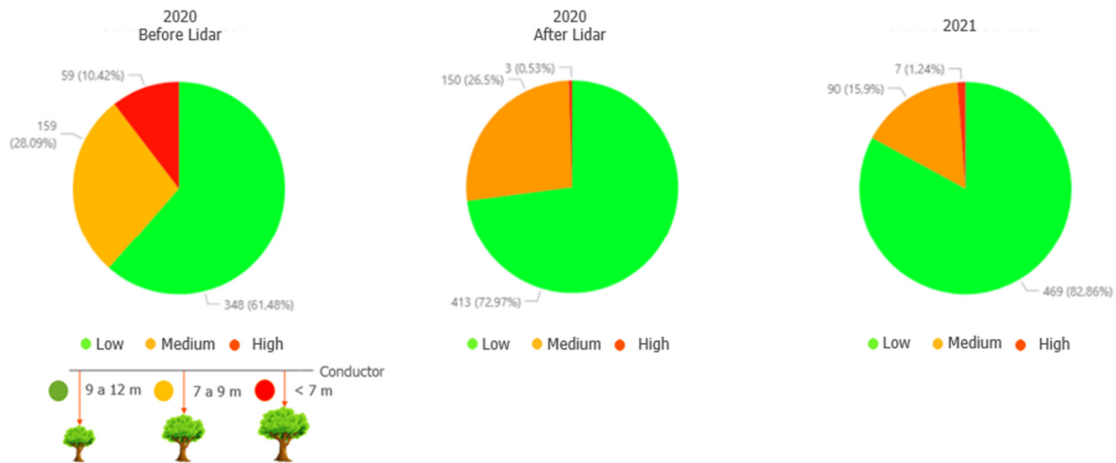
**Figure 4 Risk analysis for Primavera - Sogamoso 500 kV transmission line due to vegetation approach to conductors**

Note that in Figure 4, 3 points with risk persist after the intervention in 2020. These points correspond to access problems that are currently under monitoring. The rest of the line presents medium and low risks, which will be addressed accordingly in order from highest to lowest risk in 2021 and 2022.

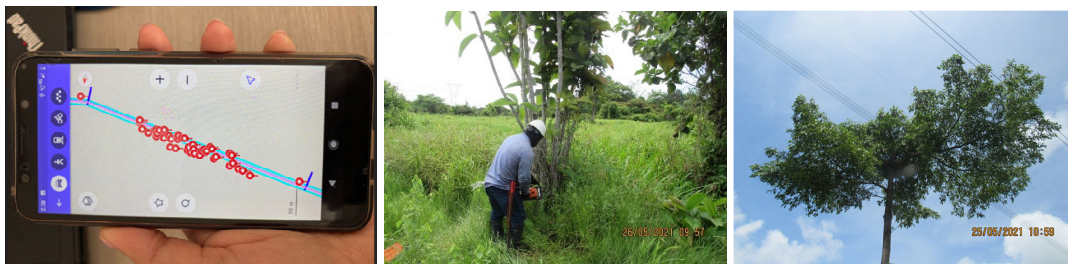
Figure 5 shows how personal on field identify and intervened vegetation cutting down whole trees and pruning. Personal mobile and a geographical app is used to locate vegetations classify as non-compliance class (risk) in LiDAR inspection.

**Figure 5 Process to identify and intervened vegetation classify with risk in LiDAR inspection**
