Paris Session 2022

Service Experience of Composite Insulators SC-A3 PS1 – Q5

Service Experience of Composite Insulators – Australia / New Zealand

AUS/NZ - 20-25 years experience

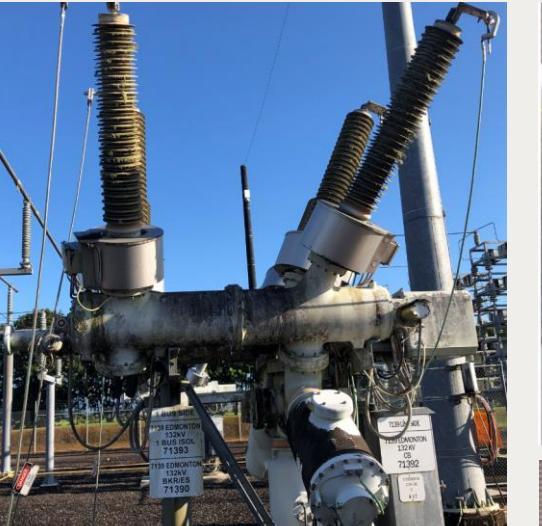
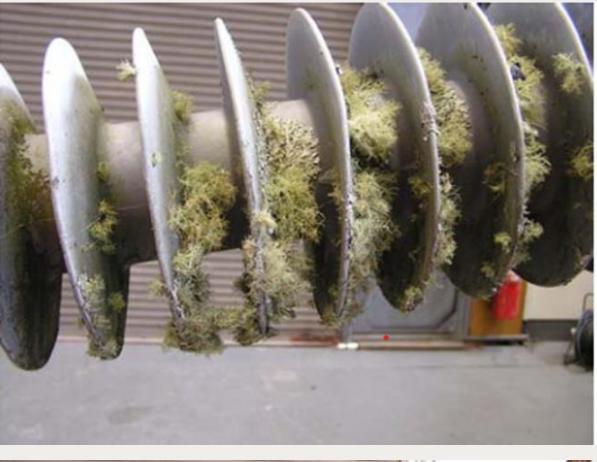
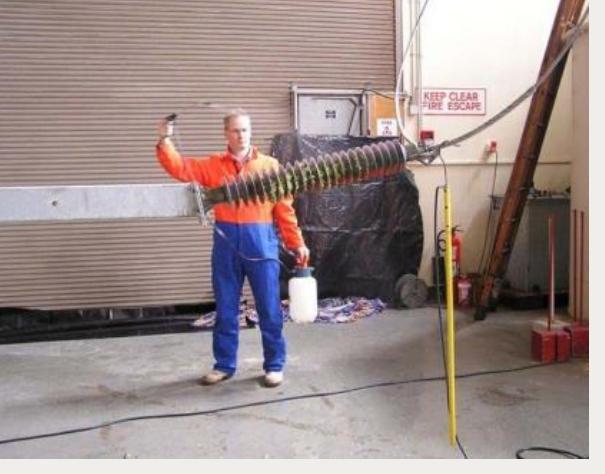
- 1. Organic pollution related:
 - a) Algae, moss and other growth
 - $\circ\,$ Common in very wet and humid environment
 - $\,\circ\,$ Dry and wet tests showed no sign of flashing over
 - $\circ\,$ Washing program as result of routine maintenance

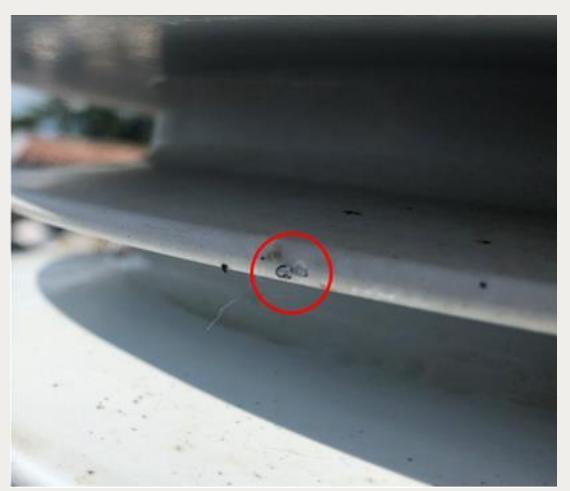
b) Lichen

- $\circ\,$ Lichen growth bridges the sheds and can reduce creepage distance
- When lichen is removed from the polymer shed it took out a little divot of polymer, damaging insulator
- o Cleaning process: warm water, soap and clean cloth

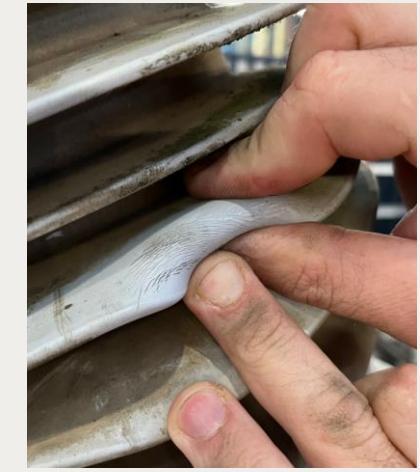
2. UV related:

- $\,\circ\,$ Small surface cracks form when the polymer shed is bent
- $_{\odot}\,$ The polymer surface layer is drier and brittle than underlying polymer
- Polymer gets extremely hard and very brittle, easy to tear with only minor contacts
- If polymer damage does not extend to the core of the polymer, the shed is repairable
