Paper 1059 Session 2022 A2 POWER TRANSFORMERS AND REACTORS PS3 - Best Practices in Transformers and Reactors Procurement

Power Transformer Fault Caused by Human Error and Inadequate In the Design

Yousef MASHAGBEH^{1,} Sami ABU SHARAR²

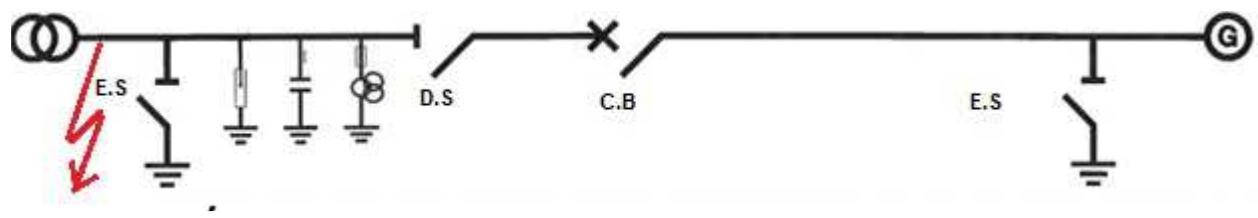
The case is grounded to the generator step-up transformer, 150 MVA, 15 kV/400 kV directly with a solid earth switch (Figure 1.2). The transformer is tripped by the overall differential relay of phases V, W, and U. The Buchholz relay and pressure relief valve do not activate.

Figure 1.2. Ground fault on generator step-up transformer

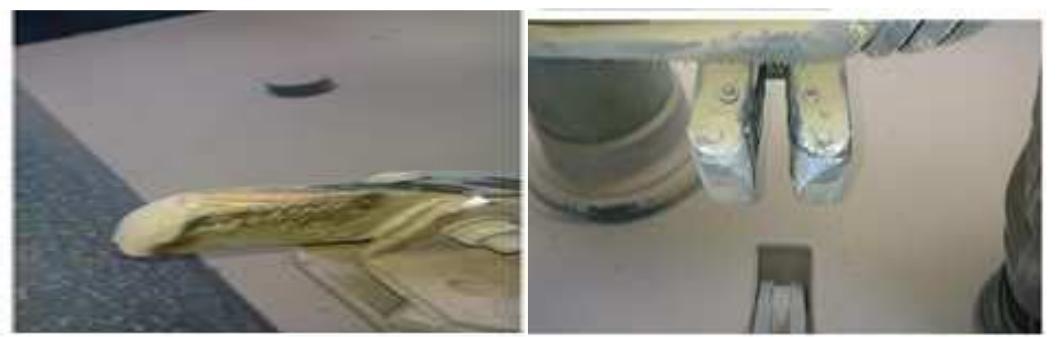
Simultaneously, the generator circuit breaker enclosure is opened to allow an internal view of all components, allowing repair and evaluation of the amount of damage. After inspecting the generator circuit breaker, it is noted that the high voltage fuse has burned down, and the earth switch connections have melted.

It is clear that the problem is in the earth switch arms. It is noted that the internal flashover has occurred on the surface of the earth switch (figure 3.a). In other words, a surface discharge has developed between the earth switch and the ground. Figure 3.b shows the carbon trace on the earth switch due to the flashover, no doubt that a flashover has occurred inside the generator circuit breaker, confirming the operation of the overall differential relay.

Fig.3.b carbon trace on the earth switch

After repairing the defective part, the electrical tests such as operating times (open and close), the conductivity of the grounding system, gas pressure SF6, and insulation resistance were conducted, and all the results were satisfactory and accepted. Since the tests indicate that the generator step-up transformer 150 MVA, 15 kV/400 kV is passing the fault without any effect in the short term, it was decided to bring the transformer back into service again.

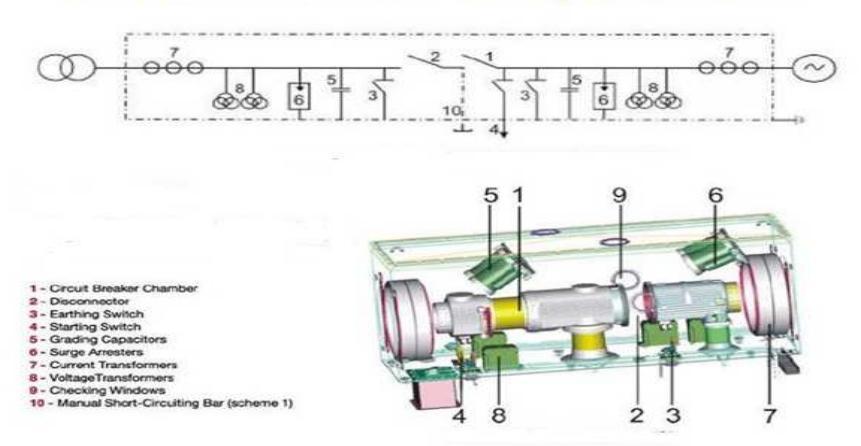
The manuals and as-built drawings were reviewed to ensure that interlocks are functioning as the recommended design. Figure 4 shows the mechanical interlock which was implemented in the circuit breaker in the proper way.

Fig. 4 Circuit Breaker Compartment

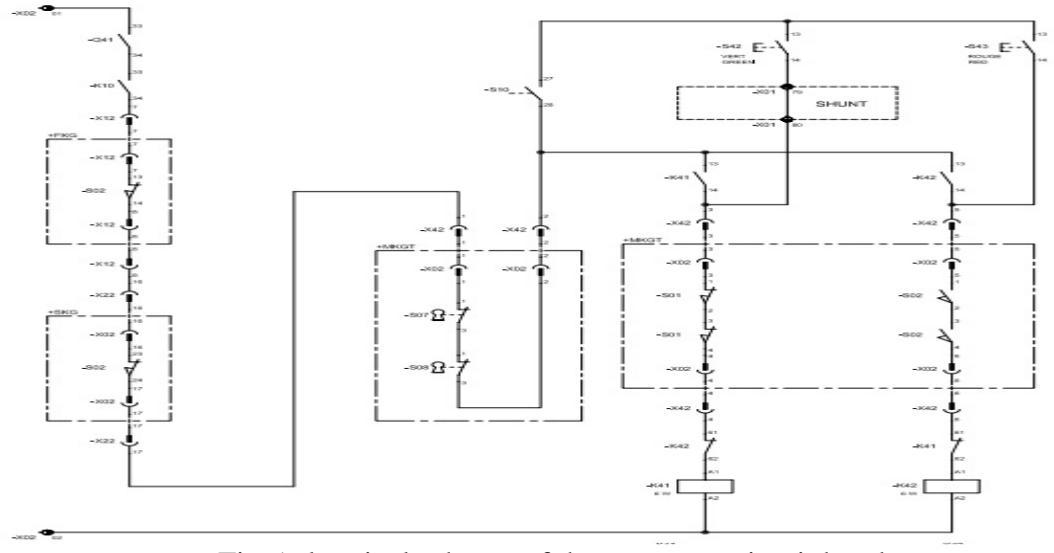
The electrical scheme of the generator circuit breaker as shown in Figure 5 shows the wiring of the interlock signal exists but does not connect to the control circuit. This brings us back to the commissioning stages, which may not have installed this signal or carried out some testing that was needed to bypass the interlocks. As a result, it has not been reconnected again.

Fig.5 electrical scheme of the generator circuit breaker

Consequently, to enhance the interlocking system and prevent human errors in the future, it was decided to redesign the control circuit and implement it immediately. The modification is adding the voltage control relays to the existing control circuit of the generator circuit breaker to sense the voltage on the generator step-up transformer. In other words, the maintenance earthing switch will not inadvertently be closed when the generator step-up transformer is energized. As a precautionary principle, a comparison was made between sister generating units that were installed by the same main contractor at that time. It was found that the interlocking signals were not set up on the breakers. As a result, the modification was implemented for all other breakers.
