Paris Session 2022

Experience with IPB PD sensors on large turbine generators

Preferential PS 2 Q 2.7

Mladen Sasic (Canada)

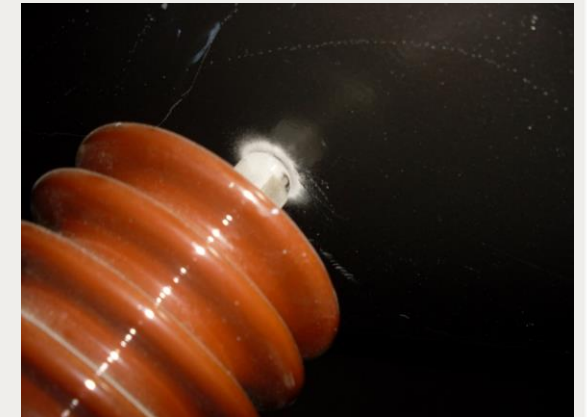
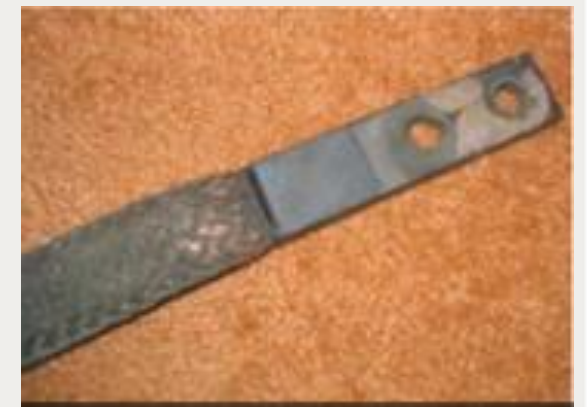
- With sensors connected to oscilloscopes or instrumentation in the 0.1-350 MHz frequency range, separating stator PD from noise was effective **ONLY IF** there was no arcing sparking from the flexible leads connecting the TG bushing to the IPB, or there were no (harmless) discharges from the first IPB post insulator

- Regrettably, a survey of operating bus shows that about 30% of large TGs have such (relatively) harmless arcing/discharging sources – which makes it extremely difficult to interpret data from such installations, causing a high false positive indication rate.

- 80 pF couplers (connected to the HV bus) have since been installed (2 sensors per phase) in about 12,000 TGs
- Compared with SSC types sensors in the stator slots in large H2-cooled TGs, IPB sensors have a higher false positive indication rate due to relatively harmless arcing/sparking at the TG terminals [2]

- Of 50,000 couplers installed on TG IPB since 1994, there have been no in-service failures of 80 pF couplers, since they exceed the requirements for capacitive coupler reliability in IEC 60034-27-2 and IEEE 1434 (which is more stringent)
