NAME :	Simon RYDER	GROUP REF. :	A2
COUNTRY :	GB	PREF. SUBJECT :	PS1
REGISTRATION NUMBER :		QUESTION N° :	Q4

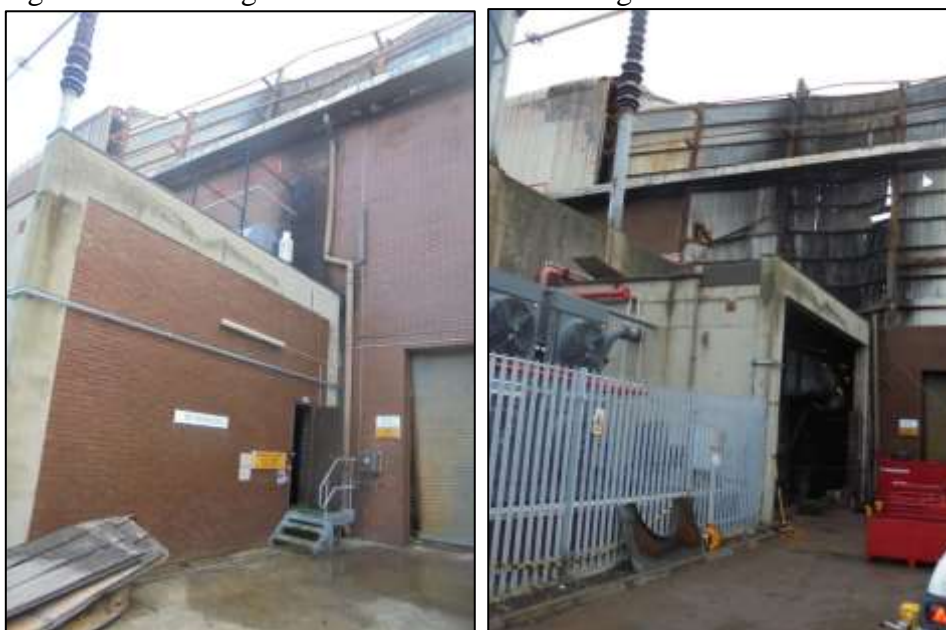
Figure 1 Smoothing Reactor with Failed Bushing

Recent operational experience has exposed a major risk with the use of bushings in the horizontal position in long turrets projecting through the wall of the building. In case of a bushing failure there is a significant risk of uncontrolled loss of oil from the transformer (or reactor) into the main building. Given the bushing failure will provide a source of ignition, there is a high probability of a fire inside the main building which will be difficult to control and extinguish.

Figure 1 shows a smoothing reactor, which experienced a bushing failure. The bushing failure resulted in uncontrolled loss of a large quantity of oil from the smoothing reactor into the main building. The oil caught fire, causing serious damage to the main building. Figure 2 shows some of the fire damage. Note that smoke damage was more extensive, resulting in the destruction of two of the converters.

- This risk is eliminated from new HVDC interconnectors by using transformers with bushings in the vertical position and wall bushings to connect the transformer (or reactor) to the equipment inside the main building.
- On existing HVDC interconnectors the risk is reduced by use of bushing monitoring on the transformers. Owing to the lack of a significant ac voltage on the bushing, monitoring may not be as useful for smoothing reactor bushings.
- On existing HVDC interconnectors the risk is reduced by use of dissolved gas monitoring. Experience suggests that progressive failure of bushings results in a characteristic change in dissolved gas signature and can therefore also be detected in this way. Dissolved gas monitoring is especially useful for smoothing reactor bushings, where progressive failure is otherwise difficult to detect.
