Development and research of the XLPE cable laid in HPFF steel pipe

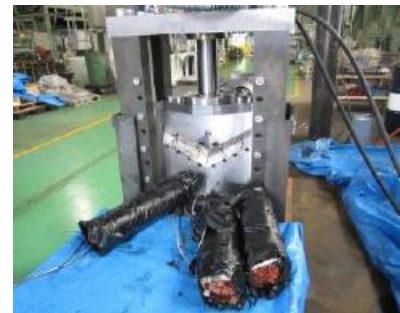
Fig 2. Hydraulic cable cutting machine

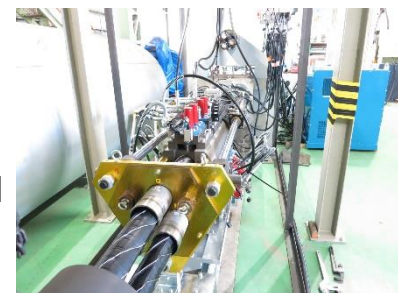
Fig 3. 3-phase simultaneous cable pulling machine
