B2\_PS1\_Q1.12\_Y. Okawa

Question 1.12: Would the experts from other countries/utilities share their experience in use of RTV coated insulators in heavy polluted areas and ageing over the years?

Field Experiences of RTV Coated Insulators in Heavy Polluted Areas

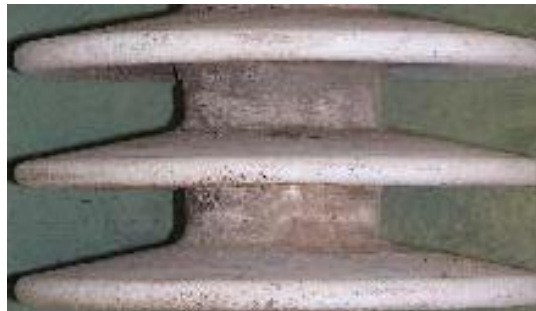
Fig. 1 Removed RTV long rod insulators for 5 years

RTV coated long rod insulators were exposed under very heavy polluted area (categorized as per IEC 60815-1) combined with sea salt and desert soils for 5 years in 380 kV line. Surface deterioration such as erosion can be observed on the part of the surface, especially trunk portion as shown in Fig. 1. Nitric acid was appeared on it. FT-IR (Fourier Transform Infrared Spectroscopy) spectrum of the RTV rubber on erosion portion is shown in Fig.2. However, significant higher fog flashover voltage than operational voltage can be obtained by laboratory test. On the other hand, the flashover voltage would be decreased with time.

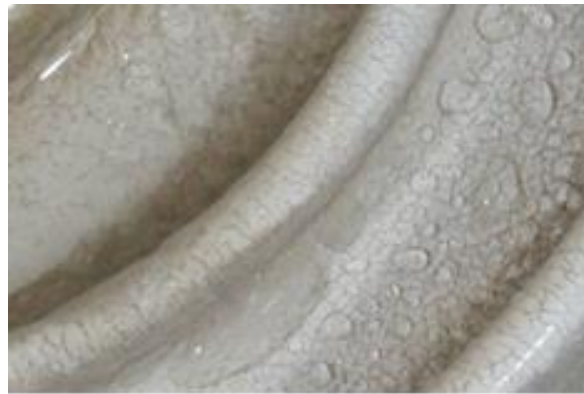
RTV coated cap and pin insulators were exposed under heavy pollution condition (Designed ESDD of  $0.375 \text{ mg/cm}^2$ ) with sea salt for 10 years in  $\pm 250 \text{ kV}$  line. Slight rough surface was observed as shown in Fig. 3. However, no erosion and excellent hydrophobicity was appeared. No significant pollution events have been reported even now.

Fig. 4 Maintained hydrophobicity
