## Experience with galloping countermeasures in Tepco PG

PS2/Group2:Conductor, Q.2.7

Tomonori SHIRAISHI, Japan

TEPCO Power Grid, Inc.

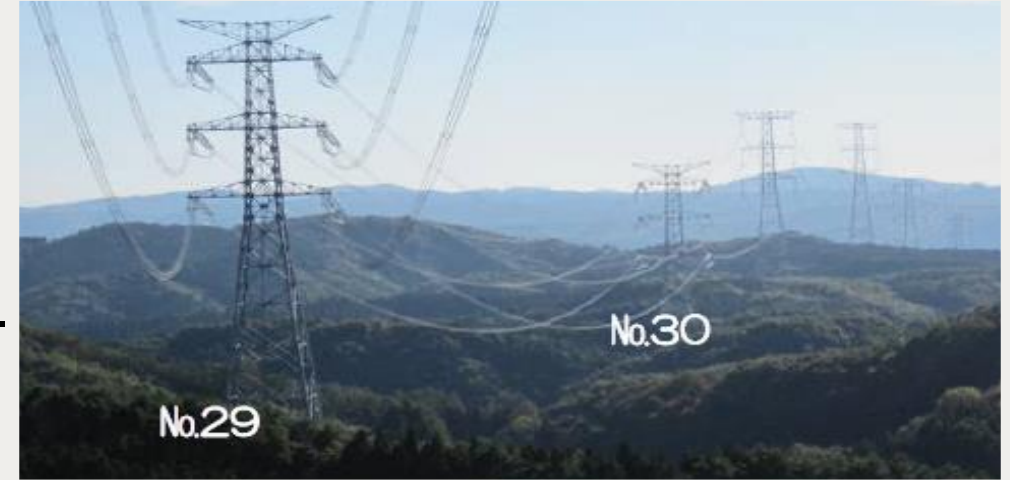
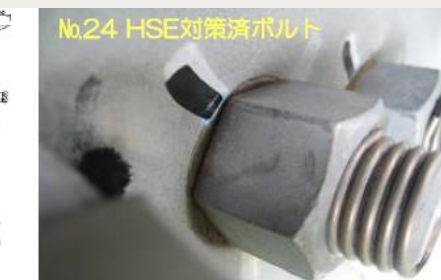
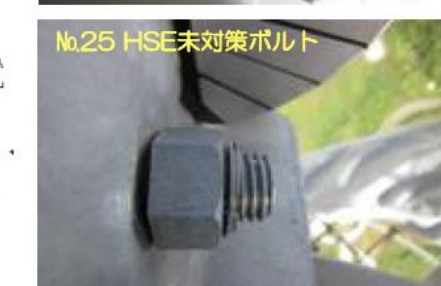
- Right Photo shows a **UHV-designed 500 kV transmission line** in northern area in Japan.
- The line suffered damage from galloping in **2007 and 2012**.
  - (1) The eight-bundle **spacers** were broken.
  - (2) The pipe-type **jumper** was broken at the welded part.
  - (3) The **insulators** were partially cracked.
  - (4) Some steel tower **bolts** came loose.

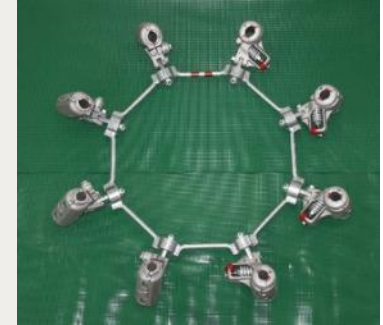
- The ratio of facilities installed galloping countermeasures is **about 4%**.
- We developed a galloping countermeasure with loose spacers for a UHV design transmission line.
- **The loose spacer for eight-bundle conductors** was applied, focusing on ten spans known to have sustained significant galloping equipment damage in the past.
- No subsequent major damage to facilities was recorded.
- Additionally, we are developing a **new type of galloping countermeasure** for single conductors as alternatives to interphase spacers at 154 kV or less.
