The confidence level and the images to learn the AI model

PS2/Group 5: Artificial intelligence AI and data analysis, Q 2.19

1. The conductor diagnosis-imaging system using helicopter VTR and AI

2.The steel tower deterioration diagnostic method using drones and AI

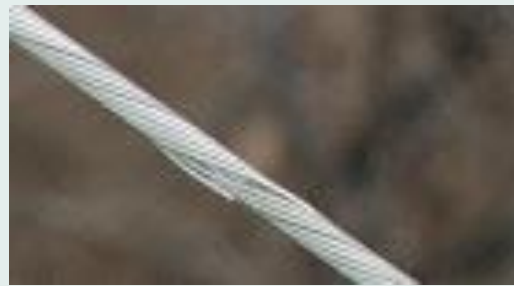
Wire breakage

Examples of failure state images used for learning

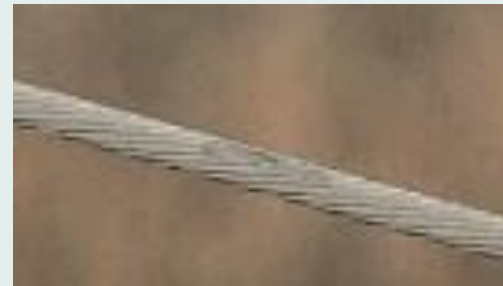
Melting

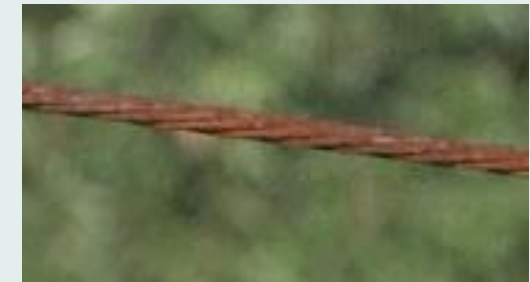
Corrosion

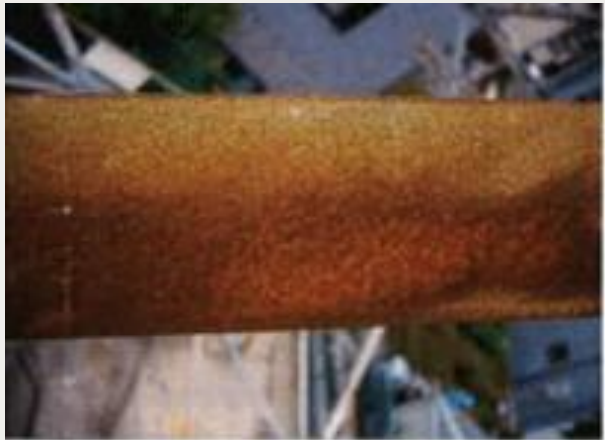
Enlarged still image of the rusted area

- This AI model is constructed by additionally learning images of rusting on 22 steel towers as part of a versatile rust detection approach, which involves the AI deep-learning numerous rust images of all kinds.
- About 1300 images are used for learning, with the versatile rust detection AI as a base. We conducted additional learning by adding 350 or so still images.
- The accuracy of this AI included confirmation of recall rate of 97% or more, conformity rate of 91% or more.

Recall rate (probability of finding rust without missing it)	97.66%
Conformity rate (probability of the existence of actual rust in target points where existence is predicted)	91.91%

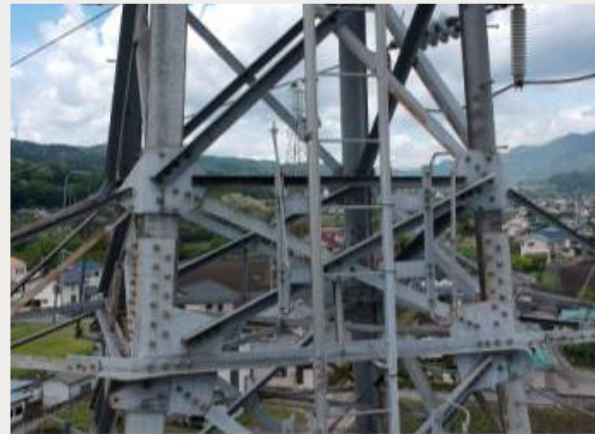
Overhead view of the steel tower containing the rusted area
