Q1.7 Are there methodologies and approaches to analyses the possible harmonic interactions and predict the scenarios with harmonic interactions?

The target AC filter is the pole 1 of the Kamikita C/S side of Hokkaido-Honshu HVDC Link. The Hokkaido-Honshu HVDC link is a bipolar +/-250 kV, 300 MWx2. The purpose of installing the AC filter is to absorb the harmonics generated by the operation of the LCC converter. The AC filter is connected to the AC 275kV bus via GCB.

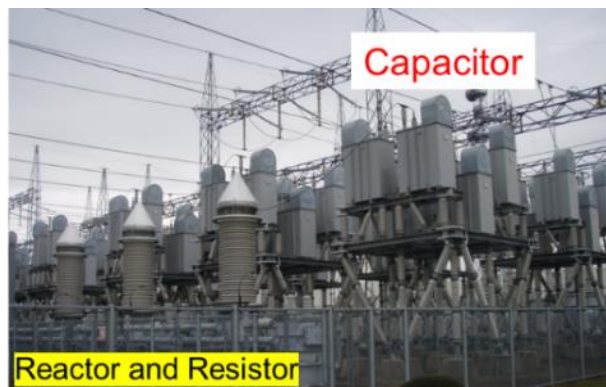
Since pole 1 can perform both 6-pulse operation and 12-pulse operation, a 5th filter and 7th filter are installed. Reactor and resistor (2011, right photo) are housed in the same insulator tank. Capacitors were installed on the insulator frames.

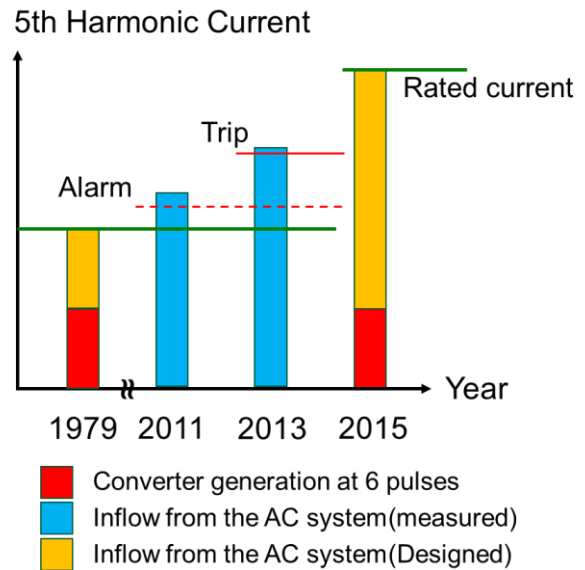
When the AC filter was installed, the harmonic current rating was designed from the value generated by 6-pulse operation (red bar) and the amount of system inflow at that time (orange bar). However, in 2011, an overload alarm occurred during 12-pulse operation where the 5th harmonic was not generated from the converter. It was found that the cause of the overload of the AC filter was an increase in inflow from the AC system. It was estimated that this was due to the enhancement of the AC system. We tried to reduce the harmonics flowing from the AC system to the AC filter, but we could not take measures by the AC system. In this state, if the converter operates in 6 pulses, the AC filter will overload trip and the converter will not be able to continue operation. Therefore, it was decided not to operate 6 pulses until 2015.

An oil cooling fan was installed in 2012 for continued use of the equipment. The cooling fan had the effect of cooling the temperature of the insulating oil more and could extend the life. After that, it was decided to take measures by replacing the equipment in 2015. The fundamental wave capacitance (32MVA) and the circuit constant (L, C and R) are the same, and only the rated harmonic current is improved. In 2013, before he could take action, we experienced a trip with an overload relay.

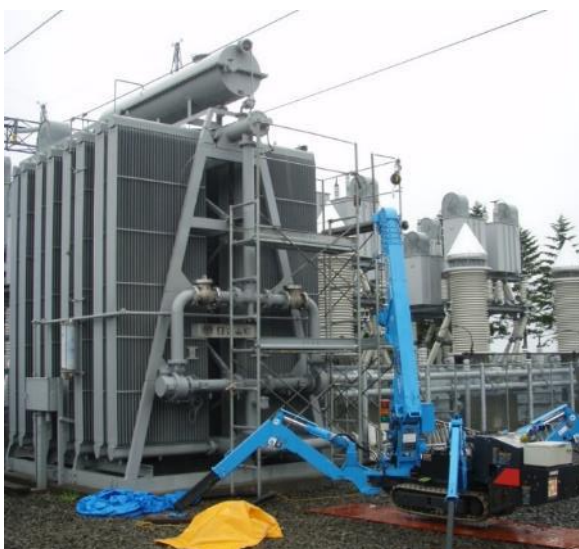
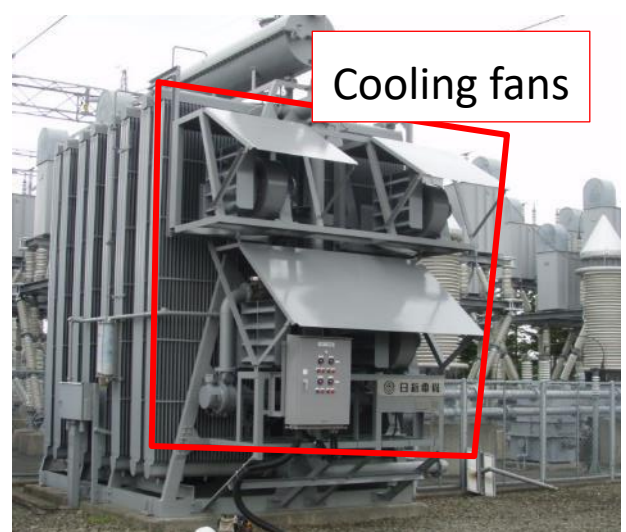
The above pictures are before and after the addition of the oil cooling fans in 2012. The additional work took about two weeks while the converter was in operation.

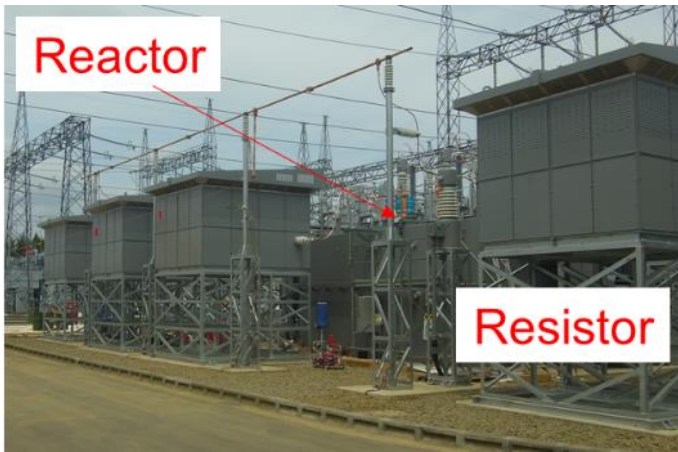
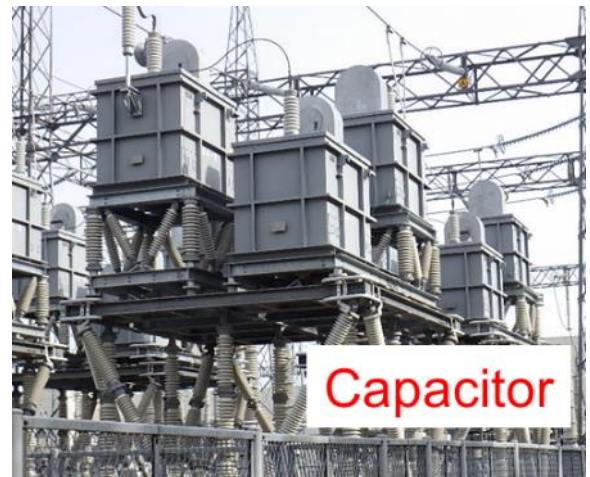
The above pictures are the AC filter after replacement in 2015. Reactors and resistors have increased in size as the harmonic rating increases. The capacitors are slightly larger. Capacitors and reactor remained OF type, and resistors were changed from OF type to dry-type.

The new AC filter is designed to enable 6-pulse operation even when the rated harmonic current flows in consideration of the urgent system harmonic inflow. The replacement targets were capacitors, reactors and resistors. The insulator frames for the capacitor were diverted.
