One case showing the importance of keeping replicas up-to-date is reported, involving Furnas Itaipu HVDC System. The project comprises two bipoles of 3150 MW at  $\pm 600$  kV, in commercial operation since 1984 (BP 1) and 1987 (BP 2). The control and protection (C & P) systems replicas were interfaced with a real-time simulator (Figure 1). Initially installed in Sweden, it has been used for the design and tests of the C & P system, like factory systems tests, dynamic performance studies, protection coordination studies and pre-commissioning tests. In 1982 the replicas were moved to Brazil to continue the studies.

Figure 1 – Control and protection system and replicas.

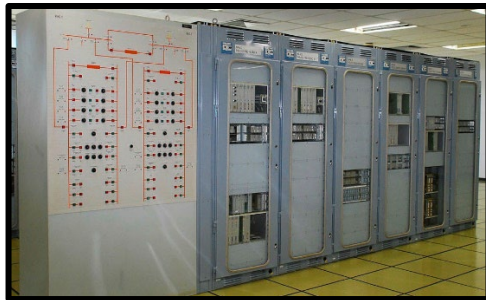
Figure 1a) Control System panels at Rectifier Station

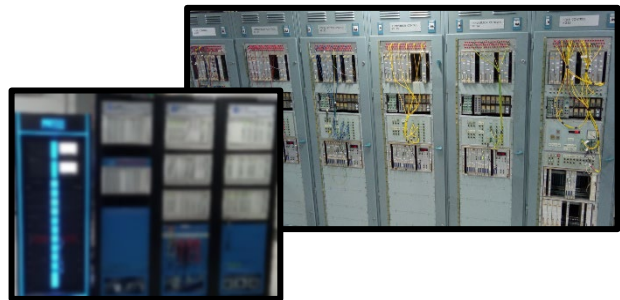
Figure 1b) Real-time simulator and control system replicas.

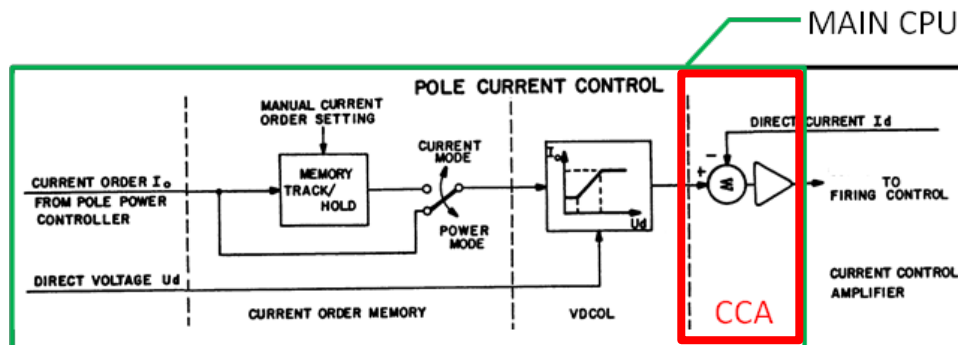
After some time in commercial operation, the current control amplifier (CCA), in the final part of the pole current control system, started to experience intermittent stall alarms, leading to the “freezing” of converter firing angles orders, hence losing regulation capacity, i.e., feedback ability. Although a CPU reset could solve the issue, it was nonetheless a maintenance action, with a chance of a converter outage. A throughout investigation concluded that an electronic component’s temporary failure due to poor thermal stress supportability provoked by ageing was the cause. Figure 2 presents a simplified block diagram of the Pole Current Control, identifying the CCA part.

Figure 2 – Pole Current Control simplified block diagram.
