Study Committee A1 ROTATING ELECTRICAL MACHINES

Damaged generator rotors: the economic and logistical benefits of repair over scrapping

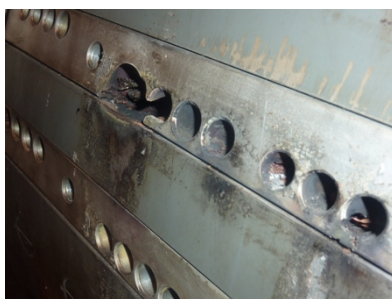
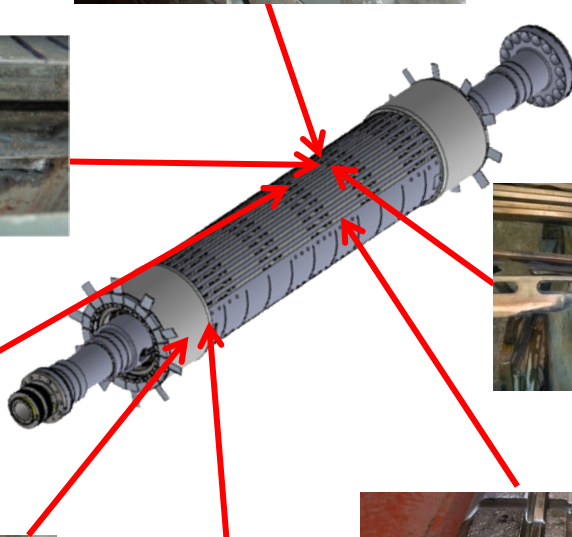
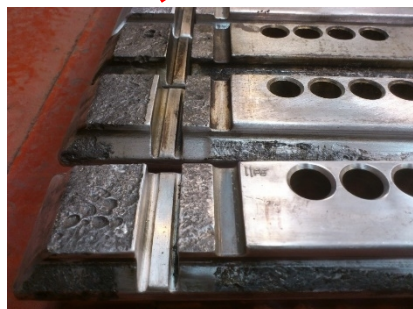
Generator motoring

- Motoring incident at standstill
- Subsequent arcing
- Rotor double earth fault

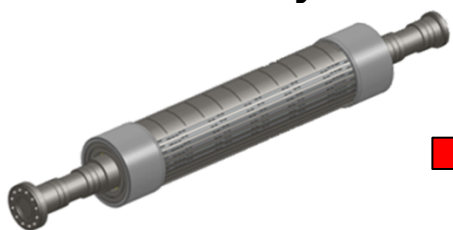
Rotor fully

Rotor damper cage

Rotor at speed

- Centrifugal force
- Good linkage between retaining rings and wedges
- Low resistance joint

Rotor standstill

- NO centrifugal force
- NO linkage between retaining rings and wedges
- HIGH resistance joint

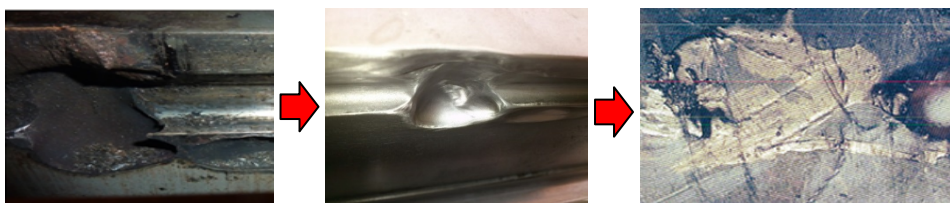
Forging repair

New slot profile

- FEA model
- Stress analysis (Von Mises) for both profiles
- 3 different mesh sizes applied
- 120% rated speed
- Comparison between both profiles

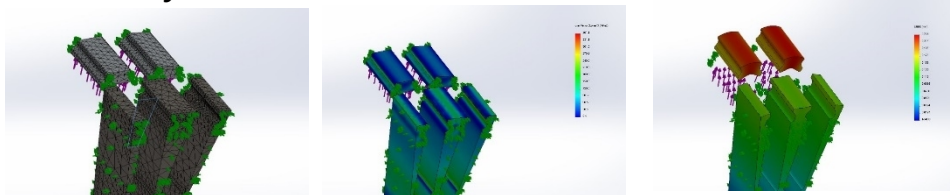
Stress analysis

Results

FEA profile	Mesh size	Von Mises stress (MPa)	Deflection (mm)
Original	8mm	516	0.331
	5mm	516	0.331
	2mm	548	0.331
New	8mm	533	0.318
	5mm	565	0.318
	2mm	564	0.310
New profile, With wedge surface contact	8mm	281	0.230
	5mm	361	0.236
	2mm	339	0.233

The Von Mises stress between the two profiles changes by only **8.7%**
