Study Committee B2

Overhead Lines

Application of Multi-stress Test Methods to evaluate Today's Composite Insulator Reliability

Jaka Strumbelj*, Christiane Baer, Jan Lachman, Frank Schmuck

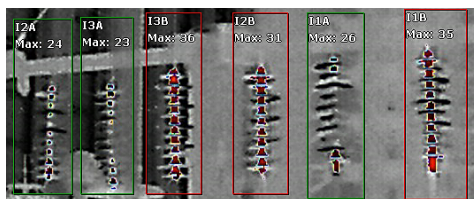
Testing with Special Water Absorption Test

Three samples prepared from one insulator fail 30 min AC withstand test

- High water ingress results in leakage currents along the interface, increasing shank temperature
- Special water absorption test using tap water was found to be more severe and detect improper adhesion compared to tests according to IEC 62217 by boiling in salt water
- Insulators with no adhesion can pass the IEC 62217 test if the sealing is applied appropriately
- Mechanical adhesion due to shrinkage and applied sealing can prevent moisture ingress in the interface during testing, but results in failures in service
- Insulators with LSR housing without adhesion can experience electrical failure during electrical testing after special water absorption test in contrast to tests according to IEC 62217
- Insulator samples taken from service with poor or no adhesion will fail the test according to IEC 62217 ($\Delta T > 20$ K) and special water absorption test

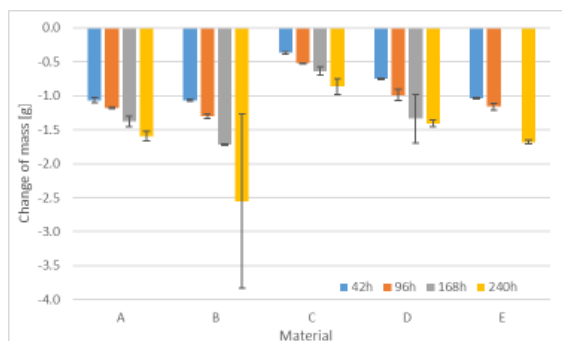
Change of Mass after Boiling for Different Materials

Material	ATH [wt.-%]	ATH type
A	58	ATH 1, silane treatment A
B	52	ATH 1, silane treatment A
C	> 50	ATH 2, silane treatment B
D	54	ATH 3, silane treatment C
E	54	ATH 3, silane treatment D

- Additional pre-stressing by boiling:
 - Increases the area of bulk erosion up to the top electrode
 - Increases the depth of the bulk erosion
- Acid attack decreases the resistance to tracking and erosion and results in a different appearance of the erosion.
- Higher amount of filler (ATH) will have a positive contribution.
