Study Committee B3

Paper ID 288

Lessons from Action Planning Based on Transformer Condition Monitoring

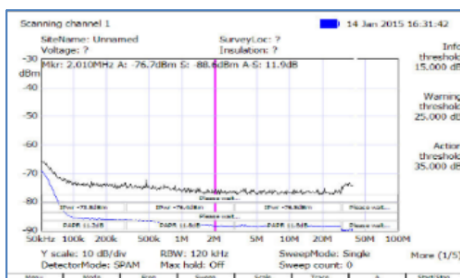
PD Spectra for PD Detection

- Broadband PD spectra allow for PD detection
- Each frequency in the spectrum is analyzed for peak to average power ratio (PAPR) which is a statistic to indicate the presence of PD within the spectrum
- More detailed diagnostics can then occur

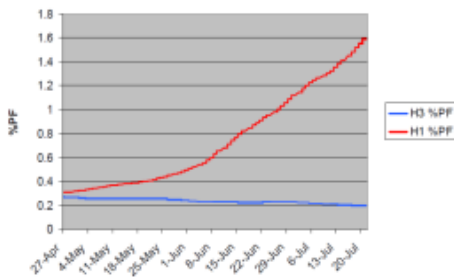
Straightforward monitoring example

- Online bushing power factor rises over several months
- Offline tests performed to confirm deterioration

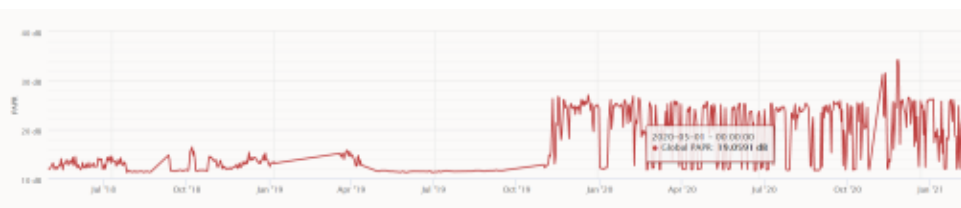
Case 1: PD on Generator

- Broadband spectra and PAPR values were recorded on a 660 MW generator for each phase and neutral
- Initial results showed low, acceptable levels of PAPR for each spectrum

- After refurbishment of the generator, higher levels of PD were recorded yielding alerts on the monitor
- Diagnostic data was reviewed with the OEM who indicated that a new but acceptable level of PD was occurring
- The generator remained in service and continues to operate successfully

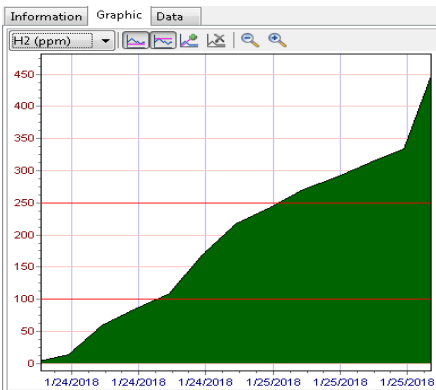
Case 2: Rise in DGA

- A 1991 500/230 kV 280 MVA McGraw-Edison auto transformer had consistently low gas levels recorded by laboratory DGA
- Hydrogen and Hydrocarbons totaled below 30ppm
- An online monitor showed a rapid increase in level of H₂, as shown below, and moderate increase in levels of CO

- It was decided to take a further sample for laboratory analysis to confirm the diagnosis
- While the sample was being taken the transformer failed
- The failure led to a tank rupture, showering field staff with hot oil
- Fortunately, there was no fire

- The company revised response plans, formalizing the approach to be taken by Engineering and Operations
- Plans were put in place for normal operation and two alert levels depending on the gases detected and their levels
- Increased frequency of automated sampling by the monitor allowed for more frequent updates if necessary
- Levels were set for developing contingency plans and for removal of a unit from service
- All plans agreed with relevant parties

- As is often the case with online DGA monitoring, a sample for laboratory/field analysis is taken
- The sample was taken without de-energizing the unit, and analyzed using a high quality portable analysis unit
- The results indicated a 'high energy electrical discharge' as per Duval interpretation D2

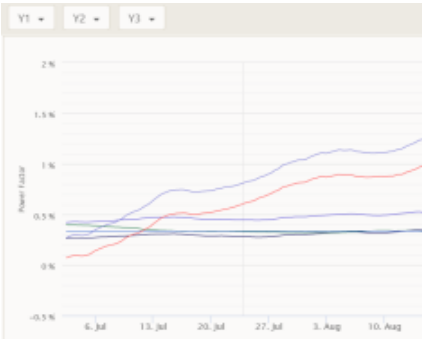
Case 3: Bushing Monitoring

- A transmission class auto-transformer with tertiary was being monitored for DGA, bushings, PD, temperature
- Both relative and true power factors began to rise gently over several weeks for the Y3 bushing

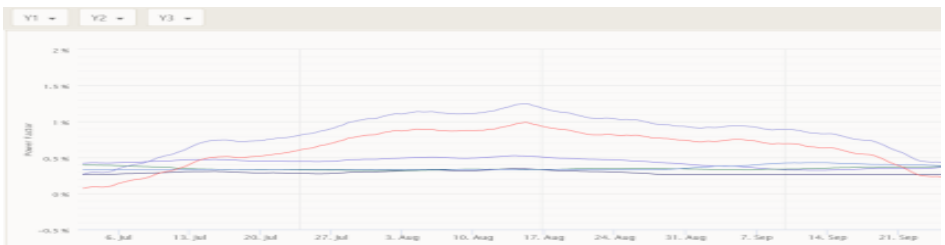
Case 3: Subsequent Progression

- The variation in data was an indicator of a change in state of the insulation, possibly deterioration
- The fact that both relative and true power factor varied indicate that the cause was, in fact, the individual Y3 bushing
- The deterioration seems to 'reverse' itself with the power factor returning to acceptable levels

- There is a scenario where moisture ingress would cause an initial deterioration in bushing power factor
- The moisture may settle on the insulation surface and provide an alternate path to ground
- The bushing was taken out of service and tested: and found to be in advanced stage deterioration due to moisture ingress due to a cracked oil fill plug gasket
- All three bushings were replaced
