A3 – TRANSMISSION AND DISTRIBUTION EQUIPMENT
PS1 - Decentralisation of T&D Equipment

Experience of composite insulators on HV substation: Some French examples

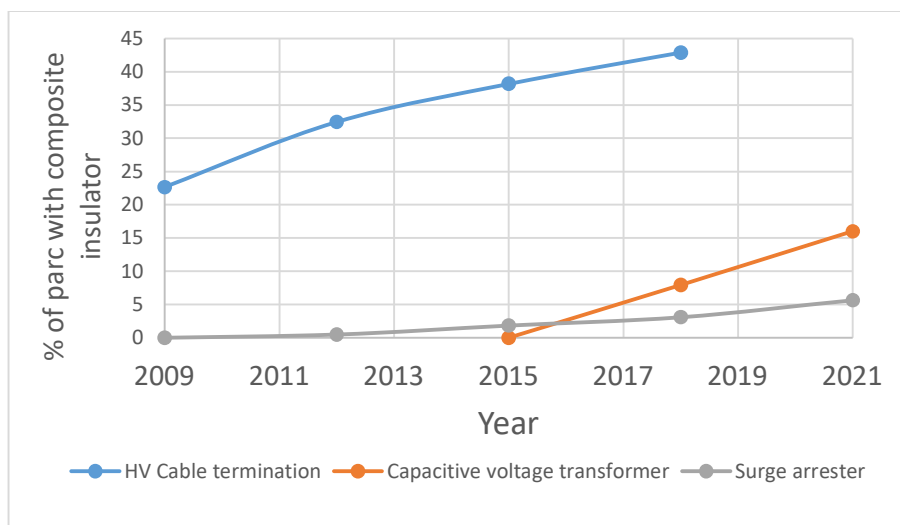
Figure 2 : Adoption of composite insulator for HV equipment of RTE network (72 kV to 420 kV)

Figure 2 presents the part of equipment with composite housings in RTE parc. For cable terminations, composite housings have been adopted for almost 30 years, and since 2010 all new cable terminations must be equipped with this technology. For capacitive voltage transformers and surge arresters, composite insulators have only been qualified recently, but the adoption speed has accelerated in recent years. For circuit breaker, composite insulator is nowadays limited to some specific applications, but more installation is expected from 2022.

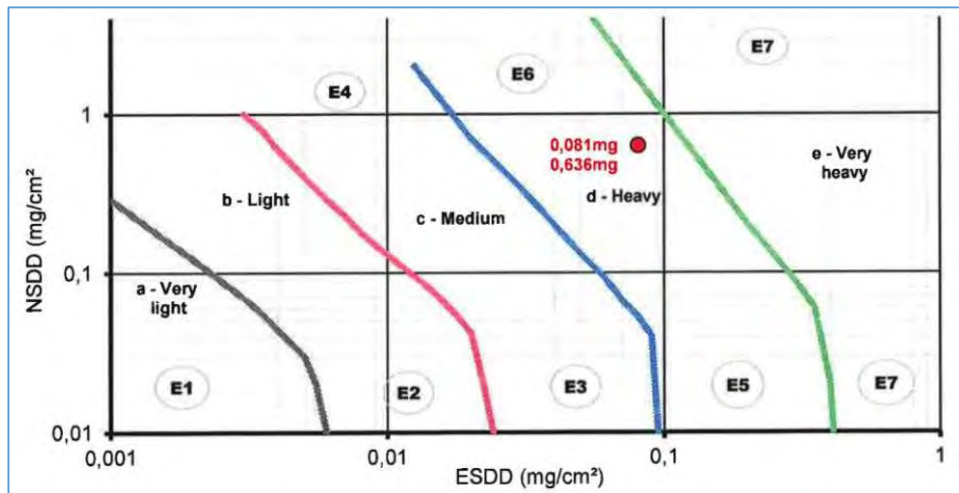
Figure 5 : Characterization of pollution level of the insulator by using figure 2 of following IEC/TS 60815-1 (2008) [2]

used to clean the surface, combined with weight and chemical analysis of non-soluble remained pollutants according the procedure presented on IEC/TS 60815-1(2008) Annex C [2]. As indicated in Figure 5, the level of the insulator pollution has been measured as class d-heavy class [2]:

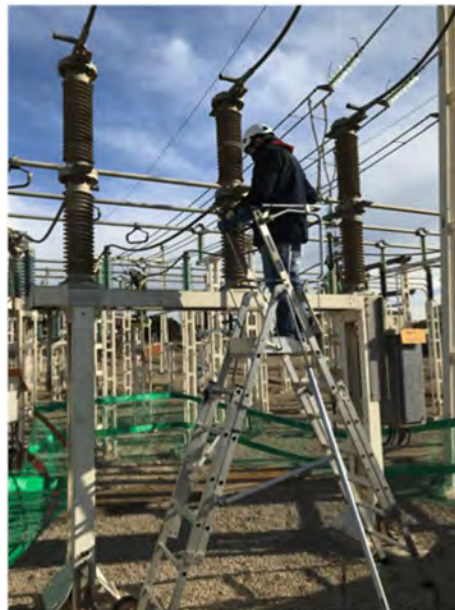
Figure 6: Characterization of pollution level of the insulators by using figure 2 of following IEC/TS 60815-1 (2008) [2]

Inspection has been carried out in 2019 on the circuit breaker of Balaruc substation. During visual inspection, no erosion, no tracking on the silicone sheds of the insulators have been observed. The applied HTV silicone rubber housing shall protect the mechanical load-carrying FRP tube from environmental influences (moisture, UV, pollution) and shall supply the required creepage distance for the polluted outdoor conditions.

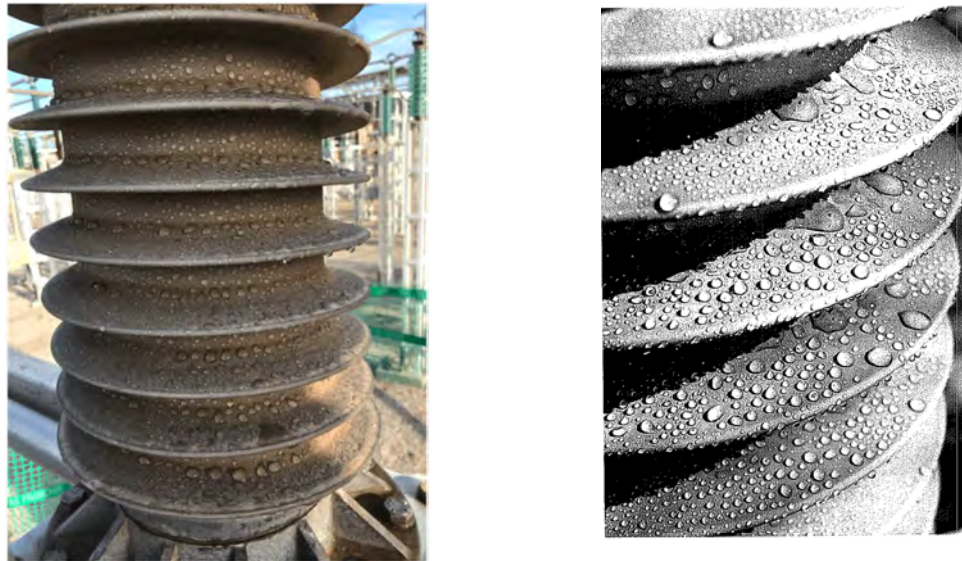
Figure 7: Inspection of hydrophobicity of 72,5 kV hollow core composite insulators, measurement in 2019 (left) vs. measurement in 1996 (right)

The hydrophobicity test has also been carried out on site according to IEC 62073 (2016-02) Annex D Spray Method [3]. The hydrophobicity was very good (level HC1 to HC3), as shown on Figure 7 (left). No major change has been observed compared to the measurement done in 1996 (Figure 7 (right)).

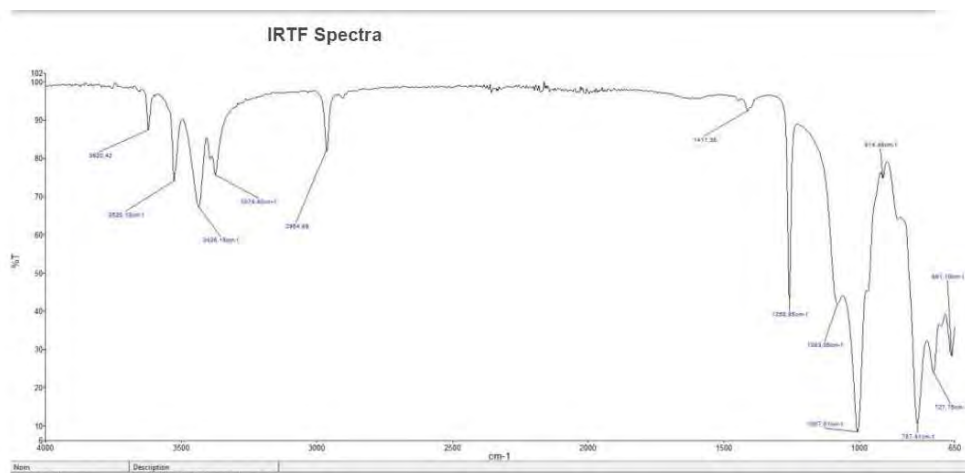
Figure 8: FTIR spectra measurement (typical for HTV with the signature of ATH = $\text{Al}(\text{OH})_3$ around $3500 \dots 3000 \text{ cm}^{-1}$)

- Hardness according to ISO 868:2003
- TGA according to ISO 9924-3:2009
- Angle of water drops according to IEC 62073: 2016 method A
- Density ($1,57 \text{ g/cm}^3$) according to ISO 2781:2018 method A
- FTIR (silicone material fingerprint) as recorded in Figure 8

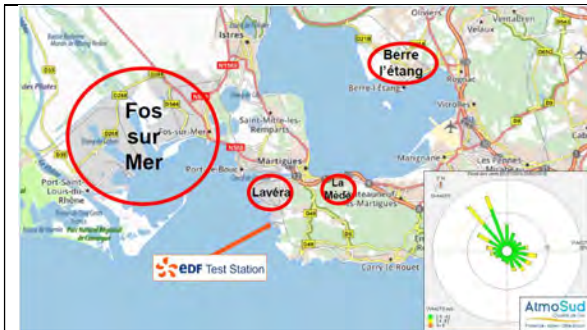
Figure 9a: Industrial sites, the EDF R&D test station, the local wind rose

For more than fifty years, EDF R&D has been carrying out ageing tests and studies of the long-term behavior of equipment under extreme natural external stress at the EDF Lab Martigues site (close to Marseille) (Figure 9a and 9b). The location meets several criteria perfectly suited to this type of study [7, 8]. The region is one of the sunniest in France with over 2800 hours of sunshine per year. This means that the materials are exposed to high levels of ultraviolet radiation. The test facility is about 10 meters from the shore. As a result, exposure to salt spray is maximum, particularly during episodes of south-south-east wind. Huge industrial complexes are in this area. The large petrochemical plant of Lavera is located two kilometers northwest of the site. The prevailing wind regime (north-northwest) carries the industry's emissions in the direction of the test station. The materials being tested are subject to a combination of marine and industrial pollution. The site pollution assessment is carried out according to IEC 60815-1 Ed. 2008 Annex E [2] using a Directional Dust Deposit Gauge device. The measurements classify the site mainly at level d (heavy) and sometimes at level c (medium). In real time, the measurement of leakage current on a reference insulator string calibrated in the laboratory allows to evaluate the current pollution level site.

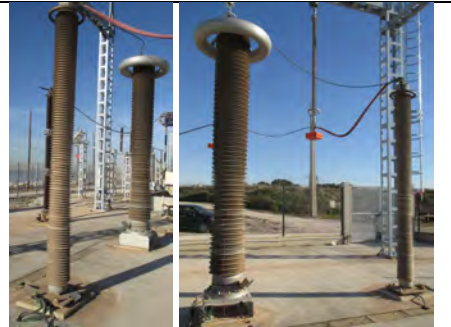
Figure 9b: The columns installed in the test area

In 2008, a HTV column (sample 1) was installed and in 2015 a second one (LSR sample 2). Figure 9b shows the columns in the 245 kV(phase-earth) test stand. The ESDD values measured for the HTV column are systematically lower than the same measurement on the RFR column. As a reminder, the LSR column diameter is larger than the HTV column. However, it can be assumed that the LSR column and the related housing profile captures the pollution more easily.

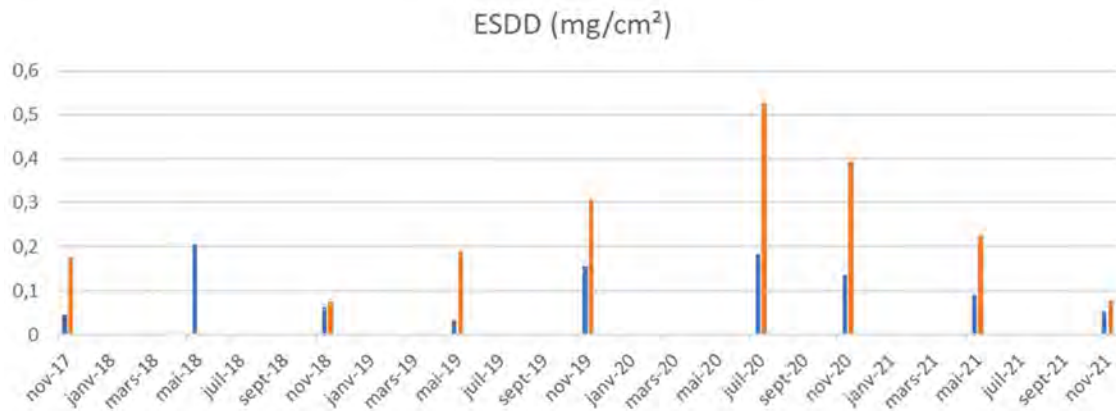
Figure 10: ESDD measured on insulators with LSR (orange) and HTV (blue) housing (the housing profiles were different). The orange material/profile seems to collect more pollution in terms of ESDD

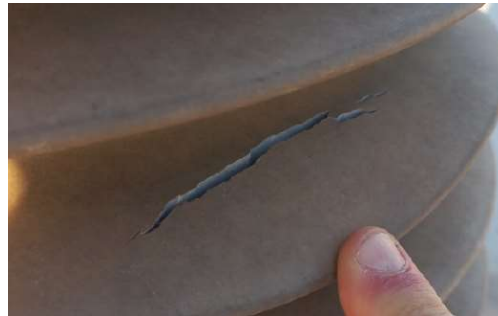
Figure 11: Mechanical damage of shed, most probably caused by shock impact

On one of the sheds of the RFR column, a crack has appeared on the 12th shed over 6 to 7 cm. To see it, you have to bend the shed slightly (Figure 11). At this stage, the cause of the damage is probably due to mechanical shock
