SC A3 - Transmission & Distribution Equipment
PS 2 / Decarbonisation of T&D equipment
Life cycle management and the impact on the design of T&D

UAV usage for Asset Condition Assessment

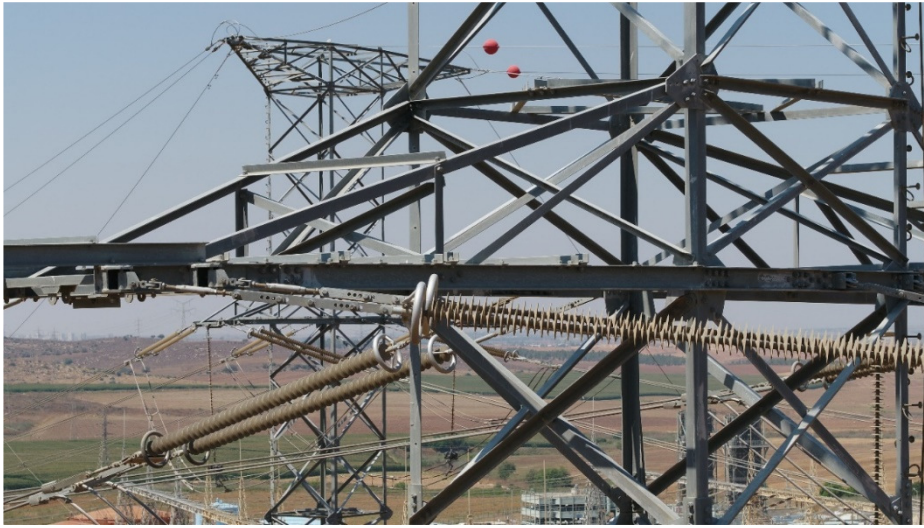
Figure 5: Breakthrough flight photo

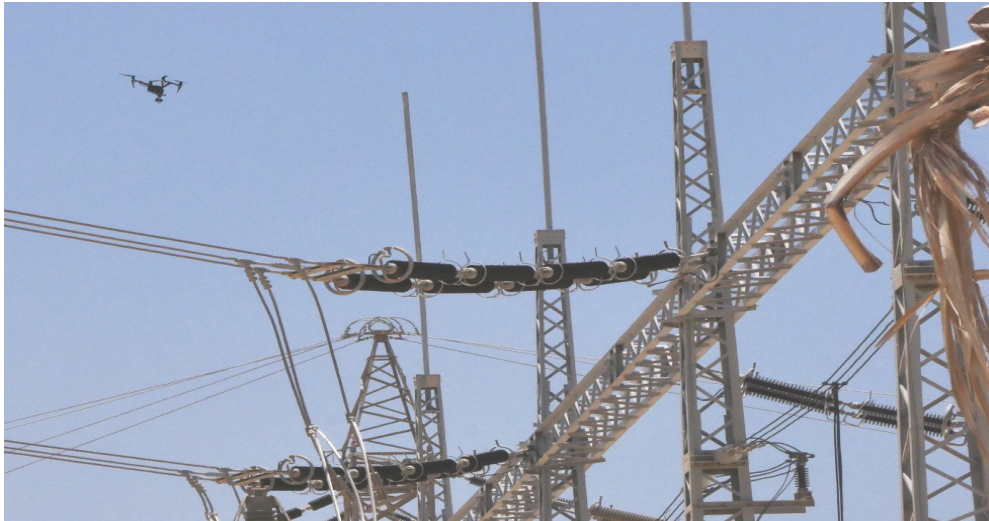
Figure 7: UAV over Live EHV circuits

Over 1700 insulators were photographed in a single working day (Figure 7), using 3 different cameras and 7 different imagery methods to guarantee full coverage. The main challenges were to keep 100% orientation, navigation and imagery standardization to meet the required output quality (Figure 8).
