10134**A3 – Transmission and Distribution Equipment
PS3 – Digitalisation of T&D Equipment****Real-time Leakage Current Measurement System Applied to LT 230 kV
Insulators****Daniel de Andrade USSUNA^{1*}, Renatto Vaz CARVALHO¹, Vitoldo SWINKA FILHO¹,
Edilson Jose FRESHI¹, William César FARIAS¹, Guilherme Cunha da SILVA¹, Marcio
TONETTI²****1 Instituto de Tecnologia para o Desenvolvimento - LACTEC
2 Companhia Paranaense de Energia Elétrica – COPEL G&T
Brazil
daniel.ussuna@lactec.org.br****SUMMARY**

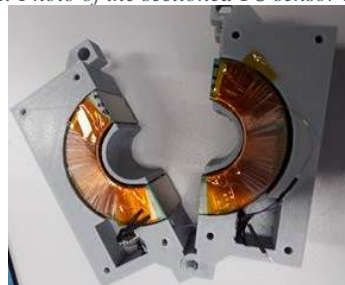
For this project, six sensors were made with sectioned toroidal cores, as shown in Figure 2, which shows the structure of the developed CTs, showing the two halves of the magnetic core with winding of the turns.

Figure 2: Photo of the sectioned TC sensor developed

The coils were rolled evenly on both sides in order to minimize interference from external magnetic fields. In this topology, external fields show influence with reverse polarity in radially opposite turns. Each sensor is 110 mm long, 81 mm wide, 35 mm high and 23 mm internal diameter and its structure was made in a 3D printer with polymeric PLA material.

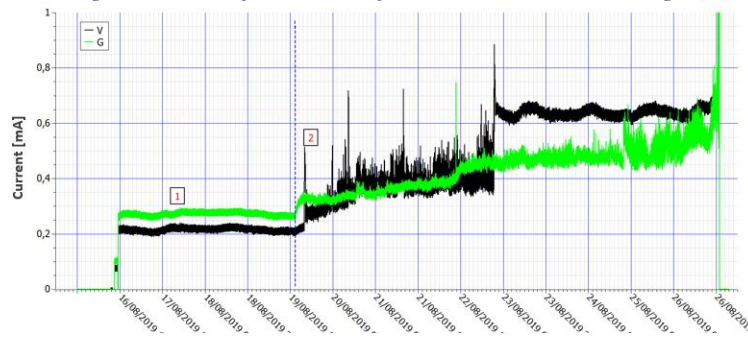
From August 16 to 26, 2019, a new test was carried out in the fog/artificial pollution chamber. In this test, lasting 11 days, a fog with a conductivity of 4 mS/cm was used. In this, a voltage of 18 kV was applied in a disk unit in each phase, being: phase R - coating 1 (G), phase S - coating 2 (H) and phase T - glass (V). The data from this test are shown in Figure 6 and 7, where Figure 6 shows the comparison of the leakage current of the coating 1 (G) and glass (V) insulators. Regions 1 and 2 of the graph

correspond, respectively, to the application of potential without mist and application of potential with mist with a conductivity of 4 mS/cm.

Figure 6: Test leakage current data for insulators from 16 to 08/26/2019 coating 1 (G) and glass (V).

In Figure 6 it can be seen that initially, without the application of fog, the leakage current intensity of the covered insulator with coating (G) is higher than the uncovered insulator (V). However, after a short period of fog application, this condition is changed, that is, the glass insulator starts to present a higher leakage current.

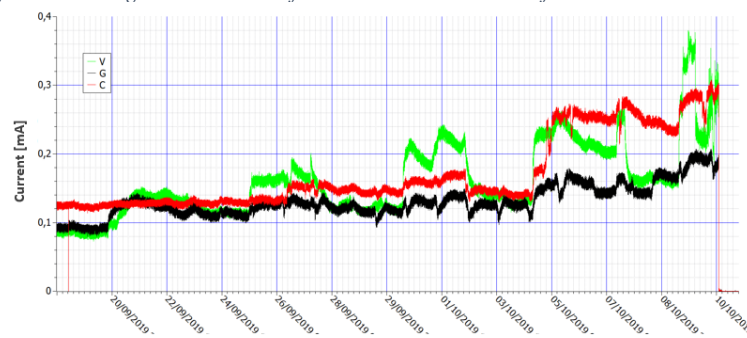
Between 9/18 to 10/10/2019 an alternating test of tension application under saline mist was carried out, lasting 23 days. This test was designed to maintain in each phase two disks with the same coating technology, that is, 2 disks in series mounted on each phase, as follows: R phase - coating 1 (G), S phase - coating 2 (C) and T phase - glass (V). During the test period, the mist was maintained at 20 mS/cm, where in alternating periods of 2 days the conditions of application of voltage of 18 kV and absence of voltage were maintained. From this test, the data presented in Figure 8 were acquired.

Figure 8: Leakage current data of the insulators under test from 09/18 to 10/10/2019.

It is verified that after the voltage-free period, the leakage current levels did not return to the intensity of the last applied voltage period. It is suggested that this is due to the accumulation of material

on the surface of the insulator. It can be seen that the glass insulator was the one with the highest leakage current values. The insulator with coating 1 (G) showed the lowest leakage current values, with practically constant behaviour throughout the test period (values between 100 and 200 μ A).

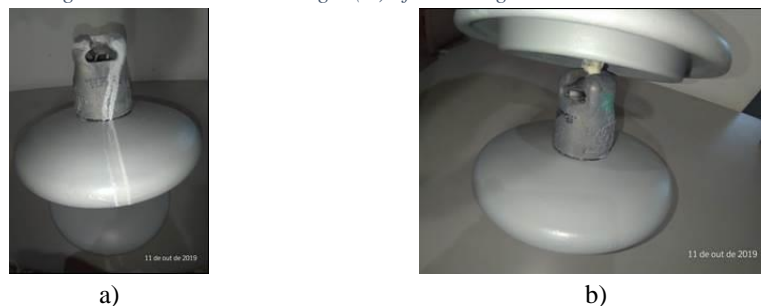
In Figure 11a, it can be seen that there was the formation of a salt path deposited on the surface of the upper insulator, sufficient to increase the leakage current observed in the test. In the lower insulator (Figure 11b) it is not observed the presence of traces or points of salt accumulation.

Figure 11: Covered glass insulator with coating 2 (C) after testing carried out between 9/18 to 10/10/2019.

It is also worth noting that the coated insulator (G) is a factory painted material and the coated insulator (C) is a material painted in Lactec with an industrial spray gun, this illustrates the effect of the quality of the paint on the final product.

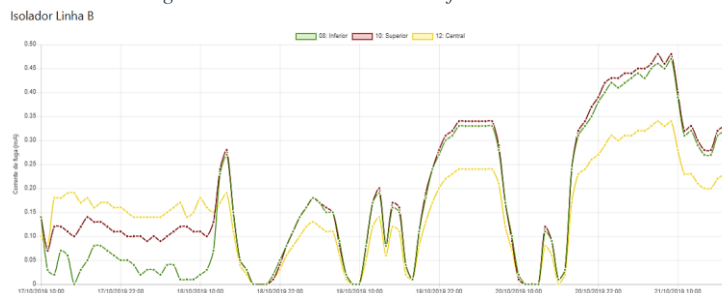
The data in Figure 14 were collected from October 17th to 21st, 2019.

Figure 14: Field data collected from 10/17/2019.

It can be noted that in the periods from 10:00 pm to 10:00 am of the following day (on average) the leakage current of the insulators increases and reaches values of up to 500 μA , probably caused by the elevation of the local humidity. This fact is also observed on the dates of October 19th and 20th, in the period of 4 pm, when there was rainfall in Curitiba and in the place where the equipment was

installed. In periods of lower humidity, the leakage current values are reduced and reach values below the equipment's resolution.

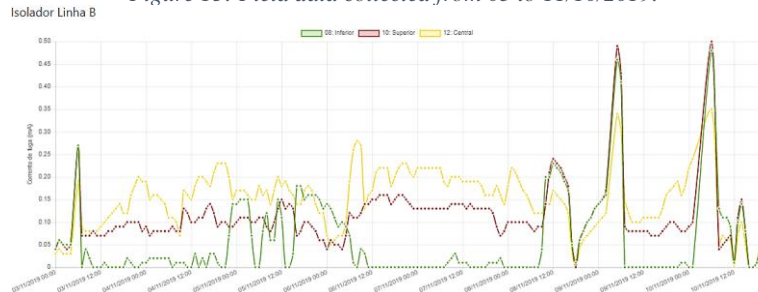
Figure 15: Field data collected from 03 to 11/10/2019.

The continuous monitoring of the leakage current in the insulators of the 230 kV Bateias – Campo Comprido transmission line shows that the two upper phases present higher values for this magnitude, while the lower phase remains with a current close to zero. However, observing the scale of the graph in Figure 15, it can be seen that the amplitude in the three phases is in a few hundred microamps, which, according to laboratory tests, indicates that the insulators are in good clean condition.

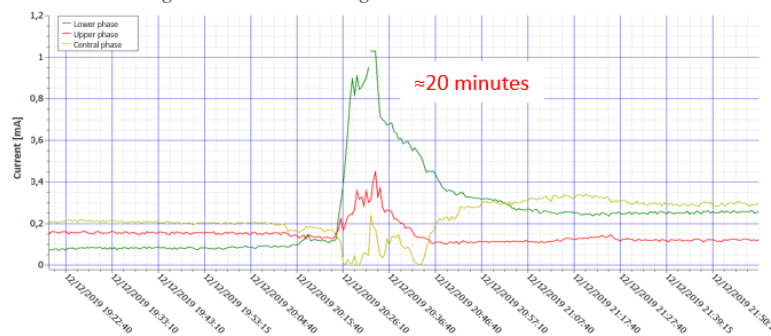
Figure 17: Field leakage current data on 12/12/2019

The duration of the event, about 20 minutes at night, where the chain of insulators closest to the ground adds the current by 10 times the stability value. The other chains showed interferences with a similar characteristic, with a tripled value in the upper chain and a reduction in the central chain.

A sharp increase in leakage current (Event) can be observed on December 12, where this magnitude went from constant levels less than 400 μA to greater than 1 mA. Expanding the graph in Figure 16, one can accurately observe in Figure 17.
