A3 – Transmission & Distribution Equipment
Preferential Subject 3 – Digitalisation of T&D Equipment

Monitor Data Management for Asset Failure Prevention

- 1. Abigail ZAFRIS* 2. Reynold CORNELL**
American Electric Power Service Corporation
United States
1. ajsutliff@aep.com 2. rpcornell1@aep.com

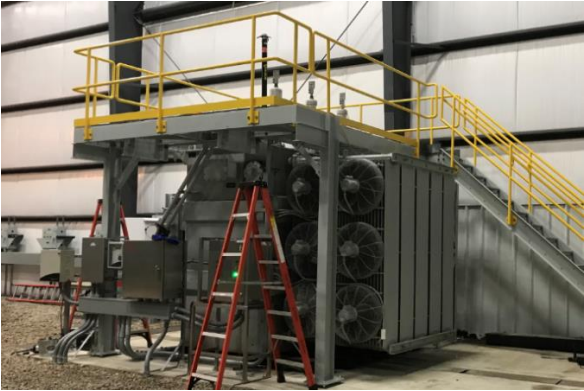
Figure 2: Monitoring Equipment Laboratory at AEP’s Training Center

After the data infrastructure and alarm ownership are established, key stakeholders must be trained to respond appropriately to alarms. There have been two significant asset monitoring training efforts for stakeholders at AEP. First, a class was launched for field personnel, covering all transformer and reactor monitoring equipment. This class, developed in collaboration with training experts within AEP, includes both lecture and interactive content. As shown below in Figure 2, a full-scale monitoring equipment laboratory was installed at AEP’s training center to facilitate hands-on learning. As a result of this training effort, field personnel are better prepared to respond appropriately to the alarms for which they are responsible.

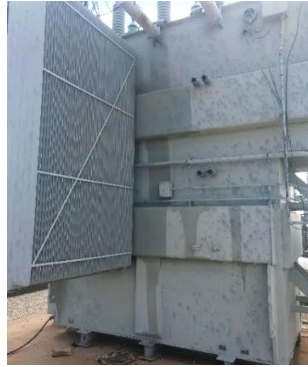
During this three-week timeframe, asset monitoring personnel analyzed the bushing data, collaborated with the monitor manufacturer, and requested an on-site inspection. The inspection revealed oil leaking from the X2 bushing and running down the side of the transformer, as shown below in Figure 6. An outage was taken to address the failing X2 bushing.

Figure 6: 138 kV to 69 kV Autotransformer Oil Leak [4]

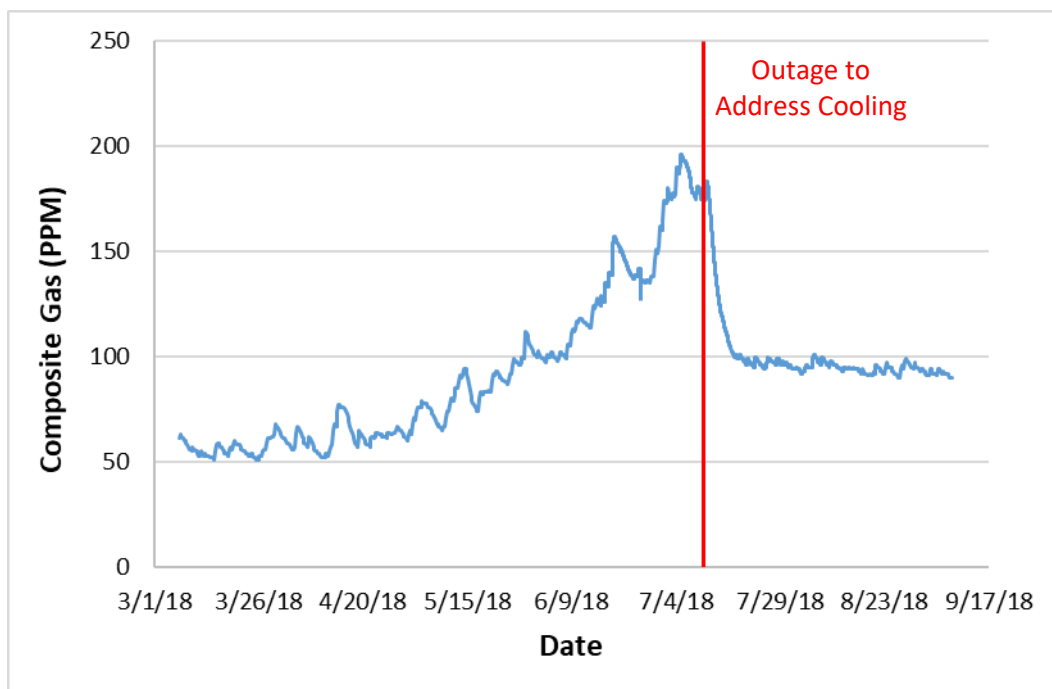
For example, the composite gas reading for a 345 kV to 138 kV autotransformer reached the lower level of criticality, causing AEP's Operations group to receive an alarm. The Operations group contacted the appropriate field personnel who performed further investigation on site during normal business hours. Their analysis found that the transformer's cooling system was ineffective due to residue on the radiators. An outage was scheduled to clean the radiators and ensure the functionality of the cooling system. Figure 7 shows that the composite gas reading dropped significantly after the scheduled outage.

Figure 7: 345 kV to 138 kV Autotransformer Composite Gas Reading

Addressing this situation over a number of days was effective. The inadequate cooling was addressed before it led to a catastrophic event. These cases, like so many others, highlight the importance of understanding data and assigning alarms appropriately.

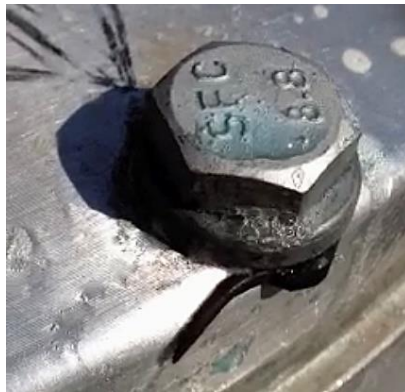
AEP had a failure prevention experience on a 345 kV circuit breaker that exhibited a CB Maintenance Alarm. The CB Maintenance Alarm was triggered by low SF₆ pressure, detected by the circuit breaker monitor. An on-site inspection confirmed that there was an SF₆ leak located on the circuit breaker bushing, as shown in Figure 9.

Figure 9: Bubbling due to SF₆ Leak on 345 kV Circuit Breaker

AEP personnel addressed the SF₆ leak, preventing a possible circuit breaker failure event. Asset monitoring paired with proper alarm response ensured that this situation was addressed in a timely and appropriate manner.
