Fire risk from XLPE cables in air

Paul FLETCHER*
Mott MacDonald Ltd
United Kingdom
paul.fletcher@mottmac.com

Gregory TZEMIS
National Grid Electricity Transmission
United Kingdom
Gregory.Tzemis@nationalgrid.com

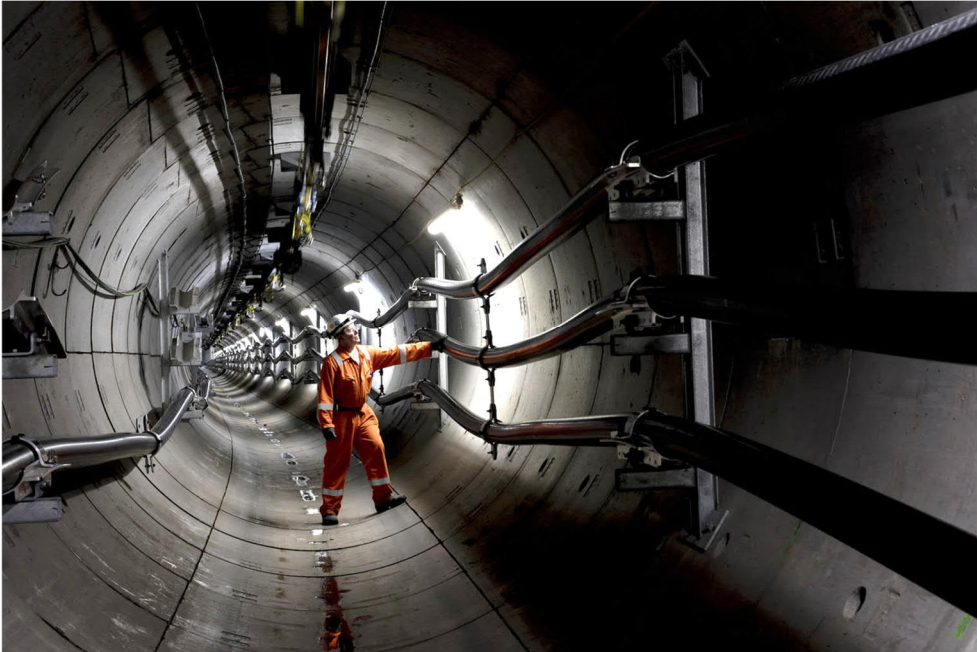
The design of the LPT tunnels and cable systems draws on experience from earlier cable tunnel projects. Each tunnel accommodates at least two EHV circuits with the cables cleated on support brackets in air, one circuit each side of a central access space. A typical configuration from the LPT1 project is illustrated in Figure 1.

Figure 1: LPT1 Cable Tunnel during Cable Installation [Copyright National Grid]

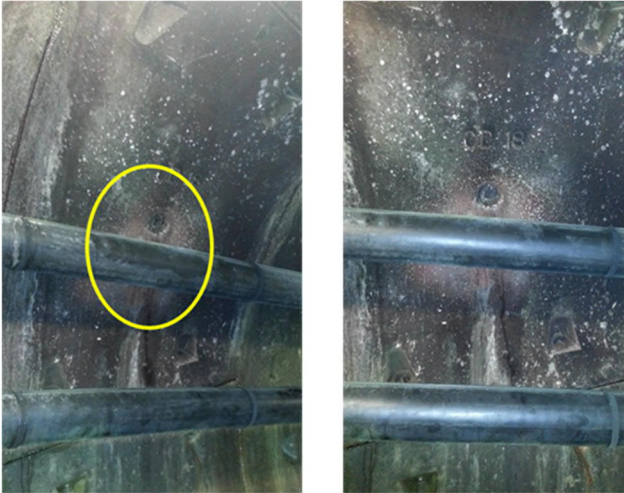
As expected, each fault simulation resulted in the ejection of a jet of plasma from the fault point. This jet was very directional along the axis of the hole that had been drilled in the insulation during preparation of the sample. Visual and thermovision records showed that the jet formed a narrow cone with the highest temperatures at its centre. It is noted that visual evidence following an in-service cable fault is consistent with a highly directional plasma jet being ejected, confirming that the test outcomes were as expected from an actual fault event (illustrated in Figure 4).

Figure 4: Example of a 400kV Cable fault in a Tunnel Installation (20 kA rms fault current / 80ms fault duration; I x t = 1.60 x 10³)

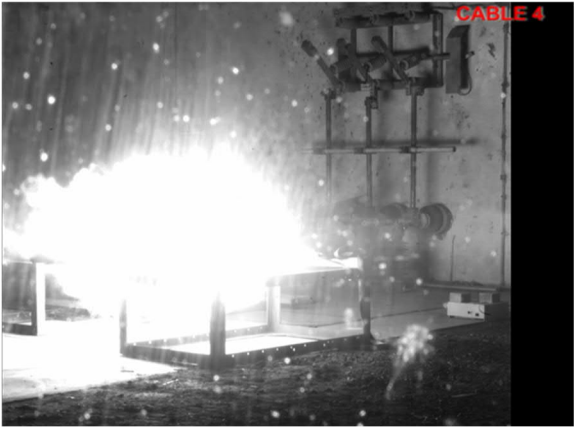
The tests were arranged such that the plasma jet was directed at a ‘target’ length of cable mounted approximately 2m horizontally from the fault. This was intended to represent a second circuit mounted on the opposite side of the cable tunnel. As illustrated in figures 5 & 6, it was evident from the test records that the high temperature plasma jet ejected during the fault completely engulfed this target cable.

Figure 5: High speed image during fault

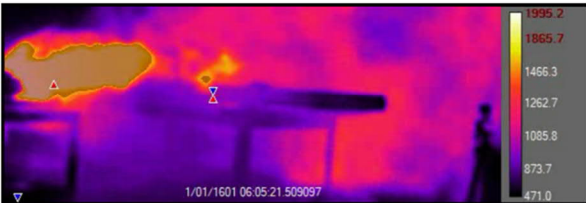
Figure 6: Thermovision image during fault

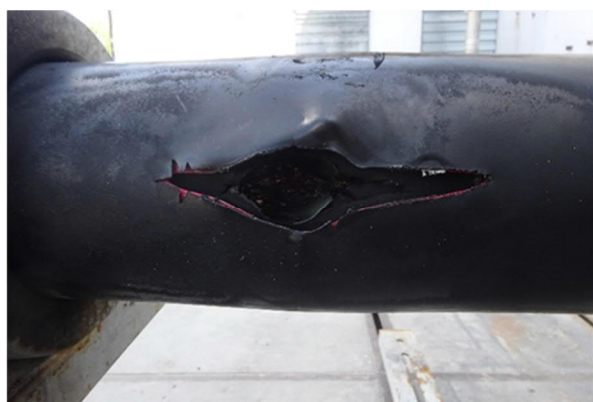
The condition of the cable following Test 2 is illustrated in Figure 7, and the condition after Test 4 is illustrated in Figure 8.

Figure 7: Cable following Test 2

In these additional tests, the cables samples were prepared by cutting the oversheath (to represent the post-fault condition illustrated in Figure 7) and creating a 50mm diameter hole in the outer layers so as to expose the XLPE insulation. A propane gas burner was then applied until the fire burnt down to the copper conductor (approximately 15 minutes), after which the burner was removed and the progression of the fire observed. The tests included a number of combinations of cable and fault orientation and considered air flow & still air conditions.

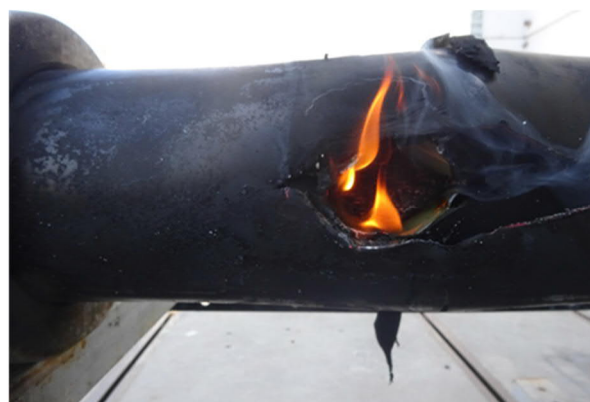
Figure 8: Cable following Test 4

Test 3	7.70×10^3	Flames maintained for a brief period after the fault (see note 1), however the fire self-extinguished and was not sustained.
Test 4	8.82×10^3	A small fire developed, centred on the ruptured area of the aluminium sheath. This was allowed to burn for approximately 15 minutes, during which the fire gradually increased in intensity. At the time it was extinguished, it was not judged to be destructive, but had the potential to become so.
Test 5	13.5×10^3	A small fire developed of a comparable size to Test 4. This was not allowed to continue burning.
Test 6	6.62×10^3	Small flame observed which was immediately self-extinguished. No sustained fire.

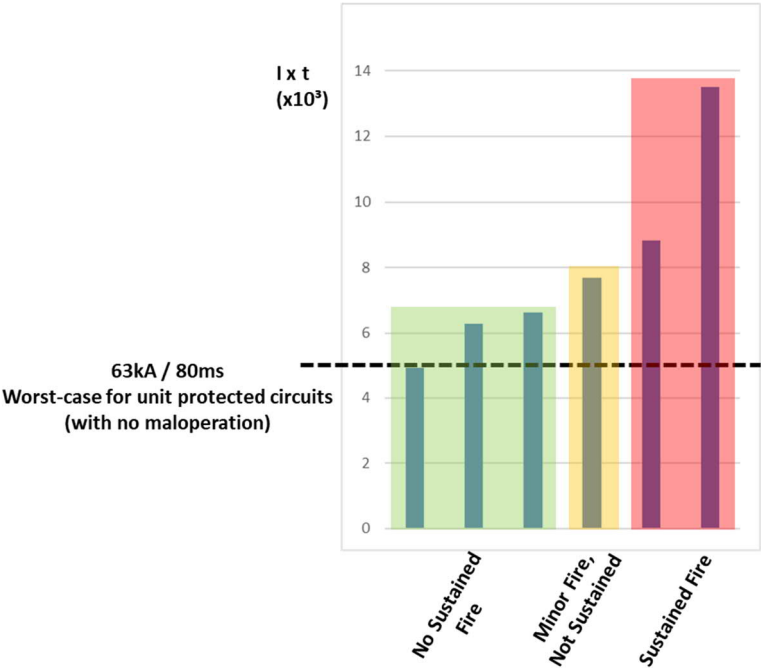
The test observations can be presented graphically as shown in Figure 9. This also shows the assumed maximum energy release for a fault on the UK NETS, which has a maximum design fault level of 63kA r.m.s and an expected fault clearance time of 80ms (where fault clearance is not dependent on operation of inter-tripping).

Figure 9: Graphical Presentation of Test Results
