10881
Study Committee B1: Insulated Cables
Preferential subject 1: LEARNING FROM EXPERIENCES

Decommissioning of a Self-Contained Fluid-Filled cable: operating method and risks mitigation

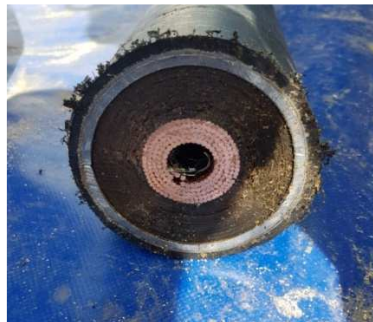
The removal project was about of 4 underground links of Self-Contained Fluid-Filled (SCFF) cables, with sections of 820mm² and 800mm² in copper, the weight is approximately 23 kg / m. The length of each link was approximately 800m, representing 9.6 km of cable.

SCFF cable cross section

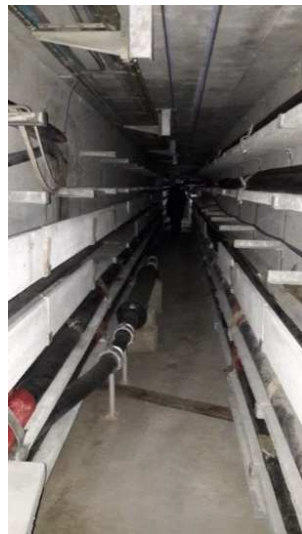
In the tunnel, other cables are still in operation and consequently electrically powered.

Moreover, as the cables were installed on support shelves, it was decided, given the period of construction of the tunnel, to take samples from the shelves to identify whether there was asbestos or not; this risk will be presented later.

Cables routed in tunnel

One of the most important safety issues was the presence of a fibre cement shelf protecting the cables in the tunnel (refer to photos).

Samples were taken a few months prior to the removal operation and it was confirmed that those vertical shelves contain asbestos. Then dust measurements of the atmosphere were carried out and did not reveal the presence of asbestos fibre in the atmosphere of the tunnel.

The removing operation of the cables was preceded by an "asbestos" operation to remove the side plates protecting the cable and to clean the tunnel to allow a safe intervention.

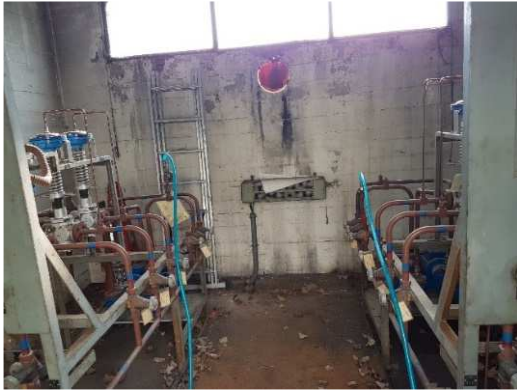
Draining requires connecting the pipes to the bottom boxes of the cable heads and to the hydraulic plant. We then push with nitrogen or compressed air to recover the oil, depending on the altimetry profile of the cable links, in suitable containers.

In the present case, we recovered 1800 litres of oil from the central hole in the cables.

Connections in the fluid station of units 3 and 4 in the power plant

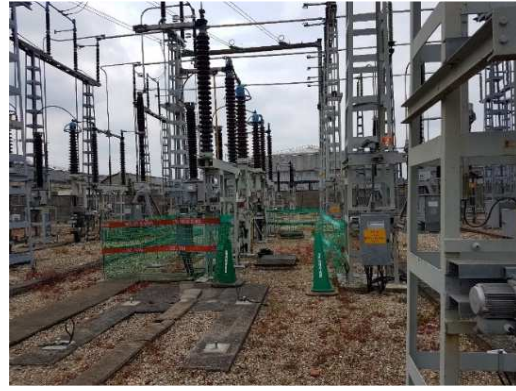
Connections in the RTE substation to the other side of the High voltage link

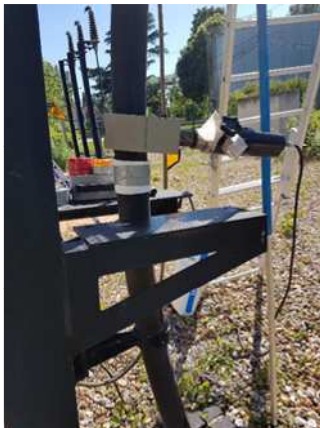
The first cut is to check that there is no voltage. On a 225 kV cable, it consists of positioning a hydraulic drifter that can be operated remotely, which is inserted into the core of the cable. On an oil filled cable, the operator shall also use a suitable container to collect the oil leaks.

Absence of voltage check under a cable sealing end

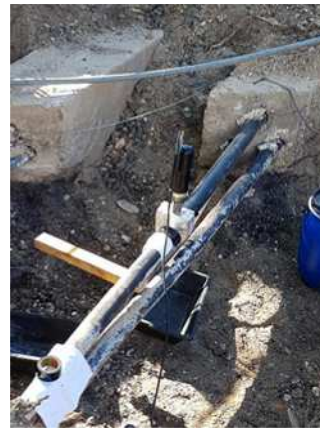
Absence of voltage check in excavation to safety cut the cables

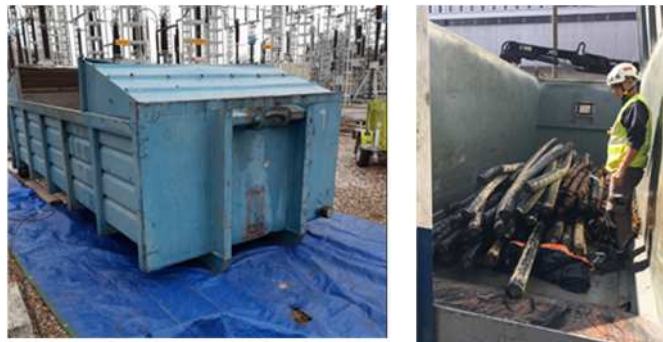
Watertight container with a roof to store cables

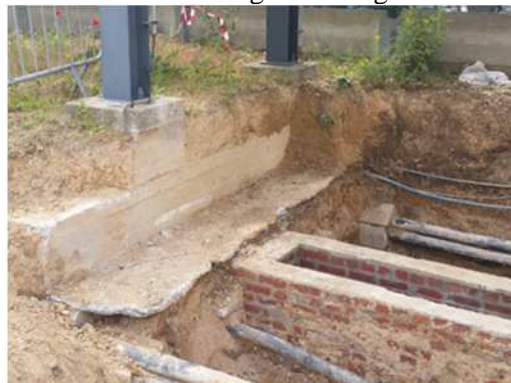
On a part of the route, during the power plant operation, an external structure with concrete foundations was built just above the cable route. This construction was a great modification and resulted in greater efforts on the cable as the friction force in the troughs was higher.

A survey excavation under the external structure

The removal of these cables would have required increasing the number of openings to cut shorter lengths. But this represented a risk on the structures above. This portion was therefore abandoned in situ and the choice was made to install a long-lasting and a hermetical sealing device. We therefore set up steel covers with the same diameter as the cable and lead-welded to the cable sheath. Below is a photo of this device:

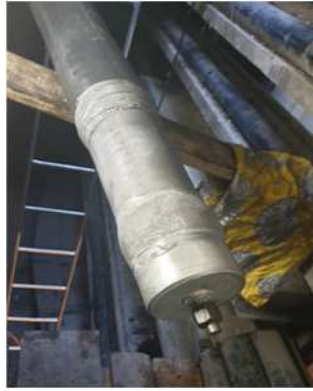
Cover in underground gallery

This solution is not a problem for the site restoration, as in the future it will be possible to remove this part of the link when the structure built above reaches its end of life. It will still be necessary to keep a monitoring of the sealed ends at regular intervals to avoid accidental leaks.

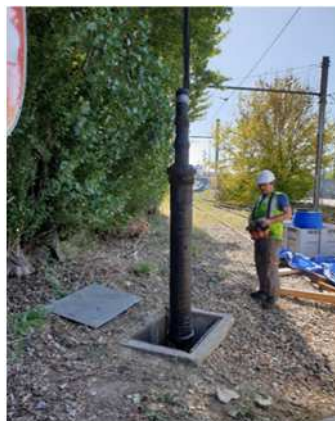
The joints have a section which contains oil remaining hydraulically separated from the central hole of the cable. This equipment must therefore be removed separately to prevent oil leaks.

Joint removal operation

Asbestos was also found in the joints of the high voltage cable; therefore, a cut was made on each side of each joint and the entire one was considered as waste containing asbestos.

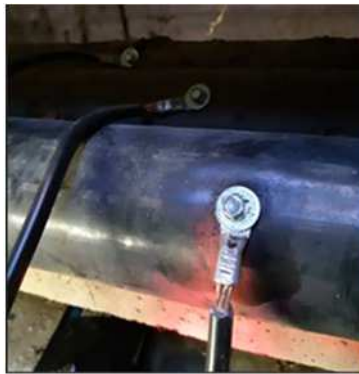
In an electrical substation, there is an electrical risk even on non-powered cables, due to the induction phenomenon. In such case, it is necessary to ground the screen and the core of cables, in several positions and at each cut point, to guarantee the operator's safety when cutting the cable.

Grounding device to connect the core and the screen of the cable
