**ID – 10757**                      **Session 2022**  
**B2 Over Head Lines**  
**PS 1 / Challenges & new solutions in design and construction of new OHL**

**Field & laboratory Assessment of Room Temperature Vulcanizing Coated  
Insulators in Harsh Desert Environment**

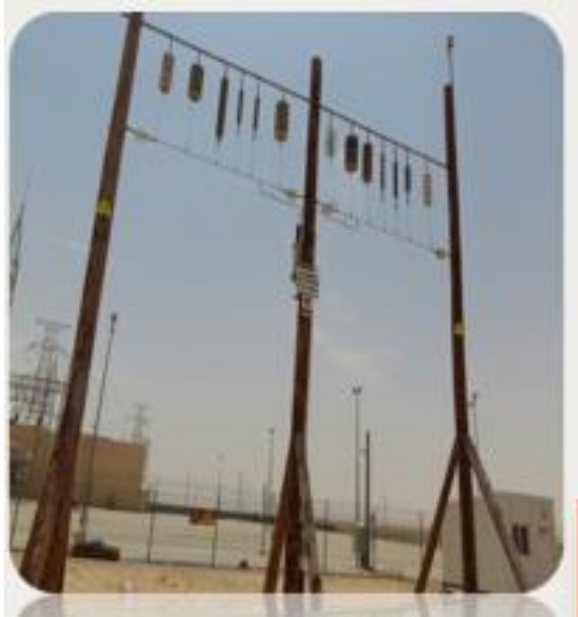
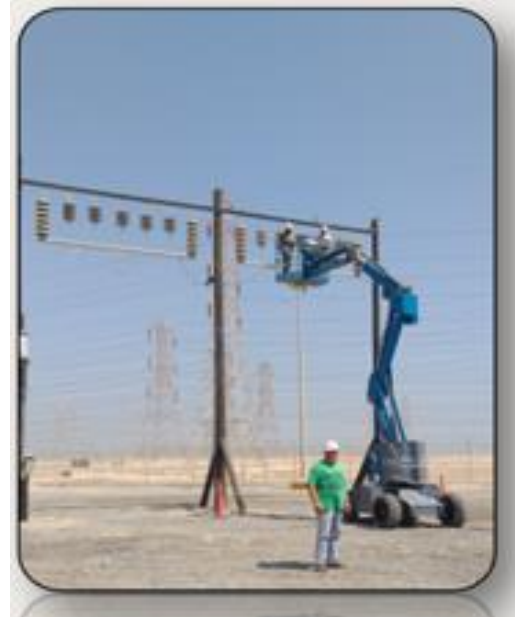
2.1. Building of two Energized Naturally Polluted Testing Stations Insulators test stations, Now Certified ISO 9001 & internationally recognized as reference (in the last Cigre TB 837/June 2021). The Pilot one is located at Al Fadhili-Eastern KSA & the second at Al-Zour-Southern Kuwait, both equipped with preselected different insulator candidates...as shown in Fig.1, 2, 3 & 4.

**Fig.1-2-3 & 4. Location of “Certified ISO” GCCIA Naturally Polluted Insulators Testing Stations: (a) - GCCIA 400KV Energy Highway Interconnecting Six GCC Member States, (b) - ISO Certificate, (c) - Al Fadhili (KSA) & (d) - Al Zour (Kuwait).**

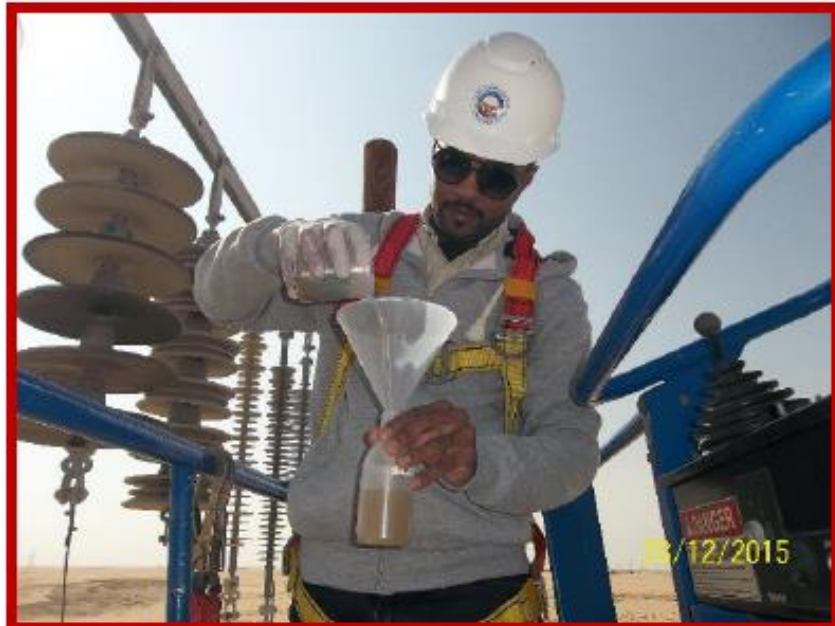
Based on more than three hundred (300) Equivalent salt deposit density (ESDD) & non-soluble deposit density (NSDD) Measurements, in contact in test station (fig.5) as well as on GCCIA overhead lines, four (04) times a year during three successive years, completed by chemical analysis of soluble & non soluble pollution contaminants removed from top & bottom surfaces of different insulator types & profiles including Standard insulator, as international reference, it was concluded that Eastern KSA’s environment is mostly characterized by:

**Fig 5: Site Pollution Severity estimation with ESDD/NSDD Method**

- Solid Pollution “Type A”, due to high level of non-soluble pollution contaminant,
- High ESDD & NSDD level in the range of 0,4 mg/cm<sup>2</sup> & 1,2 mg/cm<sup>2</sup> respectively corresponding to “high solid pollution class, according to IEC 60 815/TS “, as shown in table 1&2.
- The high proportion of very conductive & corrosive Sulfur in dissolved pollution contaminant collected from candidate insulator surface in Al Fadhili testing station, as shown in table 3.

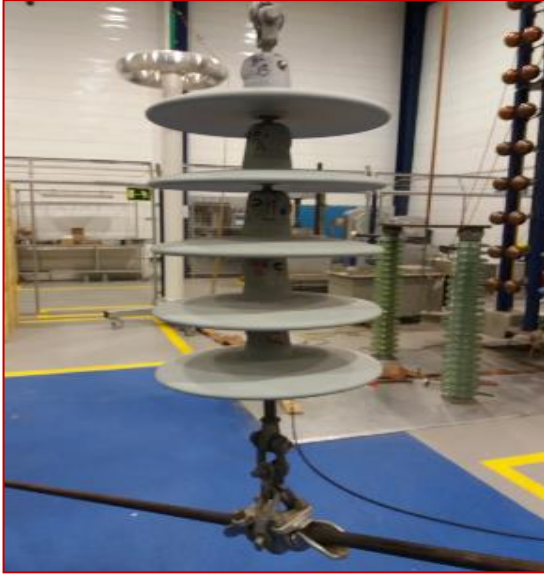
Each String Insulators of 3 ceramic discs have been be submitted to a preconditioning period of 20 minutes.

The voltage at this stage is about 90% of the already estimated flashover voltage.

After this conditioning period, the test voltage will be raised in 5% increments, and kept for one minute at each level, until flashover. After flashover, the coated insulator is re-energized (after a short break) at its initial voltage (90%) and the process has been repeated until 3 obtained flashovers. This part of the procedure finishes the conditioning of the insulator, as shown in Fig.6.

**Fig 6. Preconditioning test**

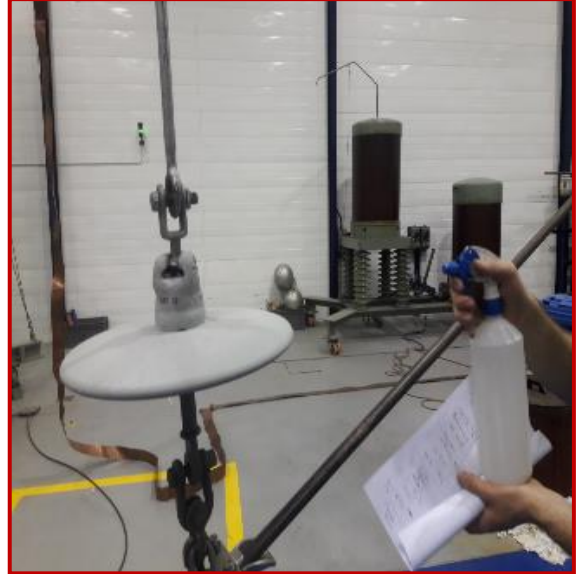
**Fig.7. Electrical Performance tests**

- Checking of Temperature & relative Humidity of testing Hall, before each test lot,
- All individual RTV coated Insulator Disc (single disc for our case) has been tested in vertical position, as shown in Fig.7.

- With the view to simulate as close as possible the early dew impact on outdoor insulation all top & bottom tested insulator surfaces have been manually wetted, using distilled water spray, before and after each RFO test (Distance between spraying bottle and insulator disc should be in the range of 15-20 cm).

- Hydrophobicity class estimation has been simultaneously checked before and after each RFO tests,
- 90% of the average of 3 obtained FO Voltage values during preconditioning tests has been applied to the insulator as a reference voltage,

- The test voltage is then raised by a smooth ramping process about 5% of flashover voltage every 3 minutes until flashover,
- Leakage or current impulses have been partly monitored and Critical highest current impulses (generally before FO), have been registered,

- The relevant value of this RFO tests is characterized by the mean of 3 successive FO voltage values for each disc,
- Maximum total test duration should do not exceed 100 min.

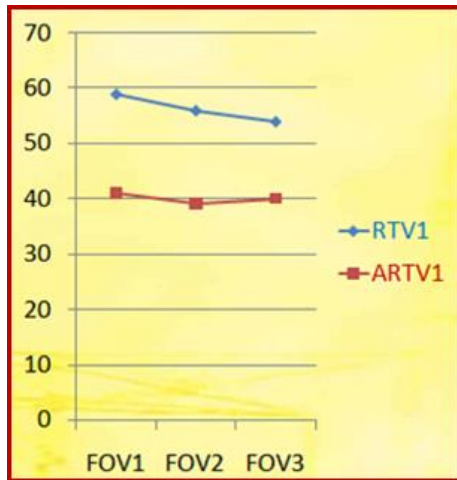
As shown in Tables 4 & 5, the residual electrical performance tests of naturally aged insulators, fully coated with silicone rubber RTV1, are in the range of 40kV while the average of FO voltage for Not aged insulators coated with the same RTV1 were in the range of 56 kV corresponding to a decreased performance in the range of 29%, after 3 years in energized test station (fig.8).

Fig.8 & 9. Significant decline of electrical performance of naturally aged RTV1 & RTV2 coating.

In addition, the partial losses of initial hydrophobicity (HC1 for new coated) have been also demonstrated after each flashover (HC2).

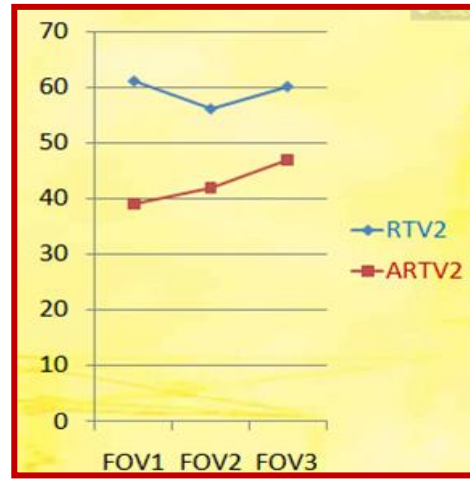
As shown in Tables 6 & 7, the residual electrical performance tests of naturally aged insulators, fully coated with different silicone rubber formulation RTV2, are in the range of 43kV while the average of FO voltage for Not aged insulators coated with the same RTV1 were in the range of 59 kV corresponding to a same decreased performance in the range of 28%, after 3 years in energized test station (fig.9).

In addition, the partial losses of initial hydrophobicity (HC1 for new coated) have been also demonstrated after each flashover (HC2).

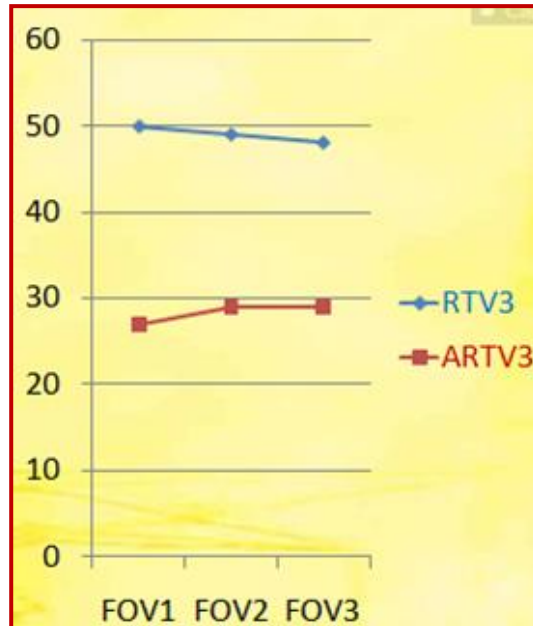
As shown in Tables 8 & 9, the residual electrical performance tests of naturally aged insulators, 50% coated (bottom side only) with another silicone rubber formulation RTV3, are in the range of 28kV while the average of FO voltage for Not aged insulators coated with the same RTV1 were in the range of 49 kV corresponding to a same decreased performance in the range of 42%, after 3 years in energized test station (fig.10).

**Fig.10. significant decline of electrical performance of naturally aged insulators half coated with RTV3 coating.**

In addition, the monitored highest leakage currents were in the range of 240 mA while partial losses of initial hydrophobicity (HC1 for new coated) of coated bottom side have been also demonstrated after each flashover (HC2).

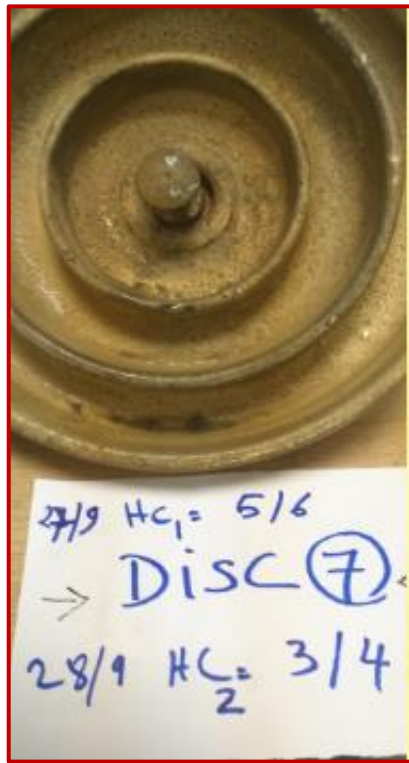
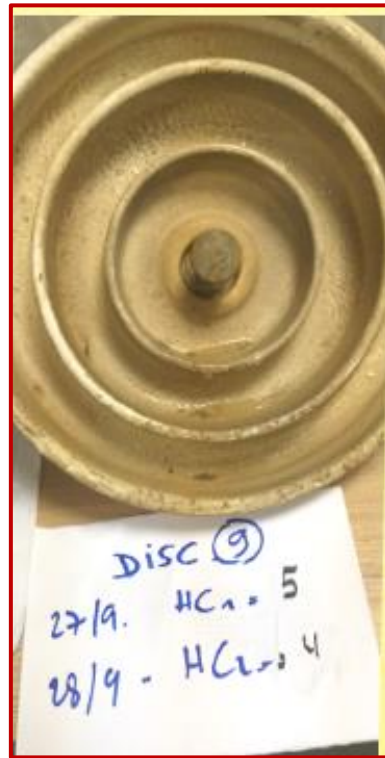
As well as for coating insulators & for polymeric insulators, It's world widely agreed by almost all Silicone rubber Sir's Specialists & Experts that "Hydrophobicity" of Silicone rubber is shown to be the key indicator of their natural aging, Fig.11 & 12 emphasize what is widely reported but not yet totally mastered at least in terms of Hydrophobicity transfer, Partial or total Loss of Hydrophobicity & then Time recovery estimation.

After visible superficial discharges by daylight, several Cap & pin 120KN insulators, removed from GCCIA Network, have showed a complete Hydrophilic states on both top & bottom sides of discs surfaces.

In an attempt to confirm if it was the beginning of end of life of silicone coating or just Partial loss issue of hydrophobicity we have performed hydrophobicity measurements after 24 H & 48 H successively on Disc 7 & 9 (removed from the same 400KV suspension string) that have showed a progressive partial

hydrophobicity recovery (from HC5 & HC6 to HC4...) of their coating after 48 Hours rest in the laboratory.

- ✓ **Manifest loss of initial hydrophobicity\*\* (HC1 for not aged disc) have been clearly demonstrated after each flashover (HC2).**
- ✓ **After localized Partial loss of Silicone rubber Hydrophobicity, Progressive hydrophobicity recovery have been observed day after day,**
