B2 - Overhead lines  
PS 2 – Latest Techniques in Asset Management,  
Capacity Enhancement, Refurbishment

**Overhead line insulators in operating constraints under severely polluted conditions: the benefits of silicone coated glass insulators and their application at the PG&E Diablo Canyon Nuclear Power Plant**

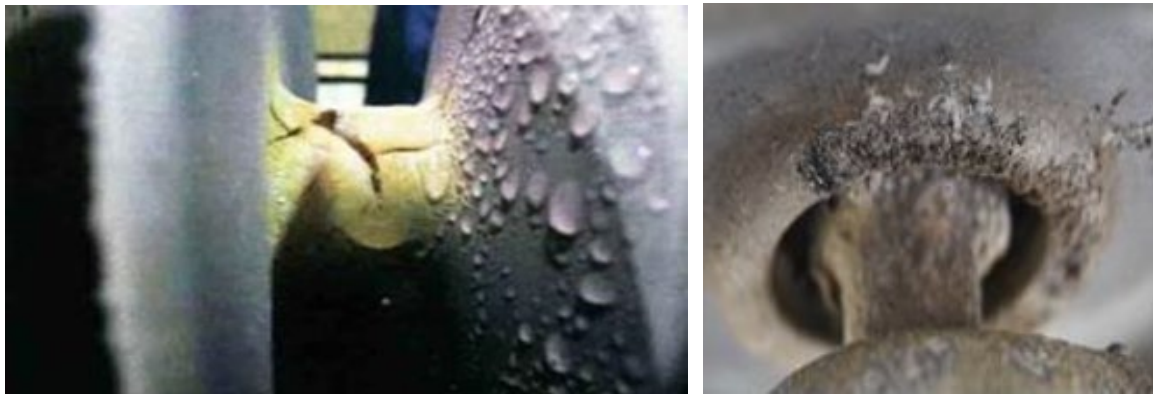
*Figure 2 (Left): Erosion of a polymer insulator which is still hydrophobic after approximately 15 years in service in harsh conditions. (Right): Comparative erosion of a silicone coated glass insulator.*

The use of polymer insulators came in for the very reason that it offered the same benefit without the need of replacing the grease. Nevertheless, polymer insulators showed their limits in a number of locations and especially harsh environments. In fact, the silicone housing, while ensuring proper overall hydrophobicity to prevent flashovers, is stressed electrically through corona and dry band activity. These conditions often led to erosion of the silicone itself and expose the internal core of the insulator until a failure occurs as shown in Figure 2. Field experience has shown that hydrophobicity often survives the stage where a silicone polymer housing is eroded but the level of erosion is usually the limiting lifetime factor for polymer insulators. It is in this context that silicone coating gained popularity in the protection of overhead line insulators when exposed to harsh contamination conditions. For coated insulators erosion can also take place (Figure 2) but the risk of a catastrophic failure is eliminated by the fact that under the silicone housing the material is not an organic fiberglass core like for polymers.

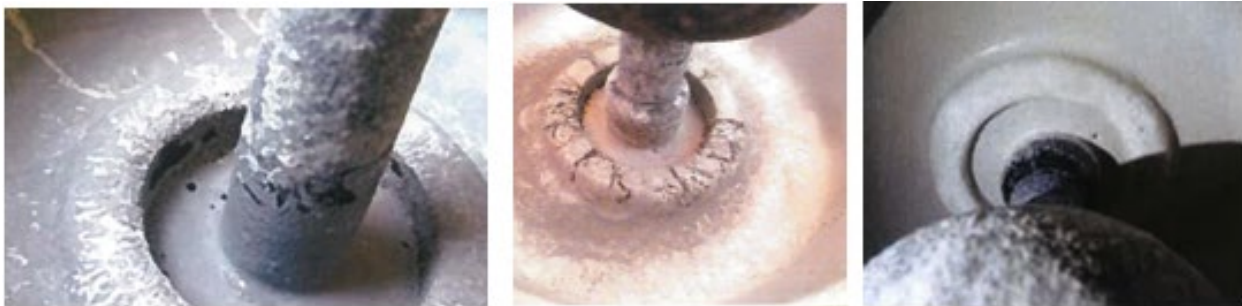
Figure 4: Examples of silicone coated glass insulators using different chemistries of coating after the 2000h test.

- Ageing testing of coated insulators can be evaluated through various test procedures, but one seems to stick out since it has already been adopted by many utilities. The test sequence is shown in Figure 3 and consist of a 2000h multi-stress test. It is an interesting test since it shows a clear ability to discriminate best performers (Figure 4).

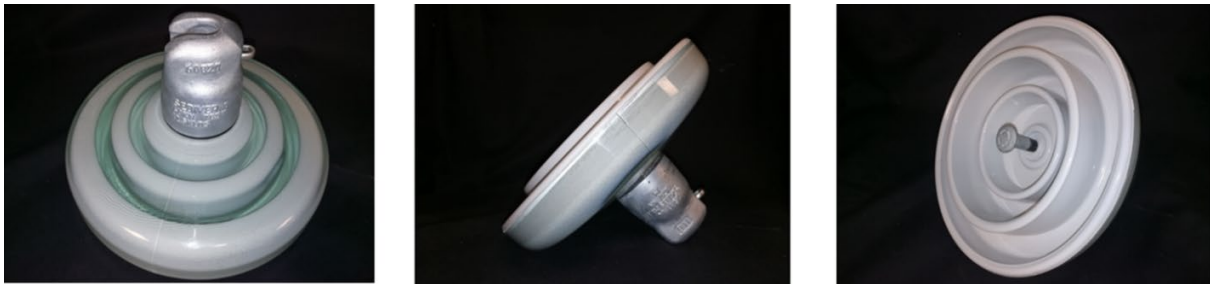
*Figure 6: Under coated glass insulators*

As illustrated in Figure 5, silicone undercoating (Figure 6) is an option which is gaining popularity since it provides very good pollution performance, and is less likely to be damaged when shipping, handling and installation. Unlike the top surface of the insulator, the underside is rarely in contact with packaging crates, or the ground when the insulator strings are being assembled for installation. Another benefit of undercoating is the visual confirmation that the dielectric shell is glass, and not porcelain. Because porcelain and glass behave differently, this is an important factor. Pacific Gas & Electric is using undercoated glass insulators as a standard feature today for their polluted areas across the grid (Figure 7).

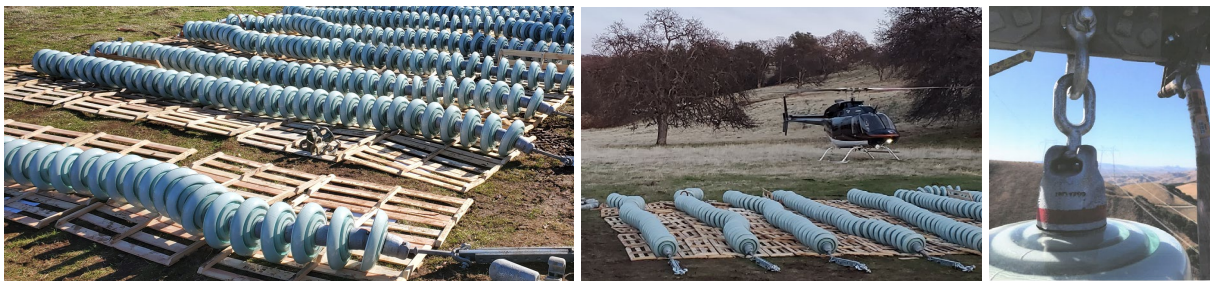
*Figure 7: Example of under coated glass insulators installation at PG&E*

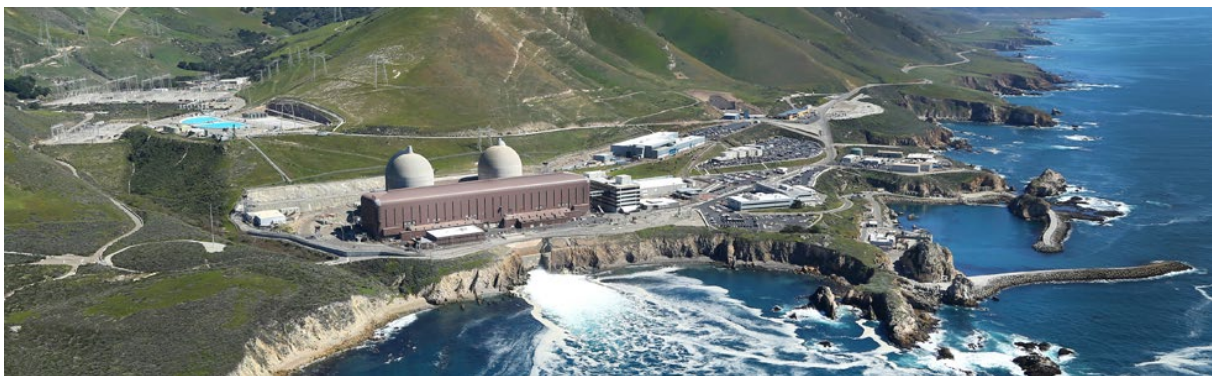
*Figure 8: DCPP nuclear generation station is located directly on the Pacific coast*

DCPP (Figure 8) was commissioned by PG&E in the mid 1980's with two 500kV overhead lines extending out from the generators and turbine building to deliver power. Since the plant's inception, DCPP would wash insulators and other equipment regularly, and as a result, had not experienced a pollution related flashover for nearly 3 decades. However, in the years of 2012 to 2014 DCPP saw an elevated number of flashover incidents at the station which resulted in loss of generation. Identified causes included insulator contamination, inadequate insulator leakage distance, and equipment not designed to withstand the harsh coastal environment. It is noteworthy that this period was documented as the 3<sup>rd</sup> driest period on record in San Luis Obispo County going back to 1870. This extremely dry period deprived the station of several inches of rain which would have had a cleaning effect on the insulators as well as other equipment. At that time, Equivalent Salt Deposit Density (ESDD) were reported at very high levels sometimes beyond 1 mg/cm<sup>2</sup> which is largely above the "very heavy" classification of IEC 61815 [7]. A risk mitigation plan was needed.

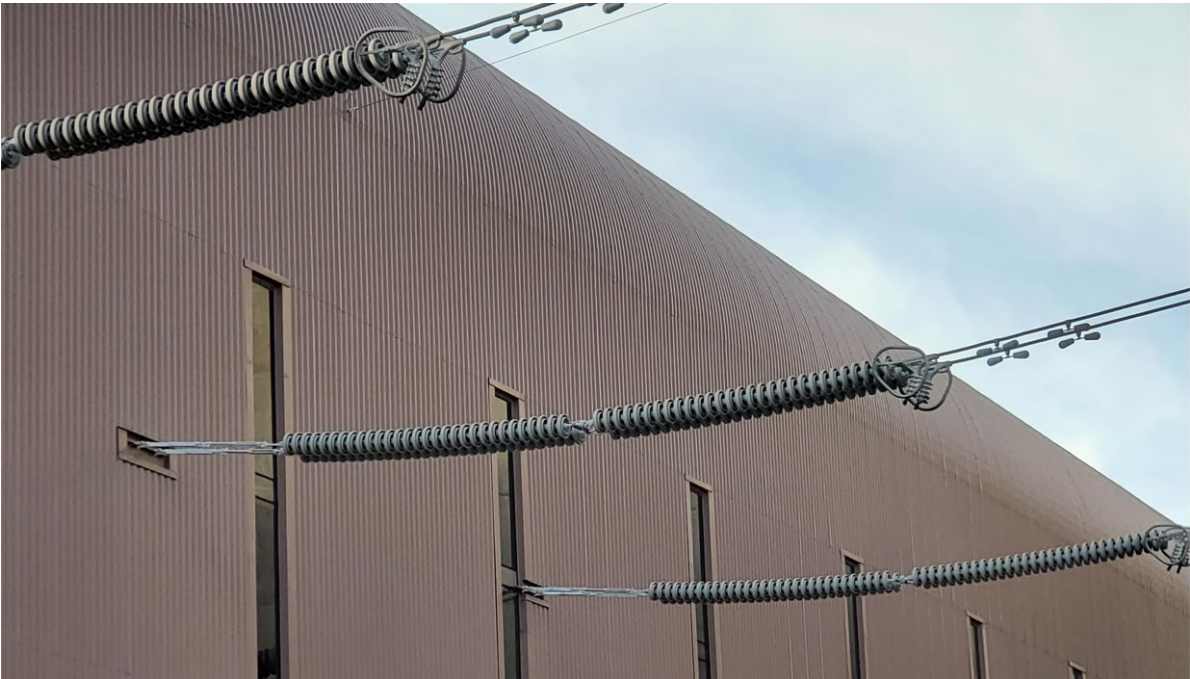
*Figure 9: String arrangement*

The 500kV lines connecting to the turbines were originally insulated with 58 porcelain insulators in a double bundle dead end configuration (Figure 9). The replacement of porcelain insulators to fully coated toughened glass was evaluated and compared in the table below. Without any change to the existing hardware, the fully coated glass units could be installed “like for like” and provide 68% more leakage distance than the porcelain. No adjustment of conductor sag was necessary.
