Study Committee B1 Insulated Cables

Effective Strategic Planning in the Restoration of a Submarine Cable Fault

Ibrahim ALNASSER*, Yasir AHMED¹, Paul O'ROURKE²
 Saudi Aramco¹/GreenLink²

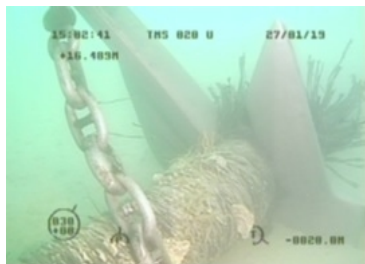
- Fault was caused by the anchor penetrating one cable up to the conductor.

- The huge mechanical force on the submarine cable led to abnormal phenomena of extensive water travel, protrusion of the conductors, shrink back of the insulation, and loose adhesion force between the conductor and the XLPE insulation.

- Cable was stretched due to the huge mechanical force exerted by the ship's anchor, which created a channel between the conductor and insulation.
 - The water penetrated the cable core through the hole caused by the anchor and flowed relatively freely in the channel between the conductor and insulation.

- The aforementioned abnormal activities stretched the cable copper conductor beyond the plastic limit and XLPE insulation below the plastic limit
 - Cable manufacturing is in accordance with the design specifications.
