**Study Committee SC-A1 | PS 3 – DEVELOPMENTS OF ROTATING  
ELECTRICAL MACHINES AND OPERATIONAL EXPERIENCE**

**FAILURE OF LARGE TURBO-GENERATOR DURING FIRST RUN-  
CASE STUDY OF INDIAN POWER UTILITY**

**R C Jha**  
**NTPC Ltd.**  
[rcjha@ntpc.co.in](mailto:rcjha@ntpc.co.in)

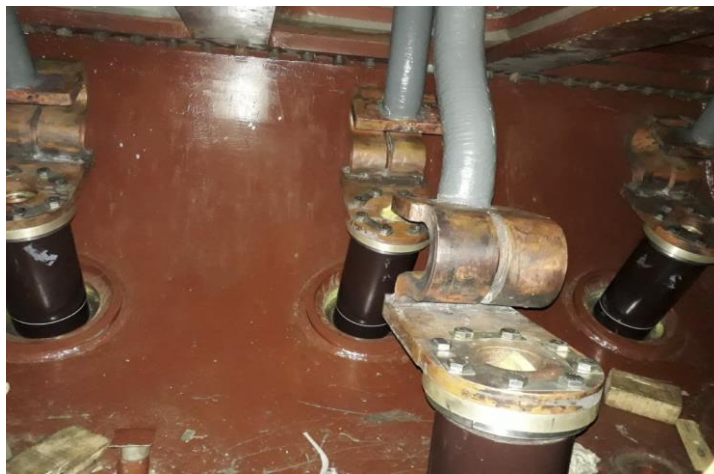
Fig.2 Detailed view of flexible droppers from CBBs to Bushings.

If an observer travels along the generator phase bushing towards inner side of the turbogenerator, then observer first reaches the flexibles (Fig.2) connecting the terminal bushing to phase rings and next stop before reaching the actual winding conductor is large circuitous phase connection ring. Six such circuitous paths i.e. six phase rings connecting the winding to six number generator bushings can be seen inside the machine.

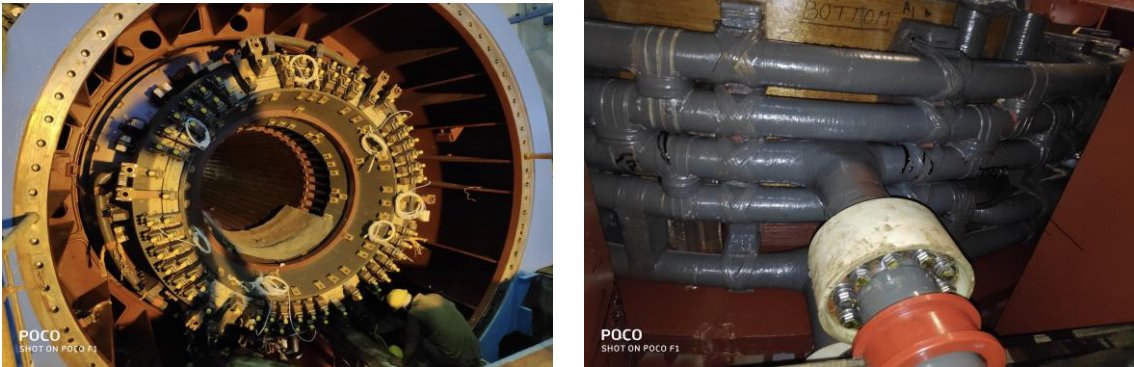
Different manufacturers use different terminology to describe these high current carrying connection rings. The term CBB is used here to describe phase rings and its arrangement in this paper. These CBBs in this 800MW generator are Hydrogen cooled (Fig.3a and 3b).

Fig.3a End winding portion of Generator. CBBs can be seen  
Fig.3b Another view of CBBs

Generator bushing connection being located at the bottom, the flexible connections besides thermal stress experience high environmental stress due to presence of dust, grease and contamination. Specific issues with CBBs have been insulation abrasion due to rubbing and grease formation. This phenomenon is common among other similar machines.
