**DAMAGED GENERATOR ROTORS:
THE ECONOMIC AND LOGISTICAL BENEFITS OF REPAIR OVER SCRAPPAGE**

Wojciech BETLEJ
Quartzelec Ltd
United Kingdom
wojciech.betlej@quartzelec.com

The following scenario occurred on a 140 MVA generator in a Ghanaian power station, causing severe damage to several rotor components. The customer report confirmed that issues with one of the circuit breakers occurred, tripping the generator during run-up. Subsequent attempts to start the machine were unsuccessful and static electrical checks indicated a problem and the decision was made to unthread the rotor and conduct the appropriate investigation.

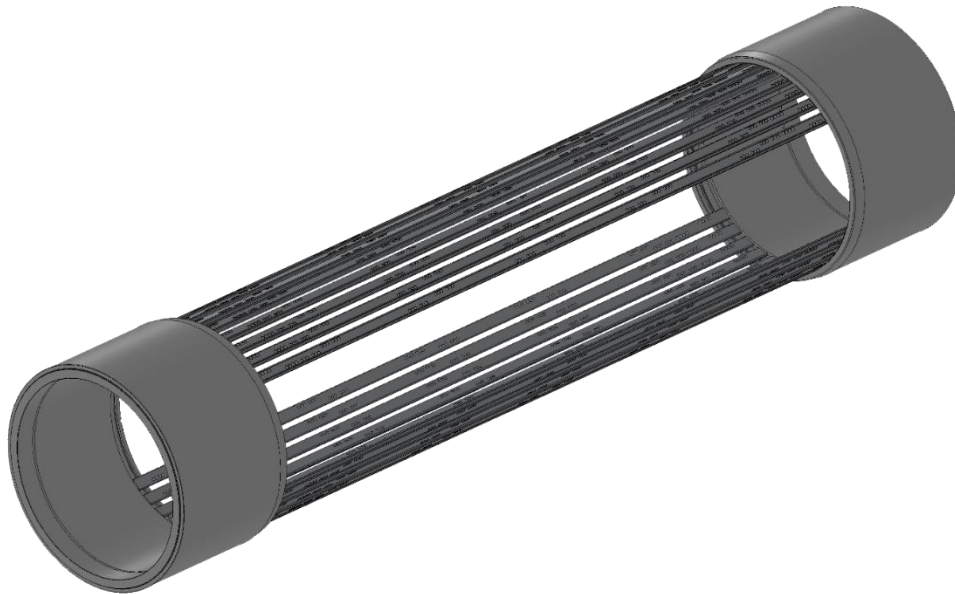
The situation changes dramatically if the generator rotor is running at low speed barring or standstill and the main circuit breaker is inadvertently closed. Under such conditions, the generator attempts to run as a "squirrel-cage" motor, using a damper circuit (Figure 1) in the rotor as the cage. High currents flowing through the stator winding induce a line frequency current to flow in the rotor cage. Due to lack of centrifugal force, there is a poor mechanical contact or even a gap across components creating high resistance joint and causing excessive heat. The rotor will try to accelerate, and experience shows that generators exposed to this condition can be permanently damaged in a matter of seconds.

Figure 1. Rotor damper circuit made from wedges and retaining ring

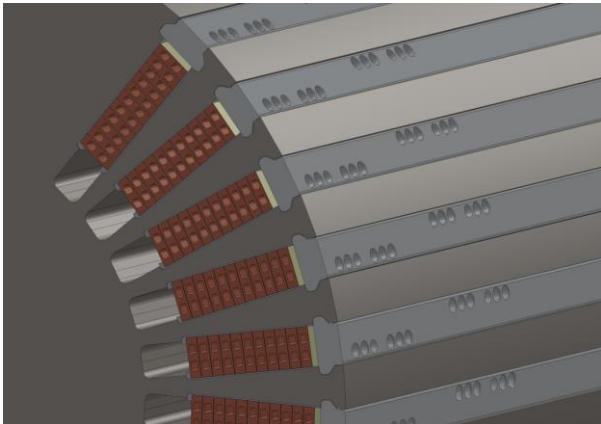
The copper coil group is made up from a series of copper turns in an ‘E’ cross section, separated from the forging by an insulated ‘slot liner’ and placed together to form cooling air passages with alternate turns electrically isolated by an insulation layer. A final top packer provides the final barrier between the current carrying conductors and the wedges. The forces generated by rotation are restrained against radial movement by the aluminium wedge that locates in the dovetail profile of each rotor slot, see Figure 9.

Figure 9. Rotor slot content

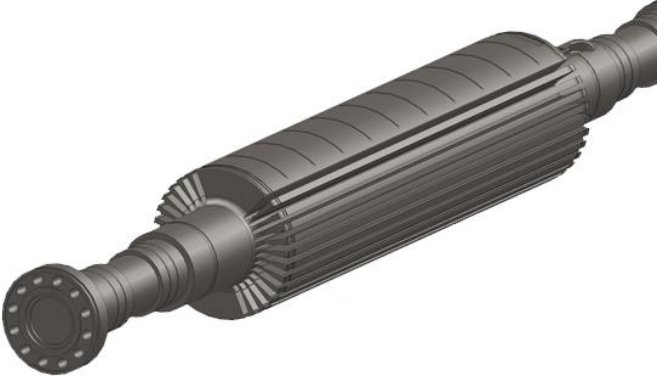
This enabled a 100mm section to be taken to represent the rotor length, see Figure 11 & Figure 12.

Figure 11. Rotor forging – general view

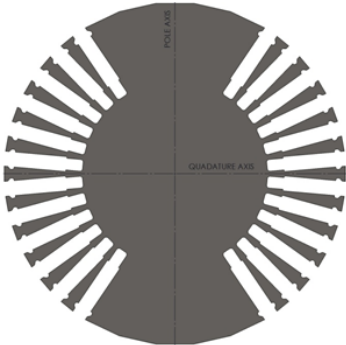
Figure 12. Rotor forging cross section through rotor body

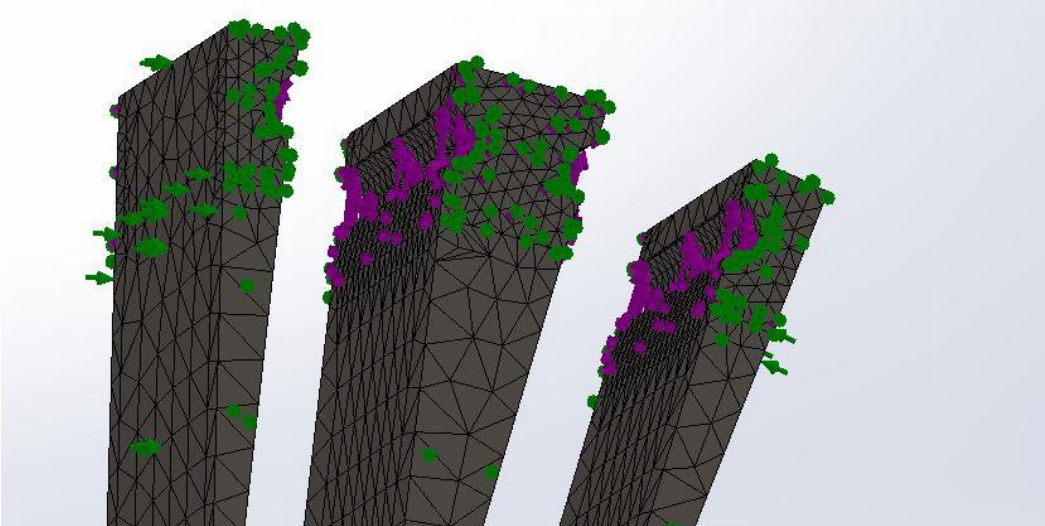
The model was restrained against movement in the Z axis (axis of rotation) on the faces – and normal to the radial faces – leaving the section free to move in the radial directions.

Figure 13. Rrestraints and applied load to profile flanks

Loads representing the copper and aluminium mass were applied to the dovetail flanks, orientated normally to a plane in the centre of the slot and reducing the FEA model to a single component. The applied centrifugal force was calculated using the restrained masses, their centre of gravity and the rotor speed, thus:

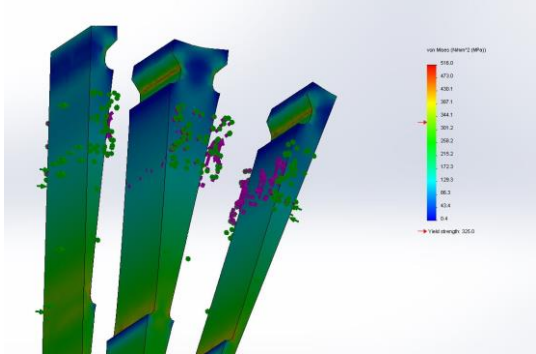
Figure 14. Stress pattern, original slot profile

Whilst not a deciding factor the predicted stress for the groove was higher than expected, for both profiles. To check that the FEA model had not been oversimplified an additional simulation was conducted but with wedge included in the model and loaded against the slot flank profile.

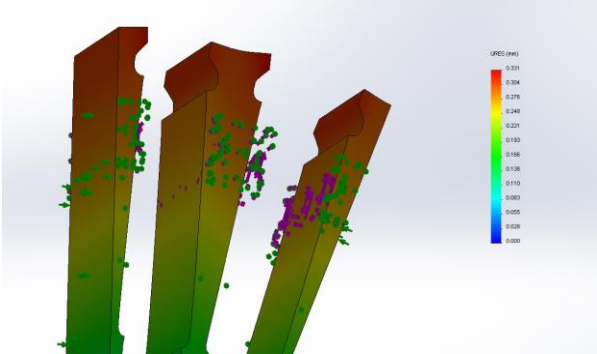
Figure 15. Displacement pattern, original slot profile

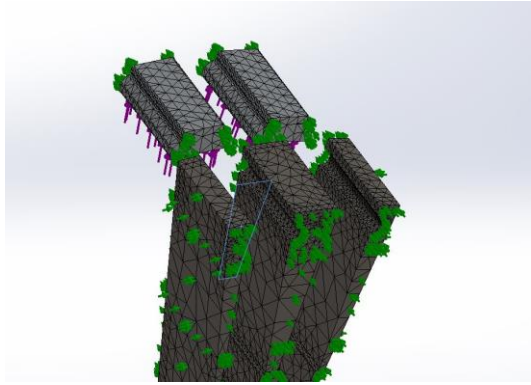
The meshing and restraints used the same symmetry principle as for the simple FEA model, with the contacting flanks of the wedge ‘mated’ to the rotor slot profile for a ‘no penetration contact’. This contact allows for sliding motion between the two faces and more realistic simulation; NB the figures below show the model in an ‘exploded view’.

Figure 16. Medium mesh with wedges in exploded view

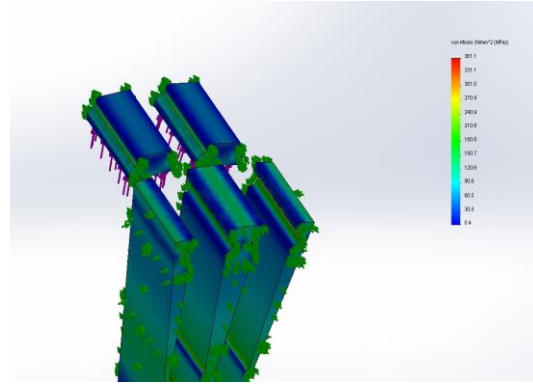
Figure 17. Stress pattern

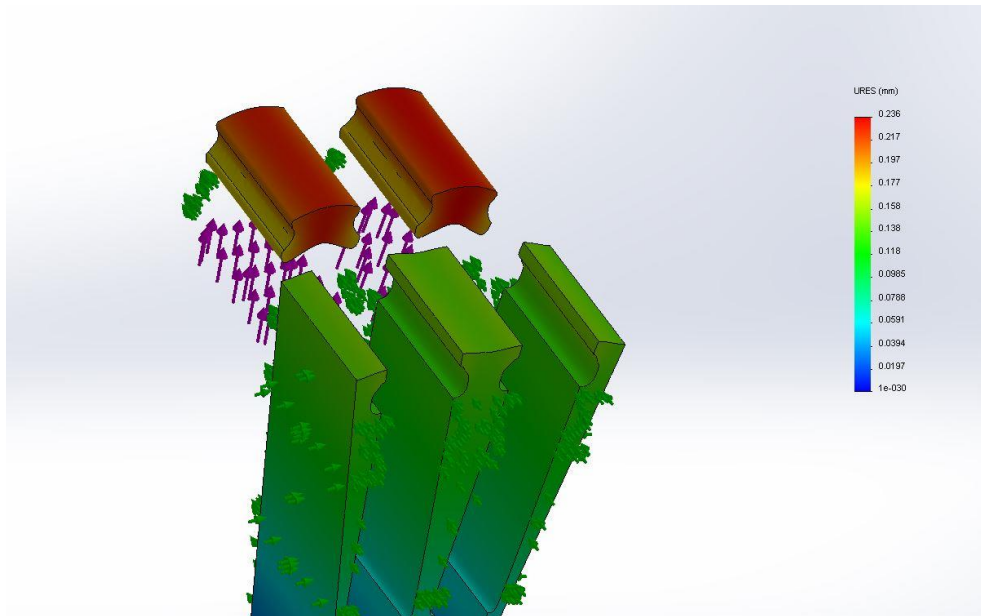
Figure 18. Displacement pattern

This also confirmed that the bending stress on the aluminium wedge remained within a reasonable level, despite in the slight increase in span.
