A2 - Power Transformers & Reactors  
PS 1 / Experience and New Requirements for Transformers  
for Renewable Generation

**Condition Assessment of HVDC converter transformers at limited time of  
outage applied to the Fenno–Skan 1 transmission system**

Fenno–Skan 1 is the HVDC transmission system between Dannebo in Sweden and Rauma in Finland. The transmission system has been in service since November 1989, and after more than 30 years of successful operation it has become necessary to evaluate operational risks of the converter transformers and make a strategic decision on the possibility of extending their expected service lifetime.

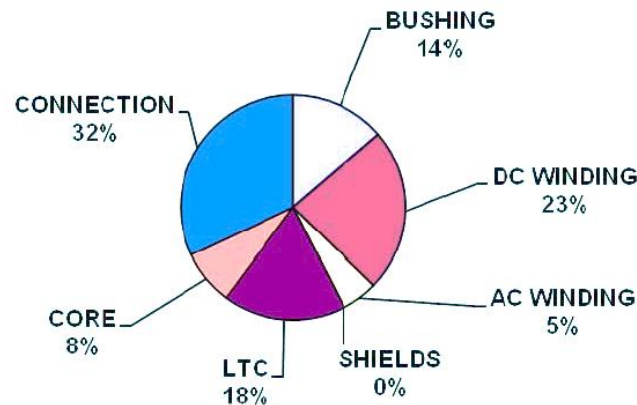
- HVDC transformers are specific in design as well as the operational stresses they face during operating life [4]. This leads to differences in failure distribution by component (see for example Figure 1) and influences the choice of methods utilized for condition assessment.

Figure 1. Failures of HVDC transformers by component 2003 -2012 [5]
