Analysis of Failed Cable Termination: Role of Workmanship and Electrical Stresses**Nitin R SHINGNE*, Gaurav S DHIMAN, Uday N PUNTAMBEKAR, Satish H CHETWANI****Electrical Research and Development Association (ERDA), Vadodara
India****nitin.shingne@erda.org; gaurav.dhiman@erda.org; uday.puntambekar@erda.org;
satish.chetwani@erda.org****SUMMARY**

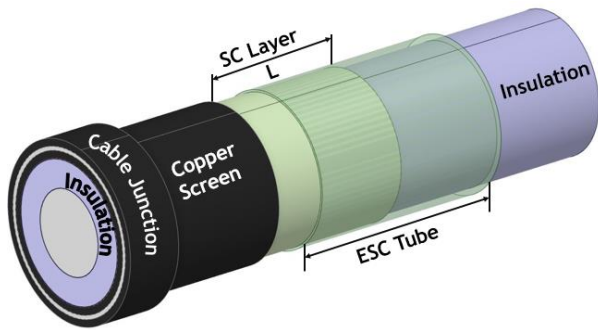
Figure 13: Sketch of cable termination components near cable junction

The ESC tube overlaps the XLPE insulation with semiconducting layer as shown in Figure 13. At the edge of semiconducting tube, when covered with ESC tube, three interfaces are overlapping which are: XLPE insulation, semiconducting layer edge and ESC tube, this junction is called ‘triple point’. In this simulation work, electrical stress at the triple point is evaluated as the actual length observed in the cable termination prepared on site and compared with an optimised case where the electrical stresses are minimised.

- length of semi-conducting (SC) layer (L) measured from edge of copper screen (Figure 13) = 65 mm,
- Length of electrical stress control (ESC) tube
 1. Actual length = 30 mm from triple point
 2. Proposed optimised length used for simulation = 10 mm

- Length of semi-conducting layer (L) = 30 mm
- Length of electrical stress control (ESC) tube
 1. Actual length = 30 mm from triple point
 2. Proposed optimised length used for simulation = 10 mm

Case-II (Proposed changes): All the above dimensions of cable termination remains same but dimensions of semi-conducting layer and ECS tube are modified as -
