**Lightning strike to ground – a case study about observed cable damages, risk estimation and protection method**

**Valentinas DUBICKAS\*, Erik THUNBERG, Johan HANSSON**  
**Svenska kraftnät**  
**Sweden**

**SUMMARY**

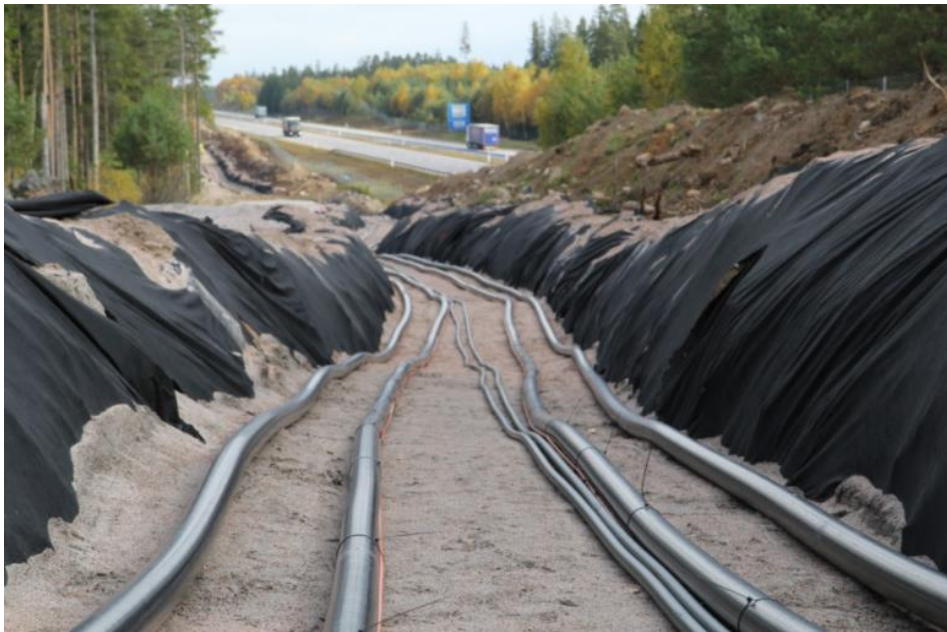
*Figure 1 The cable systems during installation.*

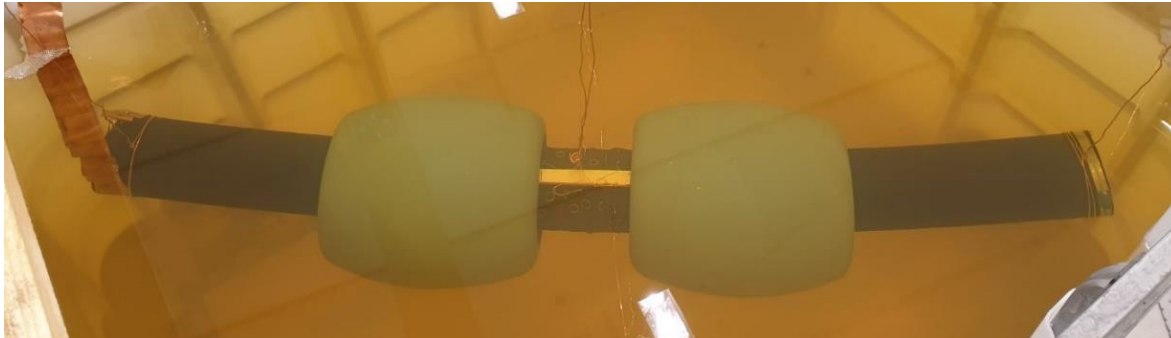
*Figure 4 Testing setup. In the picture can be seen: two bluish/grey metallic torus electrodes on the cable sample, brighter stripe in the middle is a small wooden plank for mechanical support for torus electrodes, copper wire connecting test electrode to impulse generator, copper tape connecting screen wires to earth.*

The irregularities due to sheath scrapping and small deformations of aluminium laminate causes local increase of electric field, however such conditions are considered to reflect the actual conditions in field. Considering the breakdown voltage stated above and sheath thickness of 4,5 mm the effective lightning breakdown field strength of the sheath was found to be ca 25-31 kV/mm.

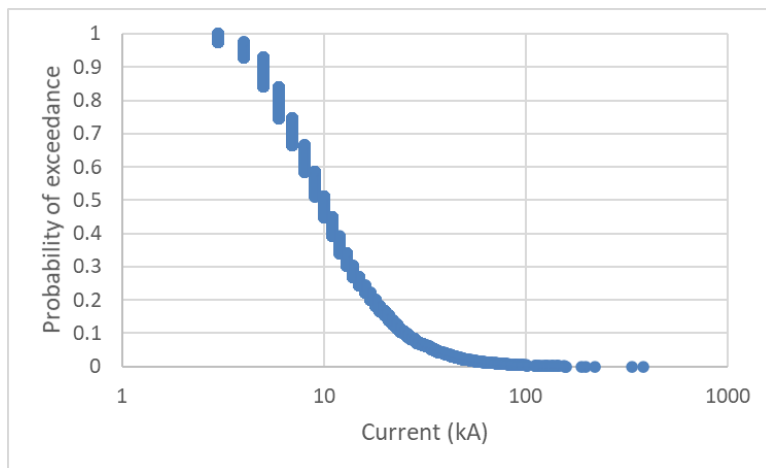
For the case studies presented in this paper, the lightning data is limited to ground strikes within an area corresponding to a 10 km wide corridor along the cable section of SWL. A summary of the data received for the period January 2013 to June 2020, corresponding to the period in which the cables have been laid, is presented in Table I. The average number of ground strikes within the SWL corridor is estimated at 0,59 per km<sup>2</sup> and year. A cumulative distribution of registered currents is shown in Figure 6.

Figure 6 Distribution of lightning strikes to ground within the 10 km wide corridor along SWL during the period January 2013 to June 2020.
