Investigation of Cause of Breakdown and Replacement of 275 kV SCOF Cable by XLPE Cable in Japan

Yusuke IKEDA*
Tomoteru KYOGOKU
Tepco Power Grid, Inc.
Japan

Kozo SUZUKI, Tai YOKOYAMA,
Takayuki MINAMI
Sumitomo Electric Industries Ltd
Japan

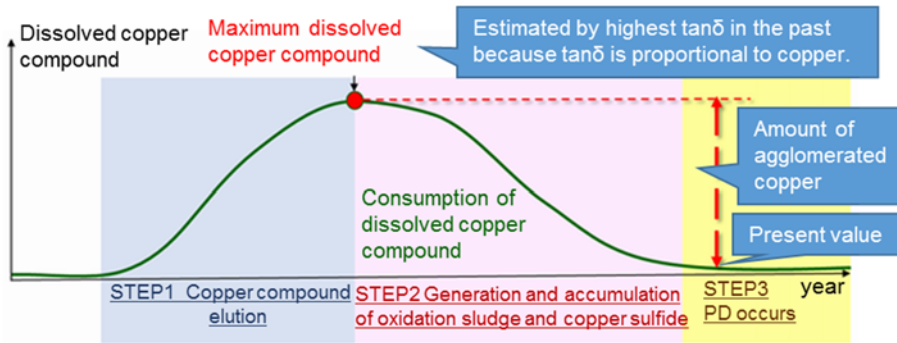
Fig. 13 Concept of diagnostic method using ICP measurement

ICP diagnosis is a diagnostic method for determining the progress of imposed deterioration based on the amount of dissolved copper and the amount of gas generated. The diagnosis results were compared with the results of dismantling surveys and were reported to be approximately 96% consistent. [4]

We applied the ICP diagnosis method to the other joints on the same line. The result of ICP diagnostic method showed a joint that had the worst abnormal rank.

Thereafter, we carried out a removal and dismantling survey of this joint, and found similar deposits, discoloration, and layering in the cable section near the joint. These results demonstrated the validity of the ICP diagnosis results. Based on the results of the insulation breakdown and dismantling survey, we decided to apply this method on a full scale.

As a future preventive measure, we applied a new diagnostic method (ICP imposed deterioration diagnosis) that can detect the above degradation process (copper dissolution is a crucial factor).
